72-16-02 R3 BEECH: Amendment 39-1494 as amended by Amendment 39-1549 and 39-2211 is further amended by Amendment 39-4085. Applies to Beech Models C45G, TC-45G, C-45H, TC-45H, TC-45J (SNB-5), RC-45J (SNB-5P), D18C, D18S, E18S, E18S-9700, G18S, H18, JRB-6, 3N, 3NM and 3TM Aircraft certificated in all categories with STC SA4-1531, STC SA111WE, STC SA1832WE or any other STC modification incorporating the provisions of the Volpar Tri-Gear Installation.

1. Nose Landing Gear Fork

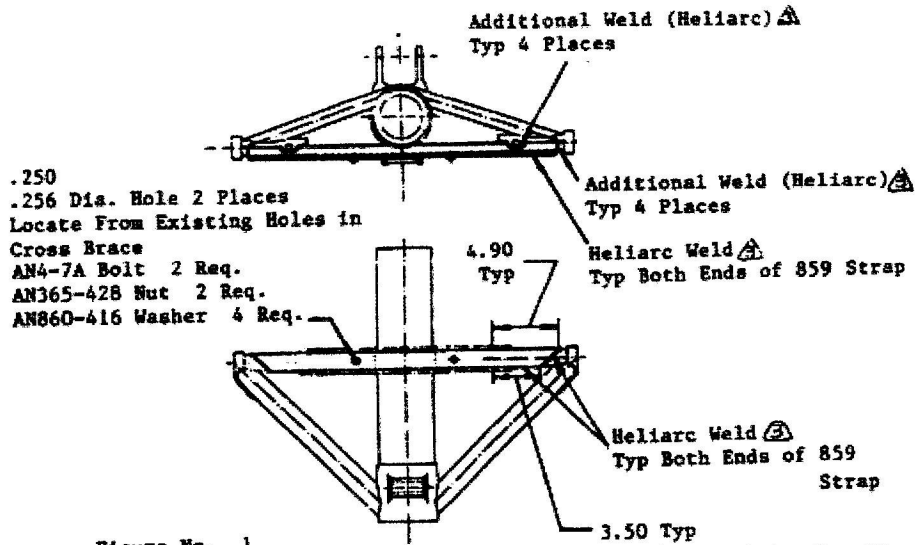
Figure No. 1
 (AD 72-16-2)

c. If no cracks are found by the inspections per paragraph 3a. above, modify cylinder and top brace assembly with Volpar P/N 859 strap reinforcement prior to further flight in accordance with the attached Figure No. 1.

NOTE: Following the installation of the reinforcement, reinspect the top brace assembly for cracks using magnetic particle inspection method per MIL-I-6868. If cracks are found, repair in accordance with FAR Part 43 prior to further flight.

5. After Welding, Paint Non-Plated Weld Areas with Zinc Chromate and then Aluminum Lacquer.
4. Heliarc Weld in accordance with the requirements of FAR 43. Δ Before Welding, Remove Cadmium Plating in Areas to be Welded.
2. Magnetic Particle Inspect 404-188406 Cylinder 4 Top Brace Asst Per Mil-I-6868 Before and After Welding.
1. Disassemble Beech 414-188400-1 or 404-188400-600/-601 Shock Absorber Assy to Obtain 404-188406 Cylinder Top Brace Assy. Part of Original Airplane. Not Furnished with Kit.

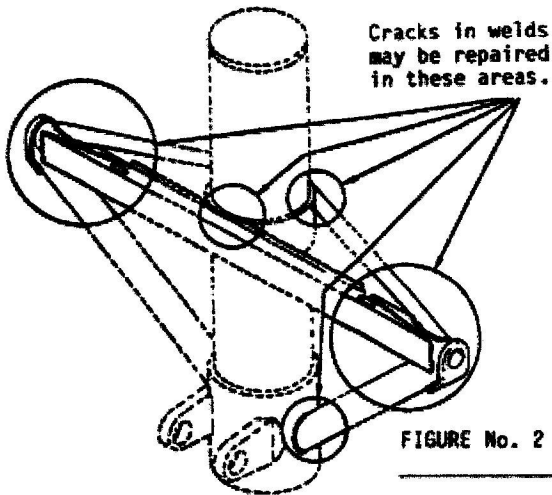
FIGURE No. 2
 (AD 72-16-2)

NOTE: The repair is restricted to the areas shown on the attached Figure No. 2. If cracks are found in areas other than shown, disassemble shock strut and replace cylinder and top brace assembly as follows:

b. If cracks are found by the inspections per paragraph 3a. above, repair in accordance with FAR Part 43 prior to accomplishing modification per paragraph 3c. below.
