**75-27-09 R2 BEECH:** Amendment 39-2482 as amended by Amendment 39-2591 is further amended by Amendment 39-3878. Applies to all Beech 18 series airplanes including military counterparts and other counterparts approved by Supplemental Type Certificates (STCs), regardless of the category or categories of airworthiness certification.

COMPLIANCE: Required as indicated. To prevent possible failure of wing structure, accomplish the following for the left and for the right sides of each affected airplane.

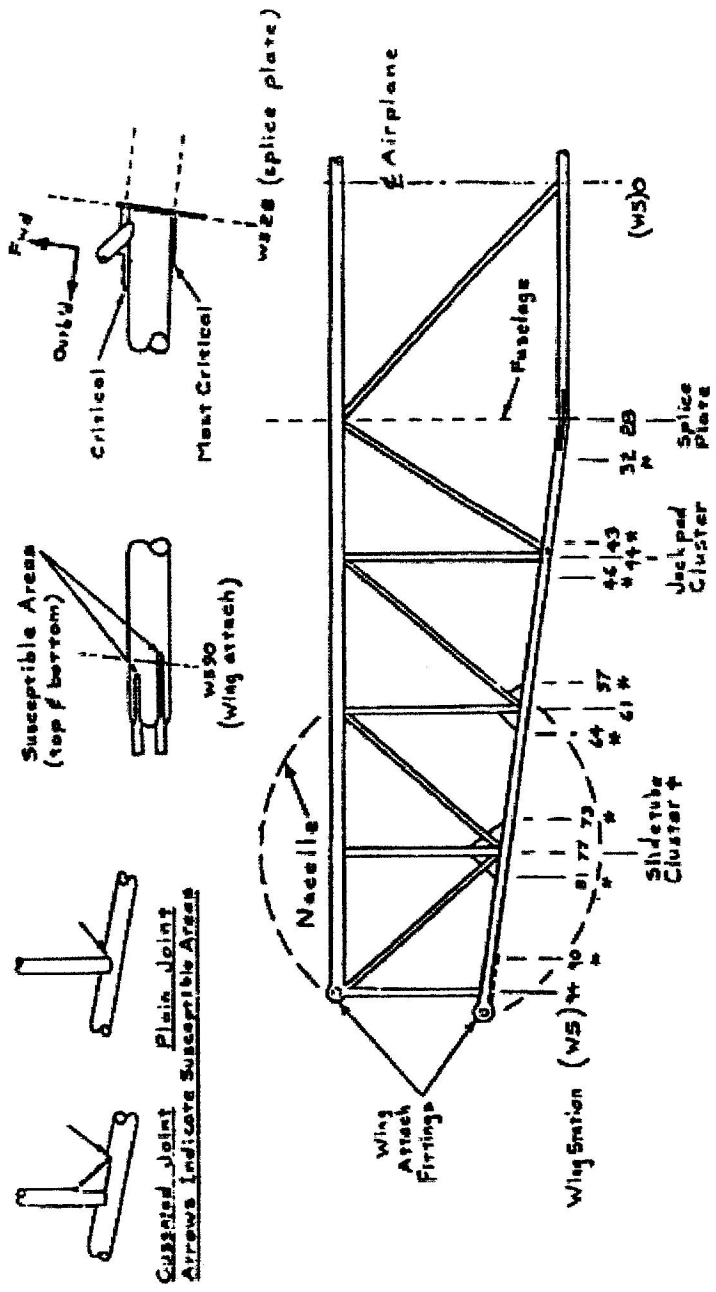
FIGURE 1 AD 75-27-09

Half of Main Spar Center Section Truss

\* INDICATES AREAS TO BE INSPECTED PER THIS A.D.

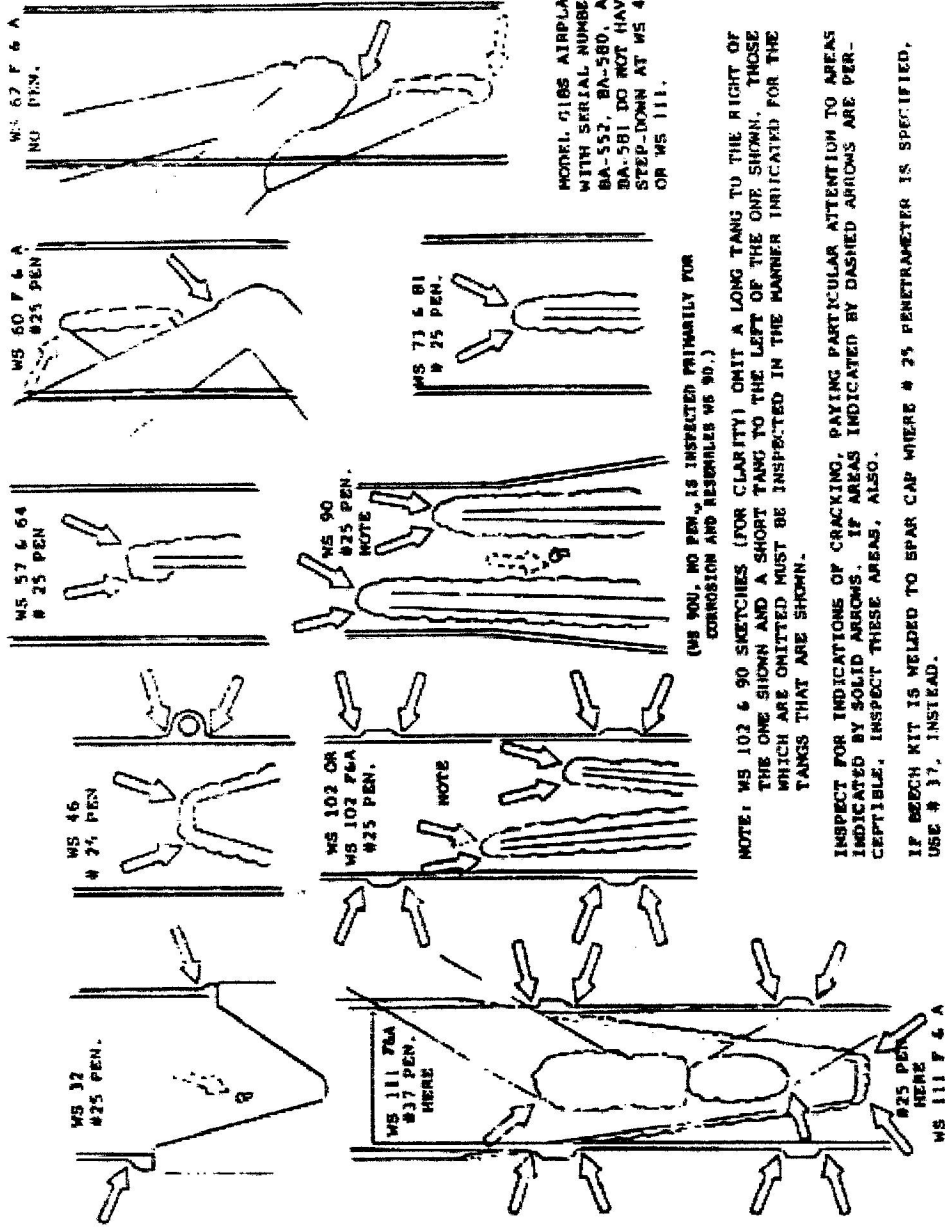
FIGURE 4 AD 75-77-09

(MS 90, NO PEN., IS INSPECTED PRIMARILY FOR CORROSION AND RESORLES MS 90.)

NOTE: MS 102 & 90 SKETCHES (FOR CLARITY) OMIT A LONG TANG TO THE RIGHT OF THE ONE SHOWN AND A SHORT TANG TO THE LEFT OF THE ONE SHOWN. THOSE WHICH ARE OMITTED MUST BE INSPECTED IN THE MANNER INDICATED FOR THE TANGS THAT ARE SHOWN.

e) Ascertain that neither the airplane nor the source will be moved by wind or other influences, and expose the film so as to obtain 1.5 to 2.8 radiographic density near inspection sites specified in Figure 4 of this directive. Use the same kinds of film and exposure time for WS 62 sites as for WS 60 sites.

INSPECT FOR INDICATIONS OF CRACKING, PAYING PARTICULAR ATTENTION TO AREAS INDICATED BY SOLID ARROWS. IF AREAS INDICATED BY DASHED ARROWS ARE PERCEPTIBLE, INSPECT THESE AREAS, ALSO.  
IF BEECH KIT IS WELDED TO SPAR CAP WHERE # 25 PENETRATOR IS SPECIFIED, USE # 37, INSTEAD.
