**78-10-01 BEECH:** Amendment 39-3210. Applies to Beech Models D18C, D18S, E18S, E18S-9700, G18S, H-18, C-45G, TC-45G, C-45H, TC-45J (SNB-5), JRB-6, 3N, 3M and 3NM modified in accordance with STC SA1243WE, SA1016WE, or SA360WE.

DOCKET NO. 78-WE-4-AD

AD 78-10-01

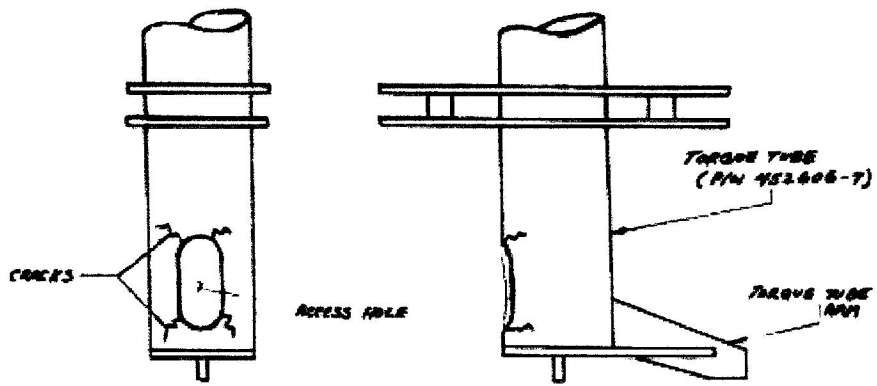
FIGURE 1

(a) Within the next 30 days after the effective date of this AD visually inspect the lower rudder torque tube for cracks in the area of the access hole as noted in figure 1 of this AD. (Reference Part Number 452606-7).

LOWER RUDDER TORQUE TUBE

(1) If any crack exceeds 1/2 inch in length, replace with a like serviceable unit, Part Number 452606-7, and reinspect per paragraph (d);

(2) If cracks are 1/2 inch or less in length, repair per a method approved by the Chief, Aircraft Engineering Division, FAA Western Region, and reinspect per paragraph (d);
