# ENGINEERING MEMORANDUM

TITLE <b>REPAIR - FLAP GEAR BOX GEAR</b>		E.M. NO. 11994 "8"	FILE CODE 111-41
PART NO. 187796-2		EFFECTIVE <b>Immediately</b>	
PART NAME <b>Flap Gear Box Gear</b>		DWG. NO.	COPIES TO NO.
USE OF E.M.		JOB NO.	ENG. 2
SALVAGE <input checked="" type="checkbox"/>	DISPOSITION OF STOCK	CUSTOMER'S ORDER NO.	INSP. 6
CONCESSION			PROD. 9
STOP ORDER/RELEASE	CHECK BLOCKS AFFECTED	CUSTOMER <b>RCAF</b>	PLANNING 2
NEW DRAWING			REWORK
REVIS. DRAWING	NOT AFFECTED	TYPE AIRCRAFT <b>Expeditor 3</b>	CONT. ADM. 1
VARIATION	USE TO DEPLETION		R.C.A.F. 3
OBSOLETE NOTICE	REWORK	AIRCRAFT REGISTRATION NO.	ESTIMATING 1
USE AS NOTED <input checked="" type="checkbox"/>	SCRAP		DATE May 31/56
	AS NOTED	DWG. CHANGE	DWG. CONT. 3
		YES <input type="checkbox"/> NO <input checked="" type="checkbox"/>	
APPROVALS	ORIGINATED BY <i>H. R. ...</i> B. A. W. PROJ. ENG.		
	<i>R. ...</i> B. A. W. INSPECTION		
	<i>J. ...</i> ENGINEERING	<i>E. ...</i> CONTRACTS ADMIN.	<i>J. ...</i> CHIEF

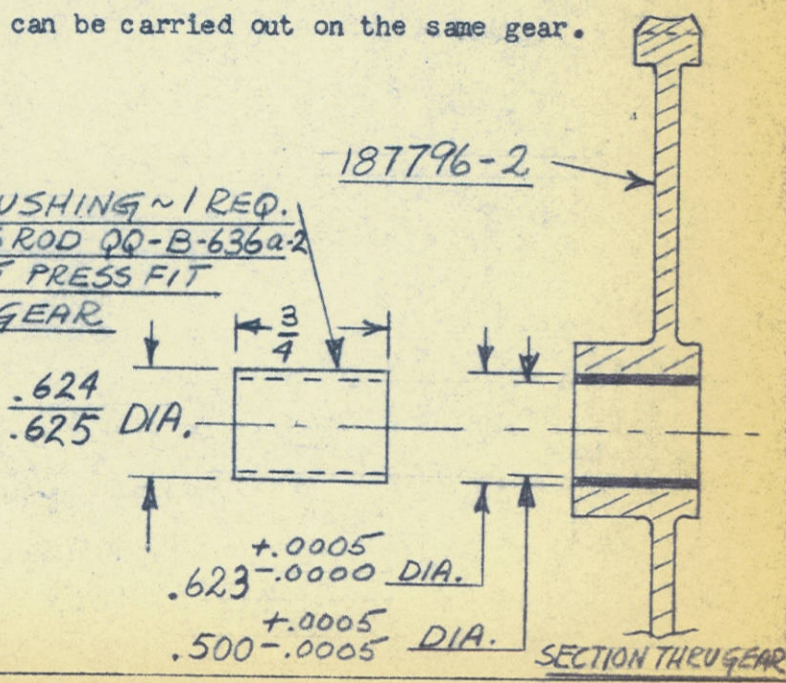
Several cases have been experienced where the flap gear box gear has elongated taper pin hole and/or elongated hole for the gear shaft.

**-3 BUSHING ~ 1 REQ.**  
**BRASS ROD QQ-B-636a-2**  
**SLIGHT PRESS FIT**  
**INTO GEAR**

**ISSUE B - ALTERNATE**  
**MATERIAL: SAE 72**  
**BRASS QQ-B-626**  
**1/2 HARD.**

- Elongated taper pin hole.  
Redrill 90° to existing hole.
- Elongated hole for gear shaft  
Drill out and rebush as shown in sketch below. If the flange is cracked, rebushing is not to be carried out. GEAR IS IN SUCH CASES TO BE REJECTED.
- Repair as in para. 1 and 2 can be carried out on the same gear.
