ENGINEERING MEMORANDUM

SLEEVE REPAIR TO TRUSS AT 189212 ATTACHMENT.

E. M. NO.		12066		FILE CODE	111
EFFECTIVE		48 required		COPYES TO	NO
DWG. NO.	JOB NO.		CUSTOMER'S ORDER NO.	ENG.	3
CUSTOMER		RCAP		INSPEC	6
TYPE AIRCRAFT		Expeditor		PROD	9
AIRCRAFT REGISTRATION NO.		PLANNING		PLANNING	2
DATE		JUL 14/56		MAT. CONT.	2
DWG. CHANGE		YES		CONT. ADM.	1
NO		NO		R.C.A.F.	2
				FIELD	1
				DWG. CONT.	4

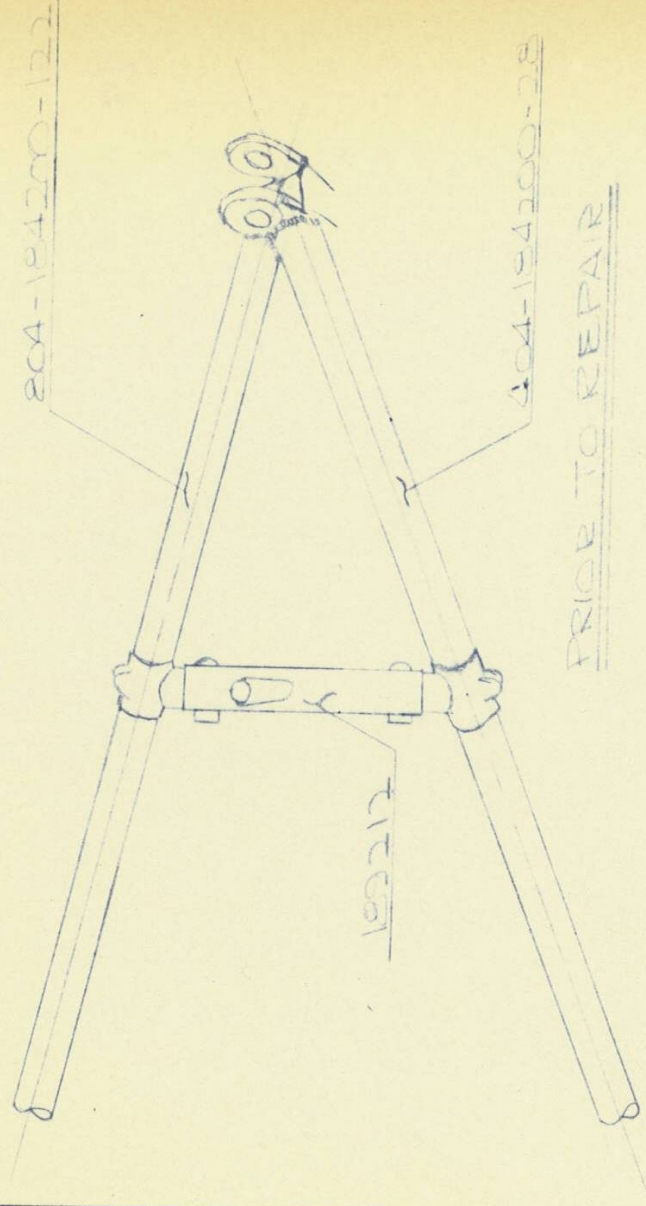
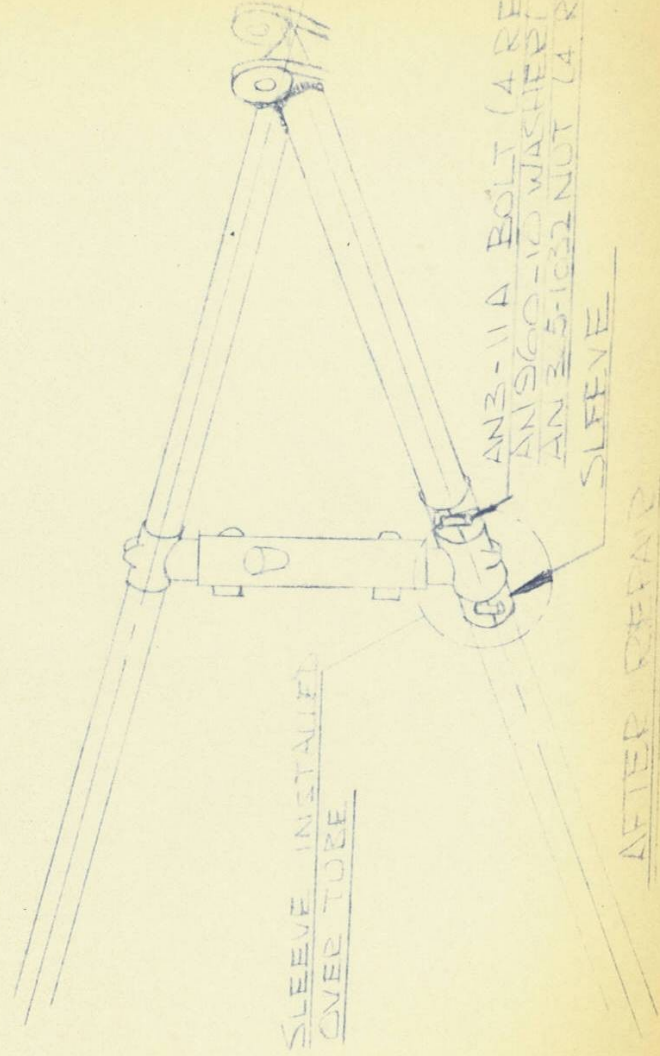
SLEEVE REPAIR TO TRUSS
AT 189212 ATTACHMENT

Cases of considerable wear have been encountered on the Expeditor truss at points of attachment of 189212 bracket since the bracket is frequently improperly secured. As a result, wear occurs under the action of vibration and backfiring.

In cases where truss tubes 404-184200-28 and 804-184200-122 wear at the points of attachment of 189212 Bracket the following repair scheme may be used. This repair scheme is restricted to cases of minor wear only. Where wear or corrosion greater than .008" occurs the Engineering Department must be consulted. For the repair, see the attached sketches.

1. Clean the truss tube (s) being repaired and clean out corrosion by means of steel wool, in such a manner as to have no sharp change in cross section.
2. Prime with zinc chromate primer to MIL-P-6889.
3. Prime the sleeve with zinc chromate primer to MIL-P-6889.
4. Install the sleeve (s) in such a manner that the bracket can be installed in accordance with drawing 189210.
5. Paint the whole assembly with aluminum lacquer to MIL-L-7178.

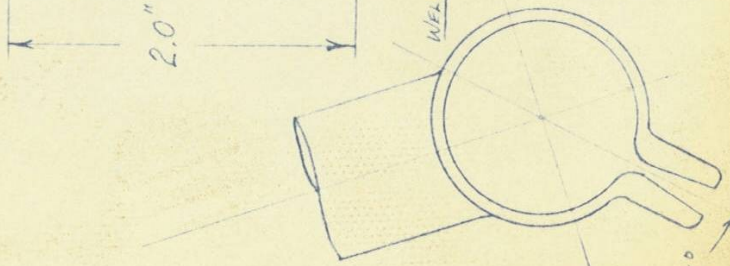
LOWER CLAMP - REPLACES

WHERE THE REPAIR SCHEME CALLED UP IN
THIS E.M. IS EMPLOYED, THE CLAMPS 189211
AND 189213 WILL HAVE TO BE REPLACED WITH
NEW CLAMPS AS SHOWN IN THE DIAGRAMS:

AN 741-9 CLAMP
1 REQ'D

$\frac{1}{8}$ x .058 TUBE
