ENGINEERING MEMORANDUM

SERVICEABILITY CONCEPT
LORD MOUNTS

E.M. NO. 12070

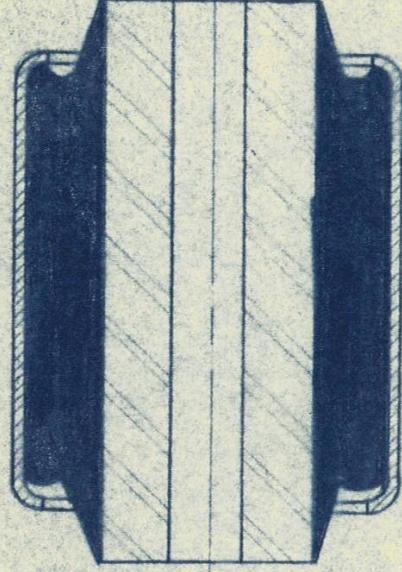
FIG. 1 - NORMAL MOUNT
(No Load)

The conditions illustrated in figures 1 - 3 inclusive are normal and are not cause for rejection. The nicks or cuts in the rubber caused by the outer shell, are a result of extreme loading conditions. These, however, do not affect the main body of the rubber or its function.

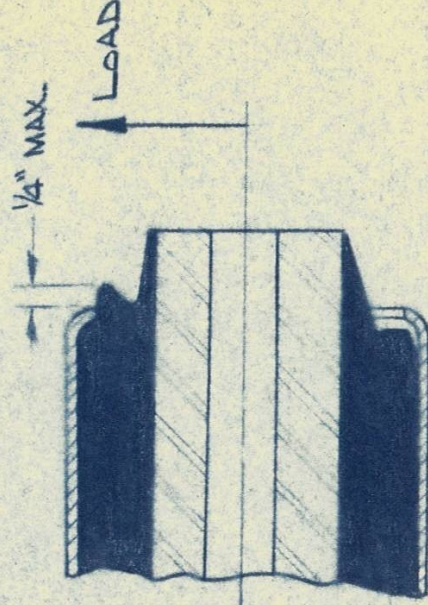
FIG. 2
(LOADS)

RUBBER CUT BY
FLANGE OF SHELL

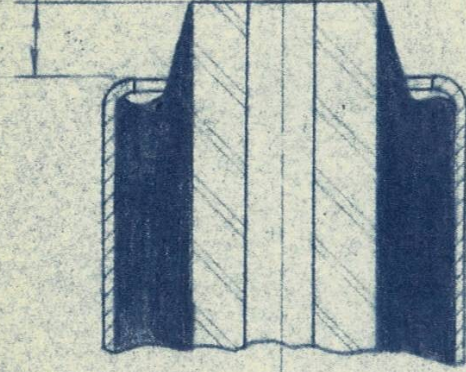
FIG. 4

In cases of doubt, the mount should be examined for the conditions shown in figures 4 and 5. This examination is to be done under "no load" conditions and this may be accomplished by taking up the weight of the engine by a crane and making the measurements prescribed.

.20-.000 MIN.
ON BOTH ENDS

THIS IS A MINIMUM,
THE DIMENSION MAY
BE CONSIDERABLY
LARGER THAN THIS

If a mount exceeds any of the above, it must be replaced by a new part.

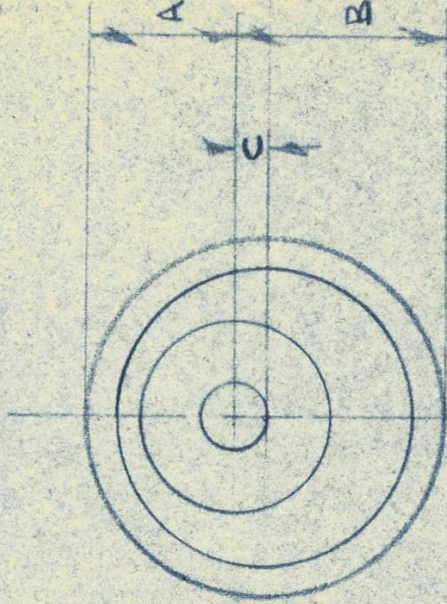
FIG. 5

DIRECTION OF
MAX. ECCENTRICITY

NOTE: $B-A = .020^{+0.000}$ MAX
OR $C = .045^{+0.000}$ MAX

THESE ARE MAX. LIMITS,
BUT IN ACTUAL CASES THE
DIMENSIONS MAY BE
CONSIDERABLY LESS.
