ENGINEERING MEMORANDUM

BRISTOL AIRCRAFT (WESTERN) LIMITED
WINNIPEG CANADA

TITLE Concession - Scored Crankshaft on R985 Engine Serial # 20886				E.M. NO. 12261		FILE CODE											
				EFFECTIVE R985 Engine Serial # 20886		111 -51											
PART NO. R985 - AN14B		PART NAME Engine		DWS. NO.		COPIES TO											
JOB NO.						NO.											
USE OF E.M.		DISPOSITION OF STOCK		CUSTOMER'S ORDER NO.		INSPEC											
SALVAGE		<table border="1" style="font-size: small;"> <tr> <th>CHECK BLOCKS AFFECTED</th> <th>NOT AFFECTED</th> <th>USE TO DUPLICATION</th> <th>REWORK</th> <th>EXCHG</th> <th>AS NOTED</th> </tr> <tr> <td></td> <td></td> <td></td> <td></td> <td></td> <td></td> </tr> </table>		CHECK BLOCKS AFFECTED	NOT AFFECTED	USE TO DUPLICATION	REWORK	EXCHG	AS NOTED							PROD. 9	
CHECK BLOCKS AFFECTED	NOT AFFECTED			USE TO DUPLICATION	REWORK	EXCHG	AS NOTED										
CONCESSION <input checked="" type="checkbox"/>				CUSTOMER H.C. A.F.		PLANNING 2											
STOP ORDER/RELEASE				TYPE AIRCRAFT Expeditor 3TM		MAY. CONT. 2											
NEW DRAWING		PARTS COMPLETED		DATE 9 APR 57		CONT. ADD. 1											
REVISED DRAWING		PARTS IN PROCESS		D.V.O. CHANGE		I.O.A.P. 3											
VARIATION		TOOLING

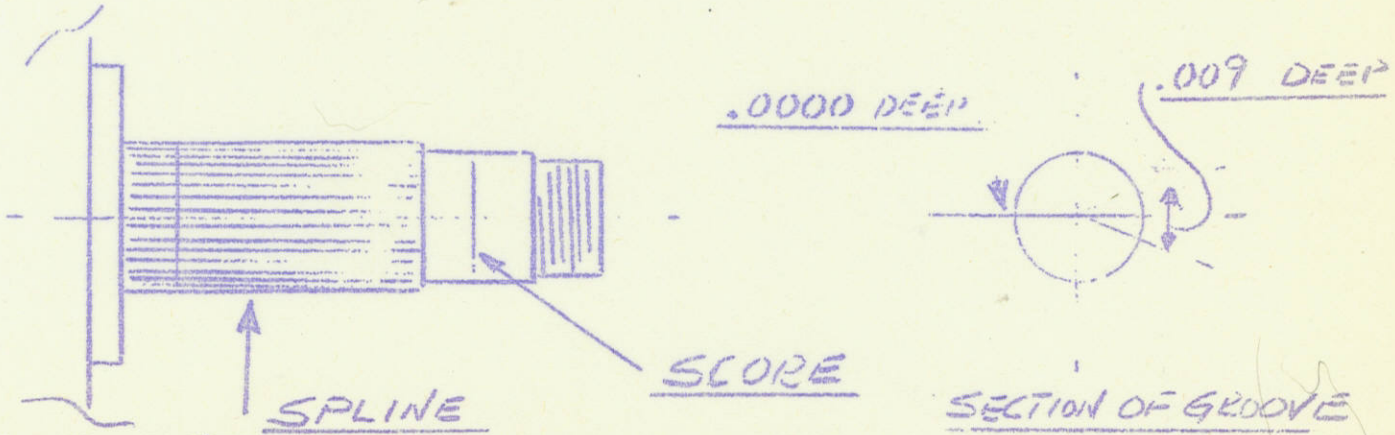
A groove has been found on the crankshaft on the starboard engine on A/C 1560. This groove is .009 inches deep over a small portion of the circumference, and it gradually decreases to zero. It is located as shown in sketch below.

The scoring is probably caused by foreign matter present when installing the propeller.

This engine will be declared serviceable, providing all sharp edges are rounded off using a large radius and the surface is polished smooth. The groove is to be ~~concealed~~ **magnafluxed** after polishing.
