# ENGINEERING MEMORANDUM

**Repair scheme - Grooves on Underside of Wing  
at Root**

F.S. NO. 12292

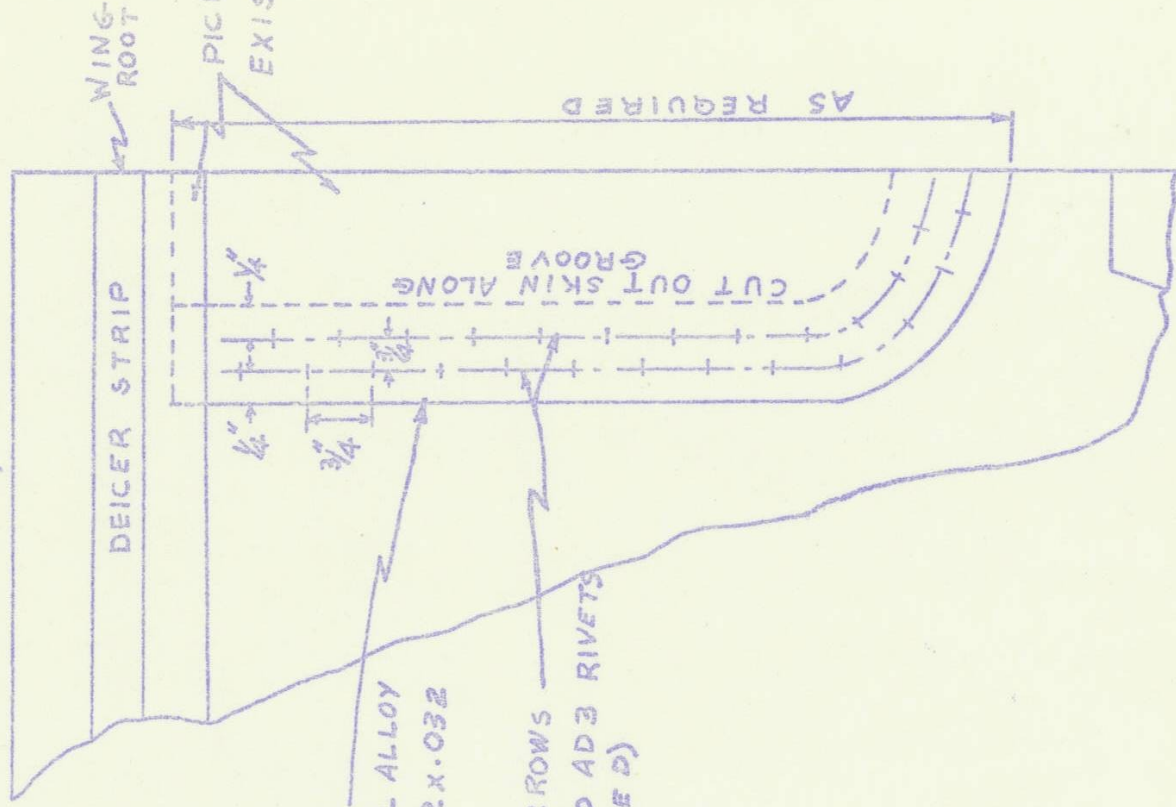
VIEW LOOKING UP

Cases have been noted of grooves occurring in de-icer strip and wing skin at wing root. for details Ref ER 2621

SKIN -- If the skin is lightly grooved, test groove IAW EM 12280 Para 3-7 inc. (If the a/cled is penetrated, the chromic acid solution should be 10%) If the skin is heavily grooved, repair as shown in sketch attached. This repair is typical. Adjustments will have to be made to suit circumstances.

PATCH ~~TO~~  
2024-T4 AL ALLOY  
TO QQ-A-362 X.032

RIVETS - 2 ROWS  
USE AN470 AD3 RIVETS  
(STAGGERED)
