TITLE REPAIR SCHEME - FLOOR BOARD
BRAKE LINE

12294

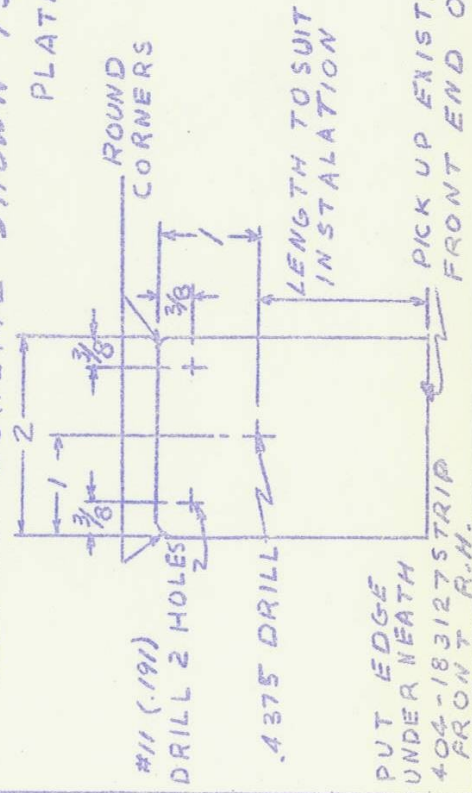
THE FLOOR BOARD, PILOT'S COMPARTMENT, R.H. HAS BEEN DAMAGED DUE TO EXCESSIVE TIGHTENING OF THE PIPING UNIONS AND THE SECURING NUTS. AS A RESULT OF THIS, THE UNIONS ARE LOOSE CAUSING DAMAGE TO FLARED ENDS AND IN SOME CASES THE PIPING IS FREE TO VIBRATE DUE TO THE FLOOR COMPLETELY BREAKING AWAY LOCALLY. TO RECTIFY THIS SITUATION THE REPAIR SCHEME SHOWN IS TO BE USED.

PLATE-2024 - 50, 5 T-X.064" TK.
 QQ-A - 355 OR 362
