ENGINEERING MEMORANDUM

TITLE REPAIR SCHEME - REPLACING EXISTING
SCREW AND WASHER ON RACK ASSEMBLY
FOR RECLINING CHAIR

12318

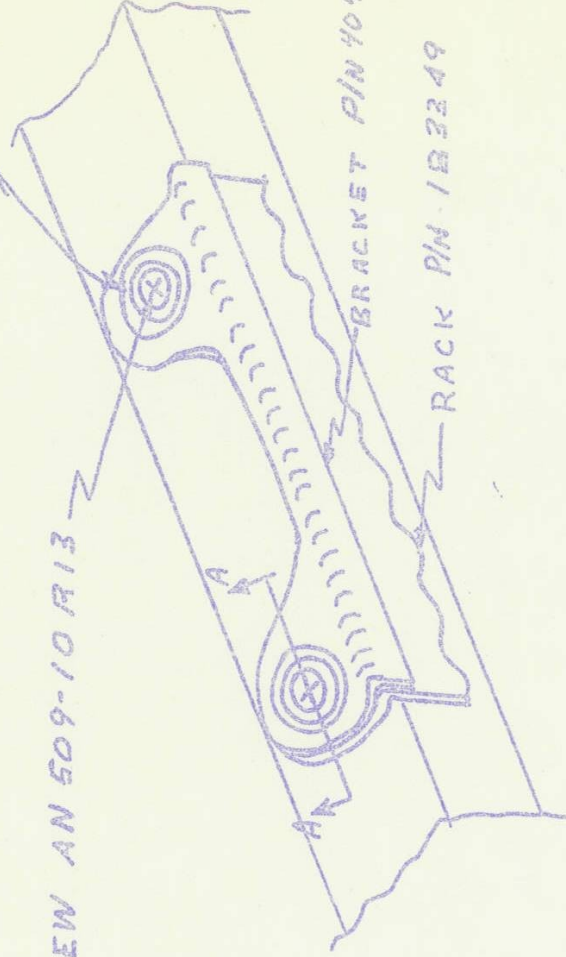
SECTION A-A

TO PROVIDE FOR SMOOTHER SLIDING ACTION ON RECLINING SEATS, THE FOLLOWING REPLACEMENTS SHALL BE MADE AND PROCEDURE CARRIED OUT.

1. REMOVE EXISTING SCREWS (P/N AN520-10-12) AND WASHER (P/N 100951-DD-187-006)
2. ENLARGE EXISTING HOLES ON BRACKET P/N 404-183302-195 BY DRILLING TO 5/16"
3. 100° COUNTERSINK ON RACK P/N 183349
4. REASSEMBLE RACK USING:

WASHER - TINNERMAN P/N A3235-020
SCREW - P/N AN509-10R13

WASHER IS PLACED DIRECTLY UNDER HEAD OF SCREW.

WASHER PIN A3235-020 (TINNER MAN)

SCREW AN 509-10 R13
