ENGINEERING MEMORANDUM

TITLE REPAIR SCHEME PILOT'S BALANCE CABLE PULLEY BRACKET		E.M. NO. 12326	FILE CODE 111 -41
EFFECTIVE AS REQ'D		DWS. NO.	
JOB NO.		COPIES TO	
CUSTOMER'S ORDER NO.		ENCL.	3
CUSTOMER RCAF		INSPECTION	6
ORIGINATED BY <i>A. W. PROUL</i>		PROG.	5
TYPE AIRCRAFT EXPEDITE		PLANNING	2
AIRCRAFT REGISTRATION NO.		SAT. CONT.	2
DATE 17/1/51		CONC. ADJ.	1
DWS. CHANGE YES <input checked="" type="checkbox"/> NO <input type="checkbox"/>		G.O.A.F.	3
DWS. CONT.		ESTIMATING	1
APPROVALS		DWS. CONT. 4	
ENGINEERING <i>[Signature]</i>		CONTRACTS ADMIN. <i>[Signature]</i>	
		CUSTOMER <i>[Signature]</i>

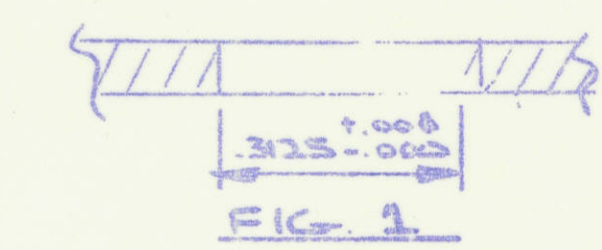
ELONGATED HOLES, FOR THE PULLEY SWIFT, IN THE BRACKET WILL BE REPAIRED AS FOLLOWS:

1. REAM EXISTING HOLES AS SHOWN (FIG 1)
2. MANUFACTURE BUSHINGS (FIG 2)
3. INSTALL BUSHINGS WET WITH ZINC CHROMATE PRIMER TO MIL-P-6889
4. REAM 1/4 AS SHOWN IN LINE WITH EXISTING HOLES. (FIG 3)
