TITLE Repair Upper Tail Truss Bearing		E.M. NO. 12123	FILE CODE 111-22
EFFECTIVE As Required			
PART NO.	PART NAME	DWG. NO.	COPIES TO
		10-9192	NO.
USE OF E.M.		CUSTOMER'S ORDER NO.	NO.
DISPOSITION OF STOCK		CUSTOMER	NO.
SALVAGE	CHECK STOCKS AFFECTED	R.C.A.B.	ENCL. 2
CONDESNON			INSPEC. 6
STOP ORDER/RELEASE	NOT AFFECTED	Expeditor 3	PROG. 9
NEW DRAWING			PLANNING 2
REVISED DRAWING	USE TO DEPLETION	TYPE AIRCRAFT	MAT. CONT. 1
VARIATION	REWORK		CONT. ADM. 1
OBSCLETE NOTICE	REWORK	AIRCRAFT REGISTRATION NO.	R.C.A.P. 3
USE AS NOTED	REWORK	DATE	ESTIMATING 1
	REWORK	DWG. CHANGE	DWG. CONT. 6
	REWORK	YES <input type="checkbox"/> NO <input checked="" type="checkbox"/>	
	REWORK	YES <input type="checkbox"/> NO <input checked="" type="checkbox"/>	
APPROVALS		DATE 18 Sept. 57	
ENGINEERING: <i>[Signature]</i> CONTRACTS ADMIN.: <i>[Signature]</i> CUSTOMER: <i>[Signature]</i>

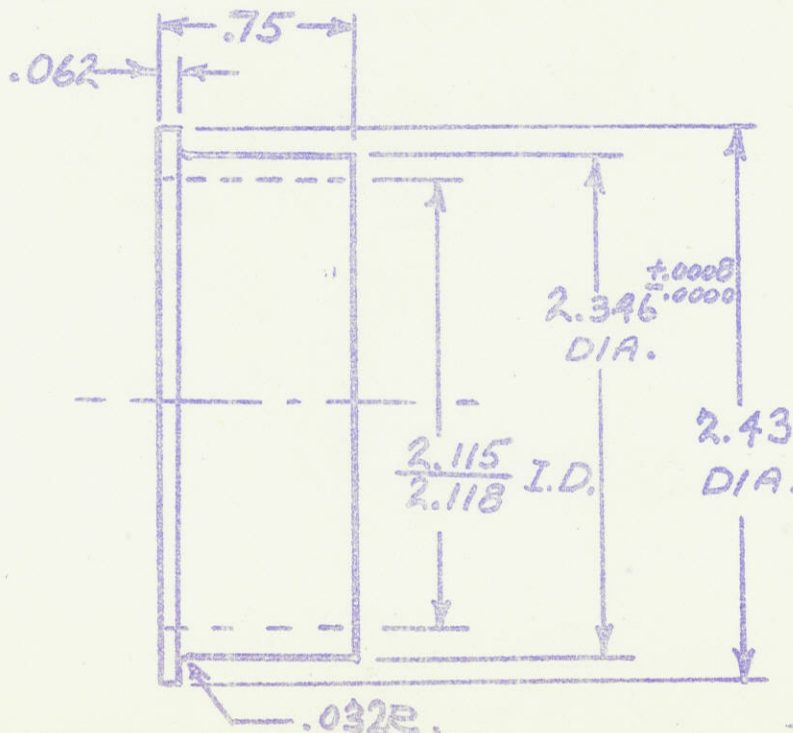
A case has occurred where the upper bushing 404-188687 in the tail wheel truss assembly has been found loose. This is due to the machined portion in the truss assembly being oversize.

This condition will be corrected by fabricating a new bushing to sketch shown below. The inside diameter of the bushing is to be met after installation.

This M.I. may be applied to general cases by making the outside diameter of the bushing equal the measured inside diameter of the truss plus

$\pm .0008$ inch.
- .0000

MAKE FROM
BRONZE SPEC.
QQ-B-746
COMP. A
