Repair - Tail Wheel Truss  
Attachment #13 Bldg.

REF: 12722  
A/C 2293

Damage to No. 13 bulkhead and tail wheel truss attaching points on Expeditior 2293 may be rectified as follows:

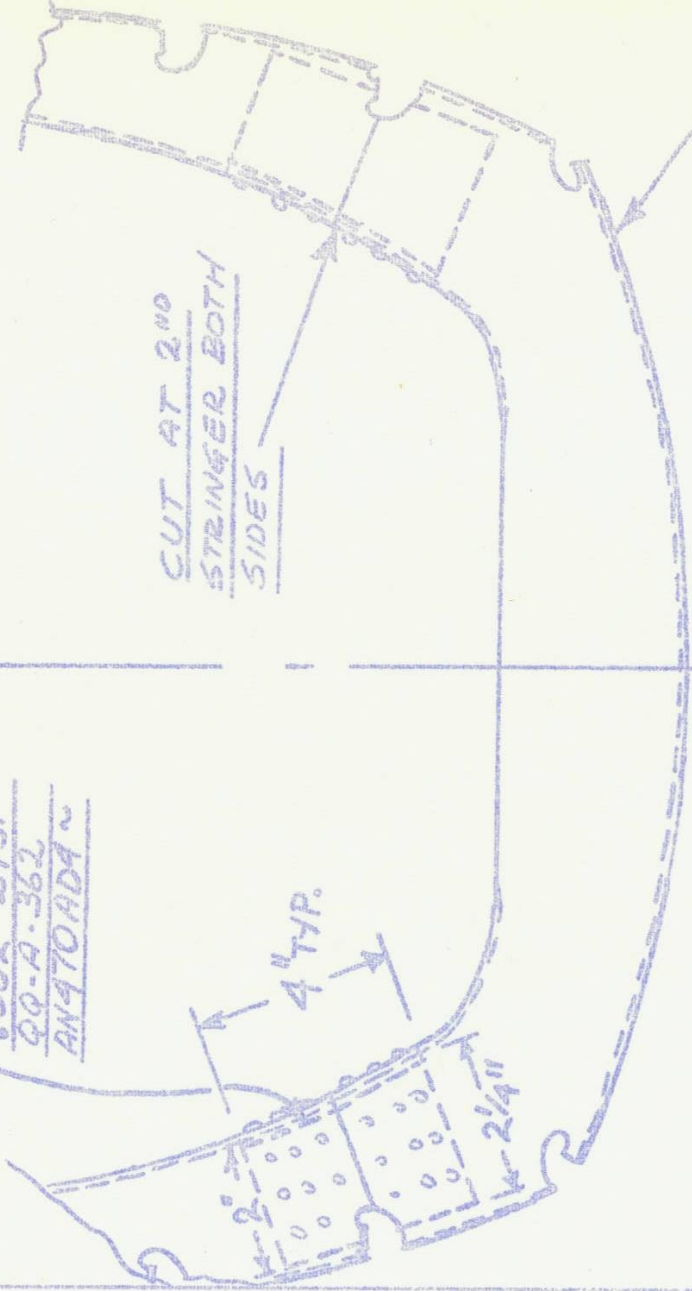
VIEW OF #13 BLKD LOOKING FWD.

CUT AT 2<sup>ND</sup>  
STRINGER BOTH  
SIDES

10. Install new lower bulkhead half as shown in sketch making sure that the original contour is maintained.
  11. Install X- brace previously removed in step 4.
  12. Carry out other repairs as per S.I.R. #115E.
  13. Reverse steps 1, 2 and 3.
- NOTE 1. Horizontal stabilizer and flying control cables need not be removed to carry out this repair.
- NOTE 2. Care should be exercised not to damage cables in the aircraft.
- NOTE 3. Ensure that EO 05-45B-6A/75 reinforcement #13 bulkhead is properly installed.
- NOTE 4. Carry out a landing gear retraction test and make sure that tail wheel shock strut is not binding as instructed in EO 05-45B-5/37.

SPLICE PLATE ~ 2 REQ.

SEE DWG 40A-184130 FOR FURTHER

DETAILS & CONTOUR

MAKE NEW BLKD FROM

0051 2450 00-A-362

HEAT TREAT TO 24ST

AFTER FORMING.
