ENGINEERING MEMORANDUM

REPAIR SCHEME
DAMAGED NOSE SECTION

A/C 1600 WAS DAMAGED ON THE NOSE SECTION & WAS INADEQUATELY REPAIRED. TO RECTIFY THIS THE FOLLOWING WILL BE CARRIED OUT:

12833

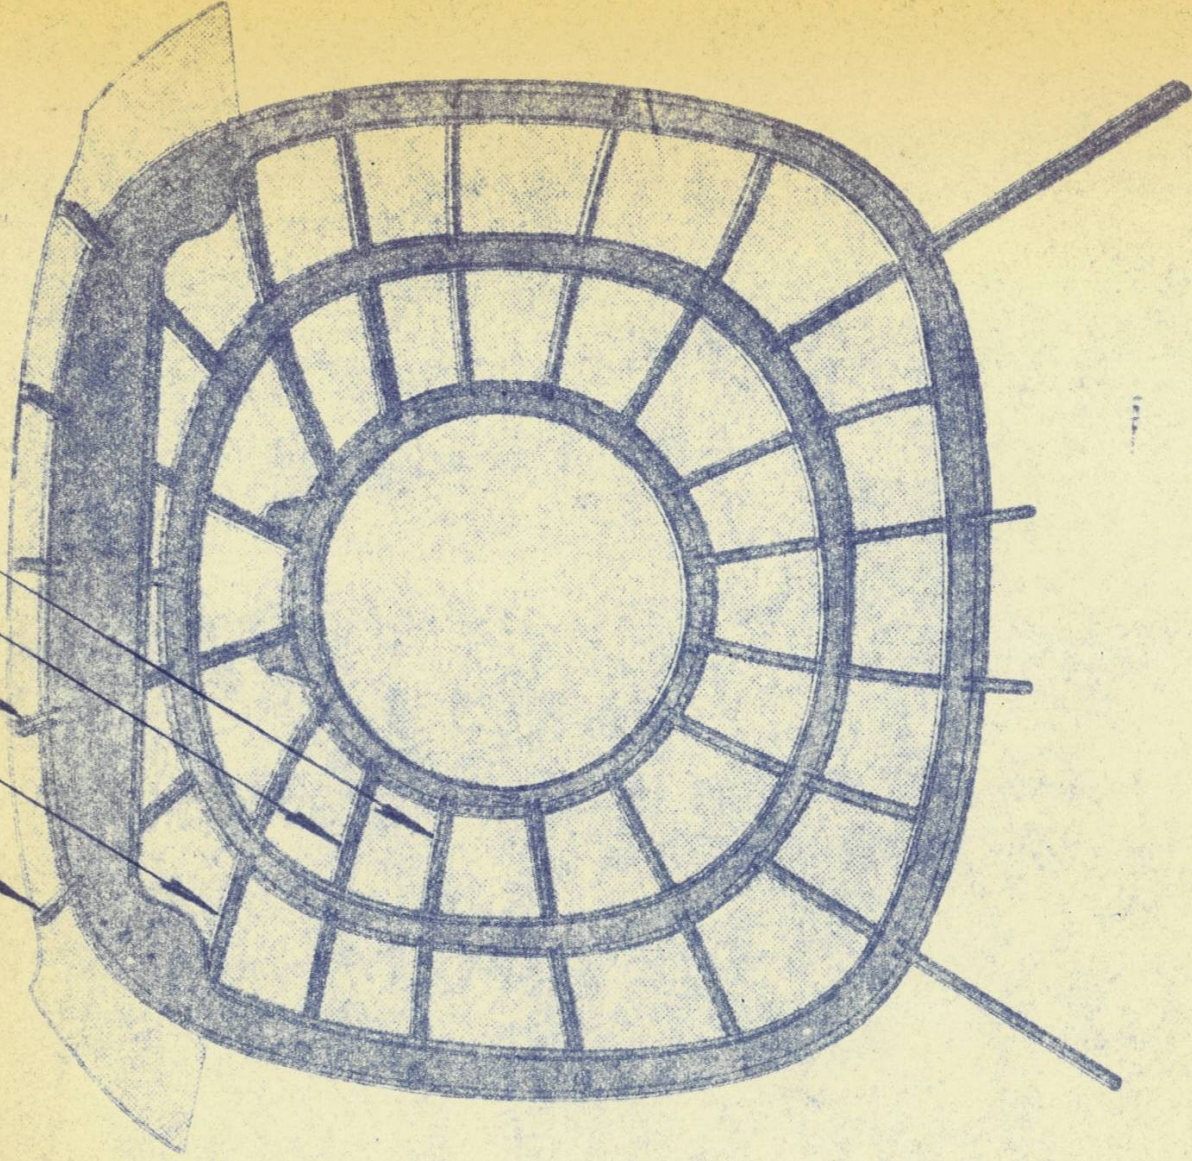
VIEW OF NOSE SECTION
LOOKING FORWARD

1. REMOVE EXISTING 404-184000-68 ICE PROTECTOR PLATE.
2. REMOVE EXISTING SKIN PATCH & DOUBLES.
3. REMOVE STRINGERS C184000-14, -18L, -19L, -20L & 404-184000-72 EXISTING AS INDICATED IN SKETCH ON PAGE 3.
4. PROPERLY SPLICE BULKHEAD 2 REPAIR SECTION TO 180417 CHANNEL ASS'Y AT TOP END & TO C184000-284 CHANNEL AT LEFT SIDE.
5. PROPERLY SPLICE C184000-284 CHANNEL AT REPAIR JUST AFT OF BULKHEAD 2.
6. MAKE & INSTALL NEW STRINGERS C184000-14, -18L, -19L, -20L & 404-184000-72.

- 404-184000-72
- C184000-18L
- C184000-14
- C184000-19L
- C184000-20L

7. INSTALL FLUSH TYPE SKIN PATCH ON INNER SKIN.
8. INSTALL NEW 404-184000-68 ICE PROTECTOR PLATE
