REPAIR - UNDERCARRIAGE SLIDE
TUBE, LOWER ATTACHMENT.

E.M. NO. 12912

804-184200-57

LOWER ATTACHMENT TUBE

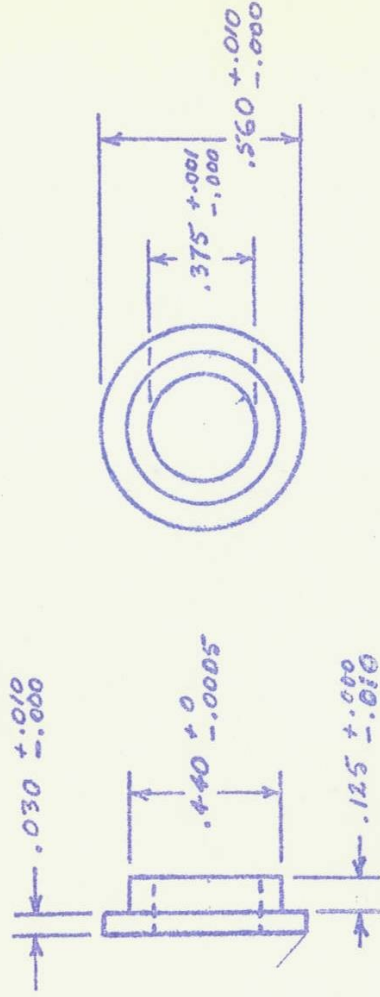
FIG. 1

THE BOTTOM HOLE IN THE LOWER ATTACHMENT TUBE, 804-184200-57, OF THE UNDERCARRIAGE SLIDE TUBE, HAS BEEN FOUND ELONGATED AND OVERSIZE ON SOME INSTALLATIONS, WHEN THIS CONDITION EXISTS IT IS TO BE REPAIRED AS FOLLOWS:

MATERIAL: 4130 STEEL

1. MANUFACTURE THE SHOULDER BUSHING AS SHOWN IN FIG. I.
2. REAM OUT THE HOLE USING A $\frac{7}{16}$ " REAMER.
3. INSTALL THE BUSHING.
4. MANUFACTURE A NEW BOLT THE SAME AS THAT DRAWN UP IN DRAWING 1 AIRA 13247 EXCEPT MAKE THE LENGTH $1\frac{1}{2}$ " AND SHORTEN IT AS REQUIRED BY THE INSTALLATION, ENSURE THE BOLT IS MARKED, "SPECIAL". DO NOT STAMP A PART NUMBER ON IT.

5. INSTALL THE SLIDE TUBE, TRIMMING THE BUSHING AS REQUIRED TO ALLOW THE SLIDE TUBE TO PASS.
6. INSTALL THE NEW BOLT.
