## ENGINEERING MEMORANDUM

TITLE      ADDITIONAL SUPPORT -  
              WINDSHIELD COMPASS MOUNT

E.M. No. 12963

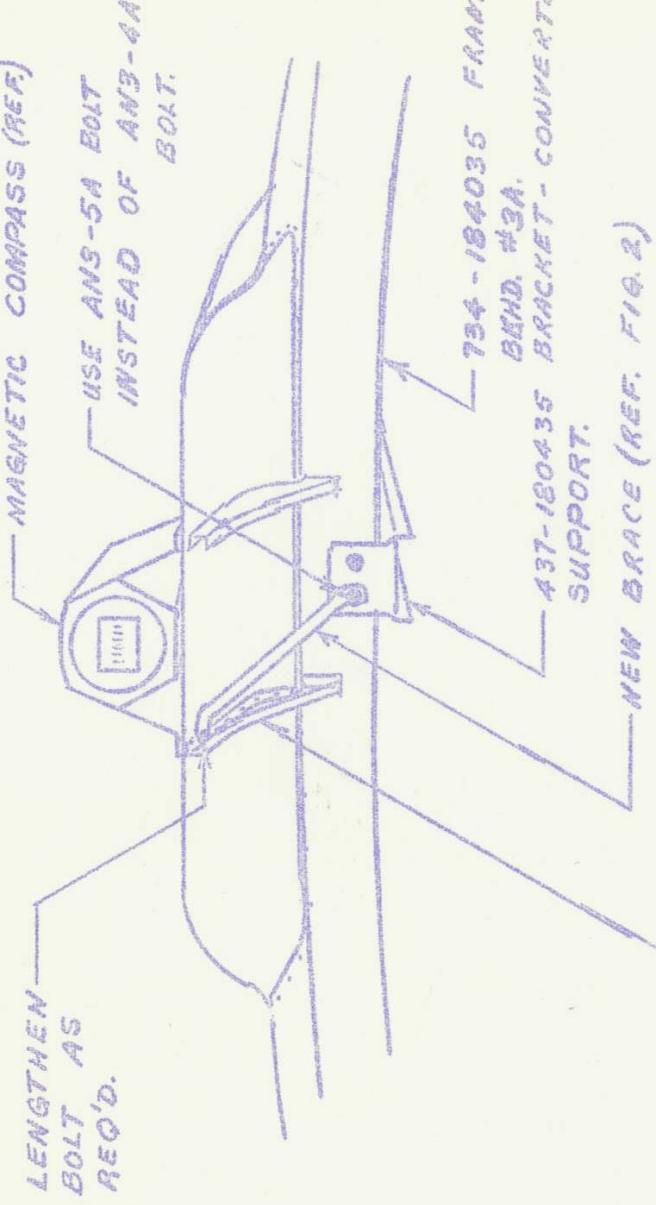
FIG. 1

THE MAGNETIC COMPASS (RCAF REF. 6B/669)  
HAS BEEN REPORTED TO VIBRATE FREELY  
ON SOME AIRCRAFT DURING FLIGHT.

TO RECTIFY THIS CONDITION THE  
WINDSHIELD COWL IS TO BE GIVEN ADDITIONAL  
SUPPORT BY INSTALLATION OF THE BRACE, SHOWN  
IN FIG. 2, AS PER FIG. 1.

THIS INST ALLATION IS OVER TO BE  
MADE ON AIRCRAFT SNAGGED FOR EXPRESSIVE  
VIBRATION OR THE MAGNETIC COMPASS.
