TITLE MODIFICATION TO SKI RETRACT ASSIST UNIT BEACH 18 WHEEL-SKI		CLASS NO. 14395	ISSUE D	FILE CODE 112 -24
EFFECTIVE AS NOTED				
DWS. NO.		DISTRIBUTION— A—ACTION B—INFORMATION		
W/O NO.		TO A B		
SUBMITTERS ORDER NO.		C DESIGN D A/O E F G		
CUSTOMER		H I J K L M N O P Q		
TYPE OR MODEL BEACH 18 SKI-PLANE		A/O PLANT'S MARKS "		
SUBCRAFT REGISTRATION NO.		MATERIAL A/O CMT.		
DATE 24 FEB '65		MOUNT. SUFT. SALES/CONT.		
DRAWING NO.		INSPECTION R.O.A.P.		
REVISIONS		TEST FLIGHT ENG. CONTROL		
CUSTOMER		DOT		
PURCHASER

MODIFICATION TO SKI RETRACT ASSIST UNIT
BEECH 18 WHEEL-SKI

14395

ENGINEERING MEMORANDUM

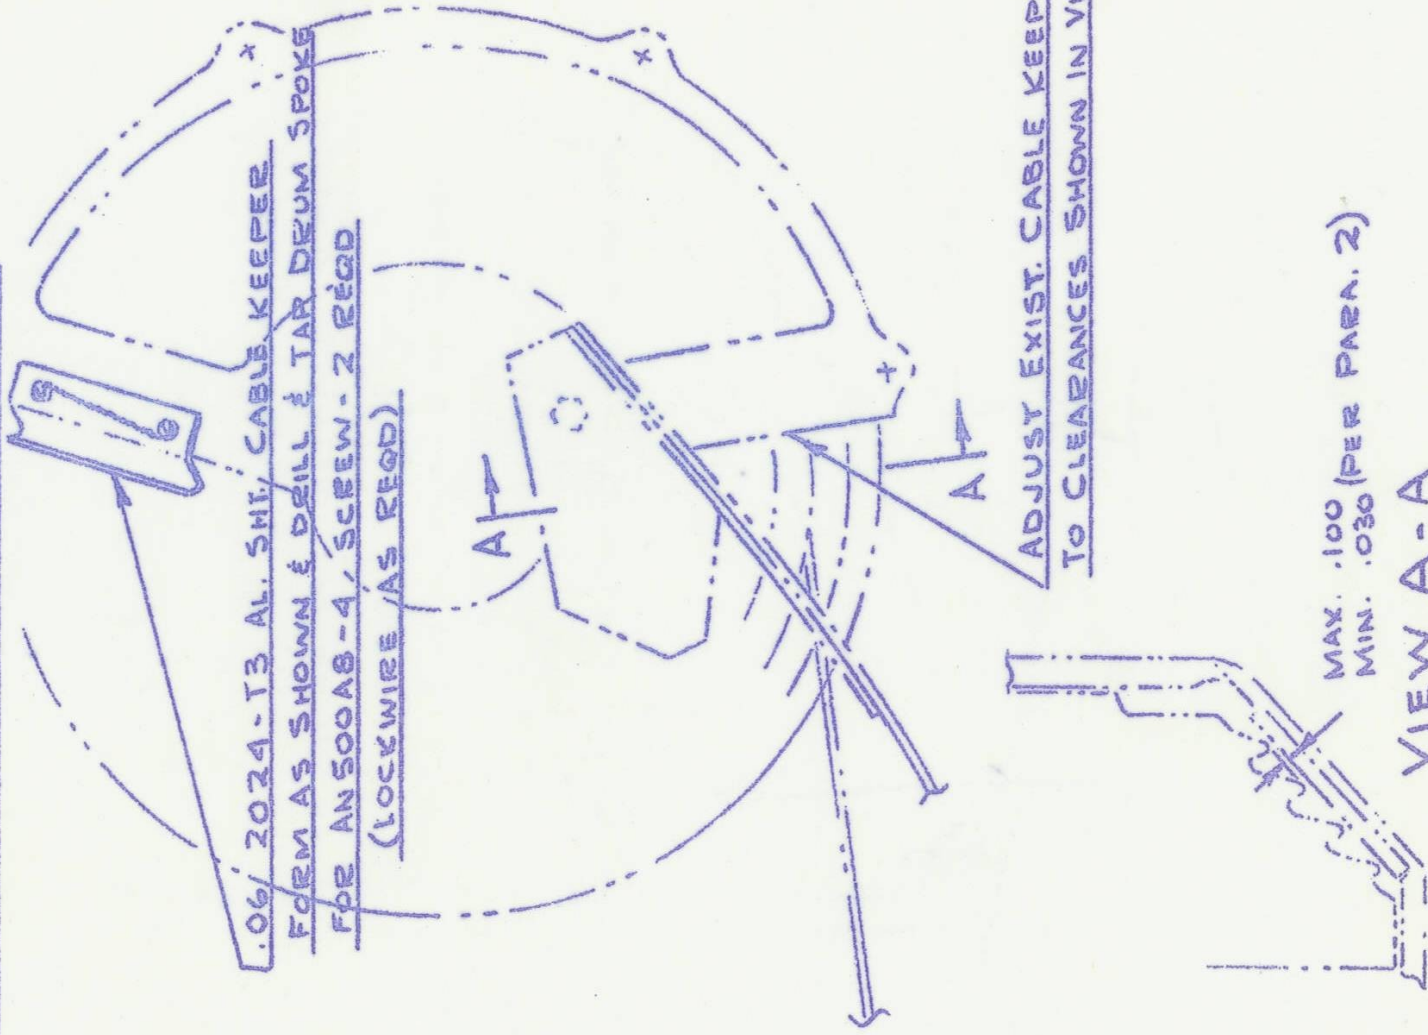
FIG. 1.

3. Install an additional cable keeper as shown in Fig. 1. This additional keeper must be adjusted to the same tolerances as in Para 2.
4. Install the retaining screw for the cable tensioning bolt as

MAX. .100 (PER PARA. 2)
MIN. .030

2. Check the clearance between the drum and the cable keeper for one complete revolution of the drum (the keeper is located under the edge of the drum frame where the cable leaves the drum (lower side on the L.H. drum and upper side on the R.H. drum), with the drum wedged over as far as it will go toward the housing plate at its large diameter, the keeper clearance must not exceed .100 inches nor be less than .060 inches for one complete revolution of the drum. With the drum wedged in the opposite direction the clearance must not be less than .030 inches for one complete revolution. (the drum may be rotated by pitching the ski tip down while in the wheel-landing condition). If necessary, local dressing of the crests on the drum by filing or grinding is permissible in order to meet these tolerances. All dressed edges must be round. Inspect for, and dress smooth, any nicks or surface irregularities which could lead to snagging, punching, fouling or chafing of either the cable or the keeper to be installed in Para. 3.
