INSPECTION OF CONTROL COLUMNS AND
CROSS SHAFT BEECH 18 AIRCRAFT

15150

BRISTOL AEROSPACE LIMITED ENGINEERING MEMORANDUM

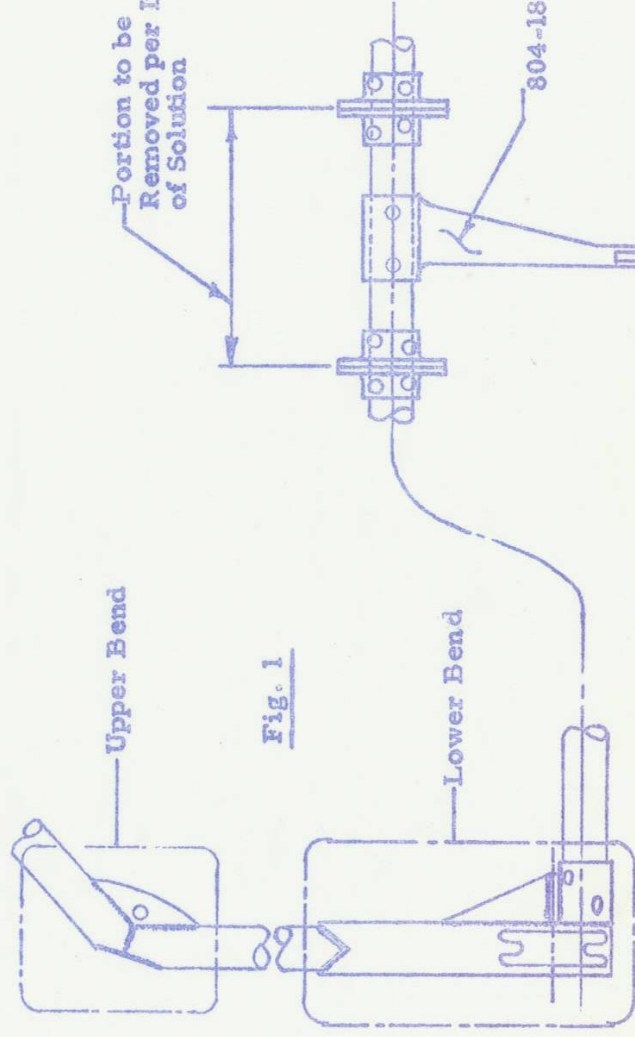
- It is permissible to inspect these items with the items installed in the aircraft with the exception that the center section of the control column cross shaft containing the elevator control arm will be removed for dye penetrant inspection. Proceed as follows:
 - Remove center portion of control column cross shaft containing the elevator arm Ass'y P/N 804-187504. Refer to Figure 1.
 - Clean and visually inspect the arm assembly for cracks.

2.0 In addition special attention is to be given the visual check of the following areas of the control columns (Refer to Figure 1):

2.1 The upper bend.

2.2 The lower bend where the control column mates with the cross shaft.

1.3 Dye check per P. P. S. 39 the arm assembly for cracks around taper pin holes. Check 1/2" from edge of holes in all directions.

1.4 If cracks are found adjacent to taper pin holes the part is to be scrapped and a new one installed.

NOTE: When installing the taper pins insure that only the proper torque values are obtained since over-torquing is likely to cause the casting to crack.

1.5 If cracks are found other than adjacent to taper pin holes, refer to Project Engineer for further instructions.
