BEECH 18 UNDERCARRIAGE FORK CAP
MODIFICATION

CLM. NO. 15305

BEECH 18

CF-72A

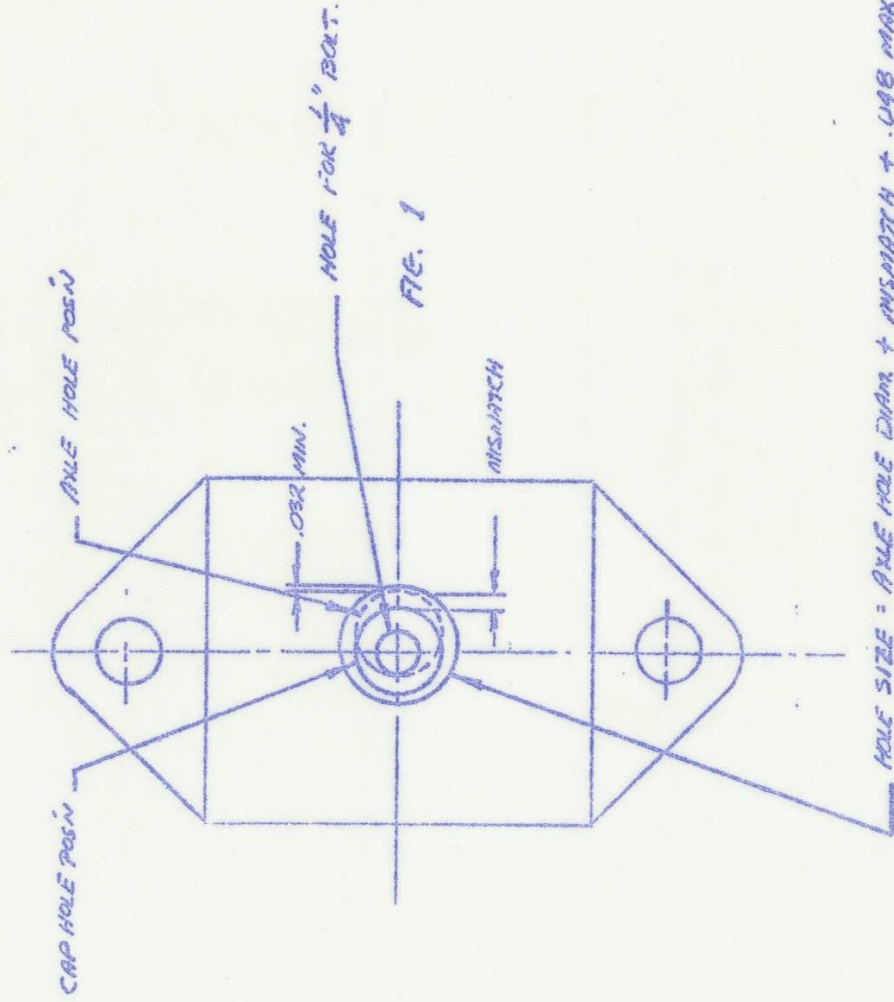
FIG. 1

MISMATCH EXISTS BETWEEN HOLE IN UNDERCARRIAGE AXLE CAP AND AXLE.

HOLE SIZE = AXLE HOLE DIAM + MISMATCH + .048 MAX.

1. DETERMINE AMOUNT OF MISMATCH BY USING AN OFFSET SCRIBER. PAINT MACHINIST BLUE ON CAP AND SCRIBE AXLE HOLE POSN ON CAP.
2. BORE OUT CAP SUCH THAT NEW HOLE DURN IS AS SHOWN IN FIG. 1.
3. HARDNESS TEST CAP. FABRICATE BLANK BUSHING FROM ETTNER SPS 245, 4130, OR 4340 STEEL OF THE SAME HARDNESS. ALLOW FOR A PRESS FIT OF .0005 - .001 IN CAP. SEE FIG. 2.
4. INSTALL BLANK BUSHING IN CAP USING LOC-TITE, ALLOW SUFFICIENT TIME TO CURE AND THEN BOLT CAP IN POSN ON UNDER CARRIAGE LEG.

5. LOCATE $\frac{1}{2}$ " HOLE IN USING BY DRILLING FROM AXLE HOLE.
6. REMOVE CAP, FINISH BIRING AND ELONGATE $\frac{1}{4}$ " HOLE IN CAP TO LINE UP WITH $\frac{1}{4}$ " HOLE IN 112-29020-7 TORQUE PIN.
