TITLE <b>REPLACEMENT OF BENDIX ADF SENSE ANTENNA WIRE &amp; FITTINGS</b>		E.M. NO. <b>15999</b>	ISSUE <b>A</b>	FILE CODE <b>112-</b>	
		EFFECTIVE <b>IMMEDIATELY</b>		<b>72</b>	
PART NO.	PART NAME	DWG. NO.	ISS.	DISTRIBUTION A-ACTION S-INFORMATION	
		W/O NO.		TO A B	
REASON FOR ISSUE		DISPOSITION OF STOCK		CUSTOMERS ORDER NO.  CUSTOMER <b>SHERRITT -GORDON</b> TYPE OR MODEL  AIRCRAFT REGISTRATION NO. <b>CF-NUY</b> DATE <b>15 AUG 69</b> DWG. CHANGE YES <input type="checkbox"/> NO <input type="checkbox"/>	
SALVAGE	CHECK BLOCKS AFFECTED	NOT AFFECTED	USE TO DEPLETION		DESIGN
CONCESSION					A/C
STOP ORDER/RELEASE					PROD.
NEW DRAWING	PARTS COMPLETED				EL'T'NG
REVISED DRAWING	PARTS IN PROCESS				A/C PLANN'G
VARIATION	TOOLING				MANUF. "
OBSOLETE NOTICE	RAW MAT'L				MATERIAL
USE AS NOTED	INTERCHANGEABILITY AFFECTED	STRENGTH AFFECTED			A/C SUPT.
	YES <input type="checkbox"/> NO <input type="checkbox"/>	YES <input type="checkbox"/> NO <input type="checkbox"/>			SALES/CONT.

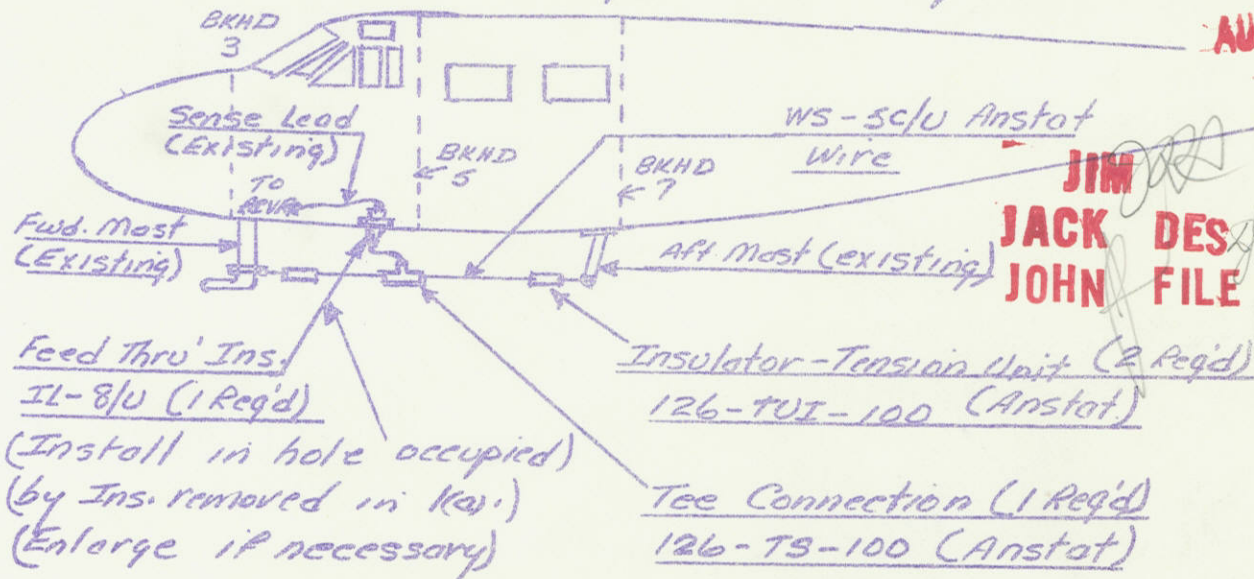
1. Remove the following sense antenna components from the underside of the aircraft.

- (a) porcelain feed thru' insulator
- (b) fwd. insulator-tension unit, aft insulator and interconnecting wire.

2. Install new components as per sketch
