TITLE <b>REPAIR TO CRACKED COWL SUPPORT</b> <i>Support Ring</i>		E.M. NO. <b>16178</b>	ISSUE <b>A</b>	P.R.S. CODE <b>112</b>
PART NO.		EFFECTIVE <b>AS REQ'D</b>		
PART NAME <b>COWL SUPPORT RING</b>		DWG. NO.	DISTRIBUTION INFORMATION A - APPROVE B - INFORMATION	
REASON FOR ISSUE		W/O NO. <b>517-1136</b>	TO A B	
DISPOSITION OF STOCK		CUSTOMER ORDER NO.	DESIGN	
SALVAGE	CHECK BLOCKS AFFECTED	CUSTOMER <b>SHERRITT ORDUN</b>	N/C	
CONCESSION	NOT AFFECTED		PROD. <b>1</b>	
STOP ORDER/RELEASE	USE TO DEFLECTION	TYPE OR MODEL <b>BORCH SUPER 18</b>	ELTYED	
NEW DRAWING	NETWORK		No FLAW'S <b>1</b>	
REVISD DRAWING	SCRAP	AIRCRAFT REGISTRATION NO. <b>CF-YRC</b>	MANUF. " <b>1</b>	
VARIATION	AS NOTED		MATERIAL	
OBSCLETE NOTICE	STRENGTH AFFECTED	DATE <b>MAR 31 70</b>	N/O SUPP.	
USE AS NOTED	YES <input type="checkbox"/> NO <input type="checkbox"/>	DWG. CHANGE YES <input type="checkbox"/> NO <input checked="" type="checkbox"/>	MANUF. SUPT. <b>4</b>

APPROVALS		CUSTOMER		SALES/CONT. <b>1</b>
ENGINEERING <i>W. R. Lawrence</i>		CUSTOMER		INSPECTION <b>3</b>
CONTRACTS ADMIN. <i>J. M. David</i>		CUSTOMER		R.O.A.F.
OTHER FULL PARTICULARS AND SKETCH WHERE POSSIBLE		CUSTOMER		TEST FLIGHT
<b>REPAIR L.H. COWL SUPPO

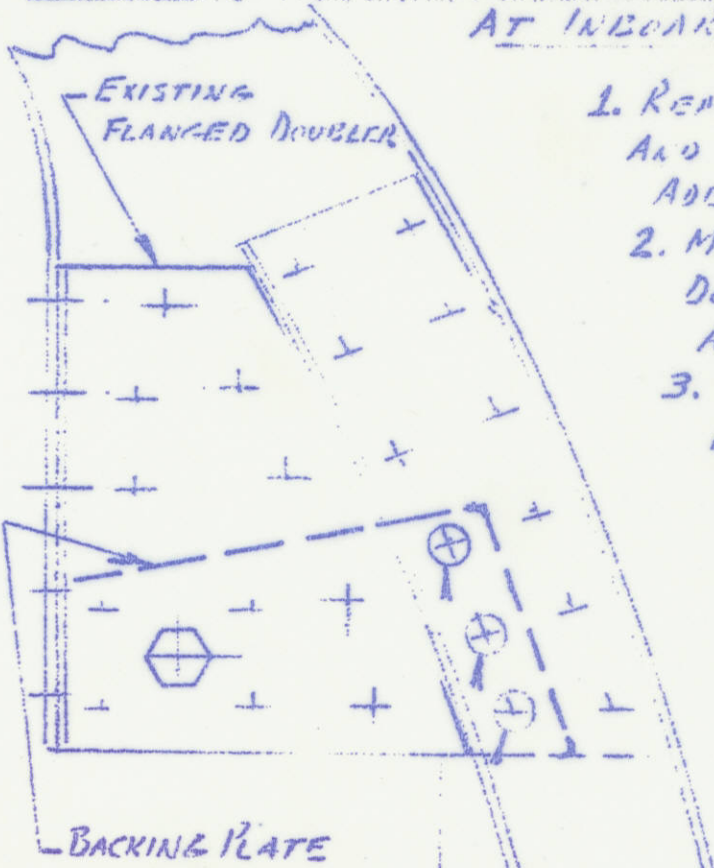
AT INBOARD AND OUTBOARD SIDES:

1. REMOVE EXISTING FLANGED DOUBLERS AND INSPECT EXPOSED AREA FOR ADEQUATE STOP DRILLING ETC.
2. MAKE REPLACEMENTS FOR ABOVE DOUBLERS USING .063-2024 T3 AND EXISTING FASTENINGS.
3. REPLACE EXISTING 3/16 PACKERS LOCATED AT REAR FACE OF RING WITH A LARGER VERSION EXTENDED TO PICK UP ON 3 INNER FASTENERS OF LOWER RING. MAKE THIS BACKING PLATE FROM .187-2024 T3 MAT'L AND REPLACE THE 3 RIVETS INDICATED WITH NO. 8 SIZE BOLTS SUCH AS MS 27039-0809 OR AN 525-832-9.
