LIST OF FIELD MODIFICATIONS

AIRCRAFT GENERAL

(This EO replaces EO 05-1-6A dated 15 Mar 62)

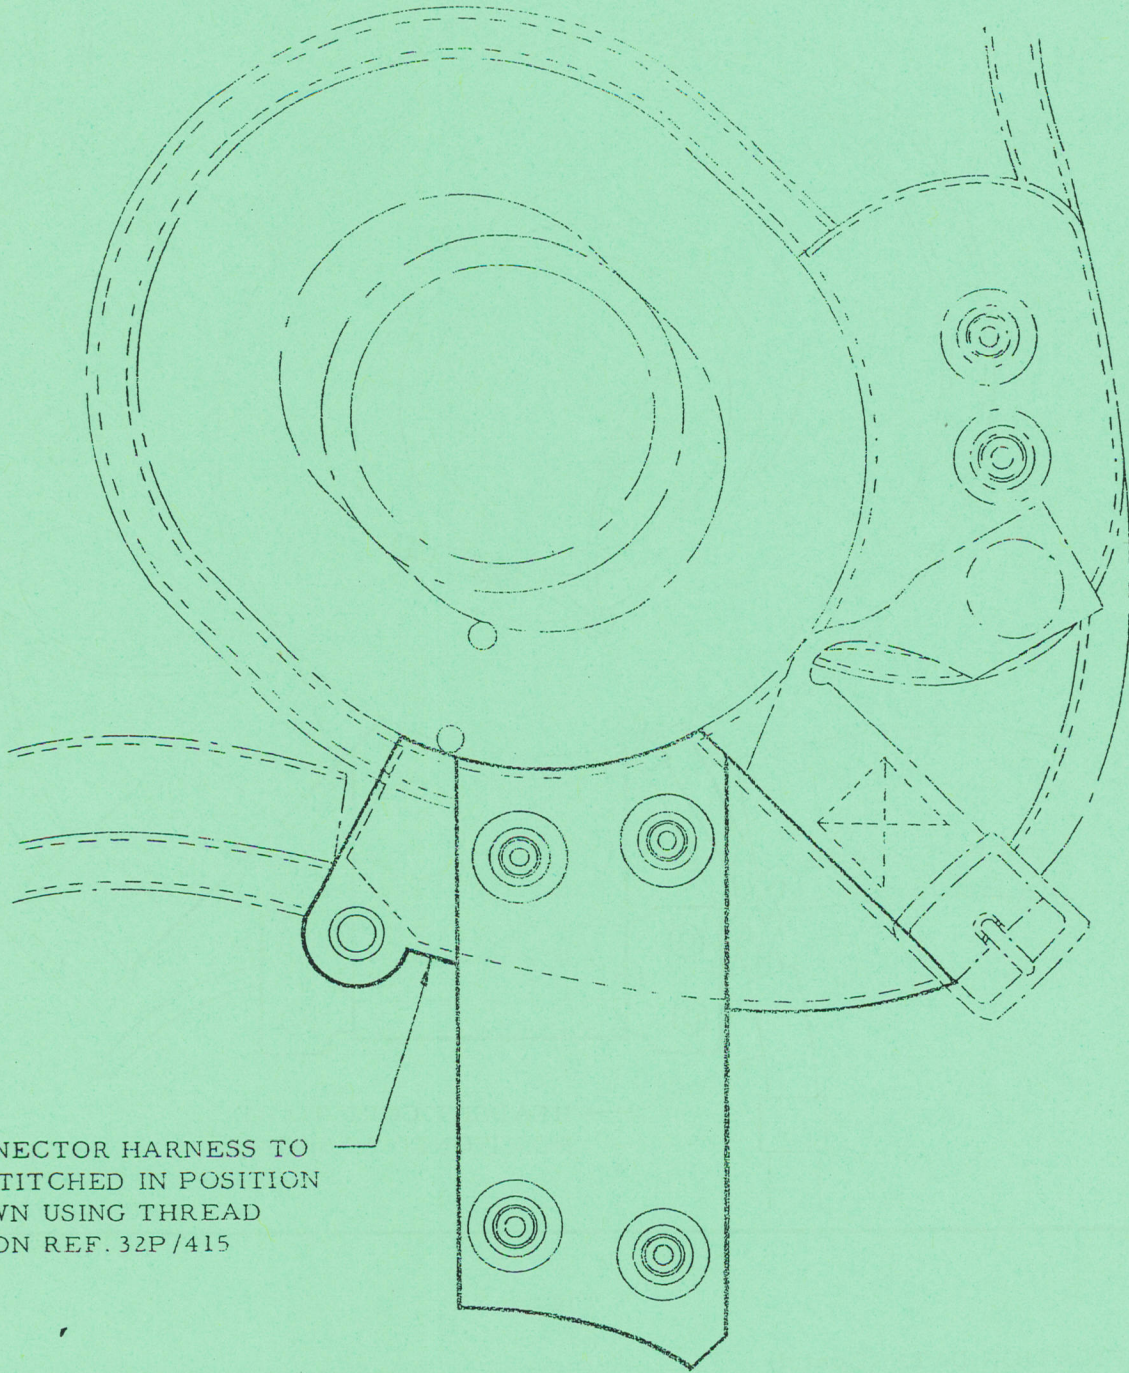
Figure 1

CONNECTOR HARNESS TO
BE STITCHED IN POSITION
SHOWN USING THREAD
NYLON REF. 32P/415

- (a) Remove the two receivers Ref. 10EC/27819 from the helmet.
- (b) Remove headset cords Ref. 10EA/29525 and 10EA/29526 from the helmet.
- (c) Stitch the microphone connector harness to the helmet as shown in Figure 1, using thread nylon Ref. 32P/415.
- (d) From the new cord assembly Ref. 10EA/56726 remove the cross bar strain reliefs at the end of receiver cables. Retain the cross bars.

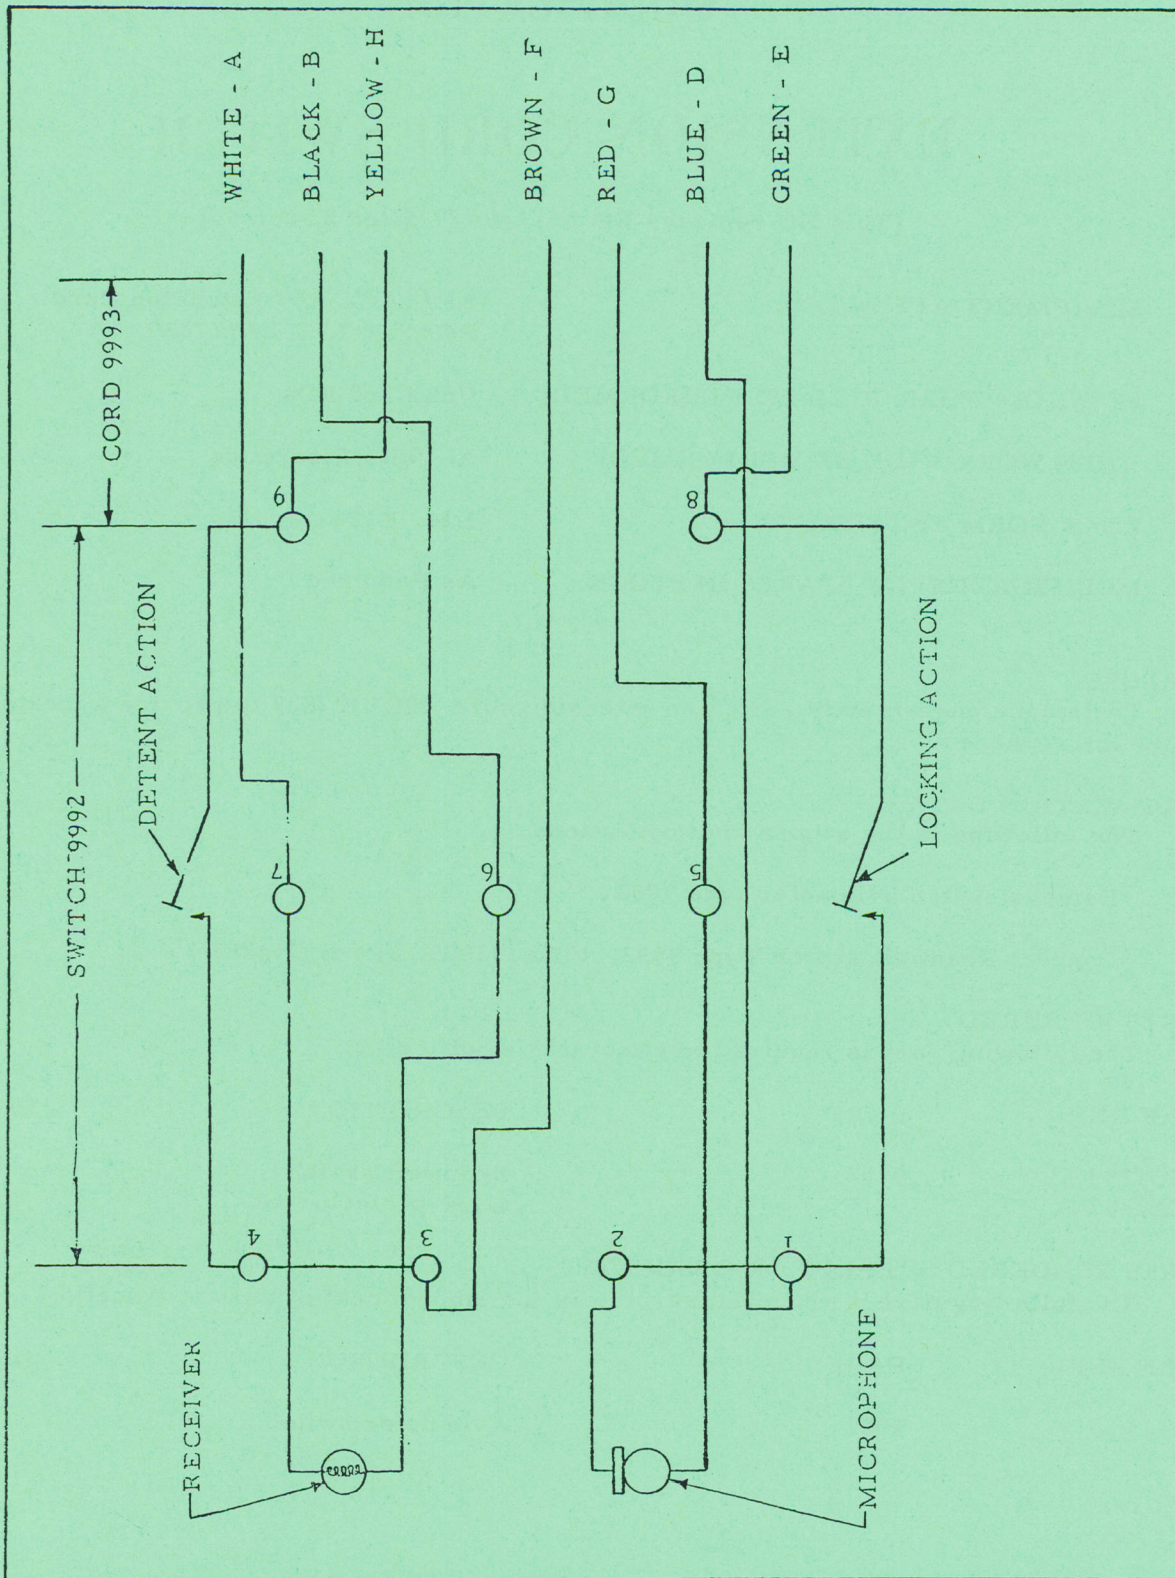
Figure 1

1 To replace push-to-talk switch on extension cord 10EA/27829 to provide a locking circuit for the microphone.

- (a) Remove switch aviometer type 9002.
- (b) Connect Roanwell switch Type 9992, 10EA/33905, as per Figure 1.
