### REPAIR AND OVERHAUL INSTRUCTIONS

# CONTROL PEDESTAL REPAIR SCHEME AT THE PRIMING PUMP MOUNTING FLANGE

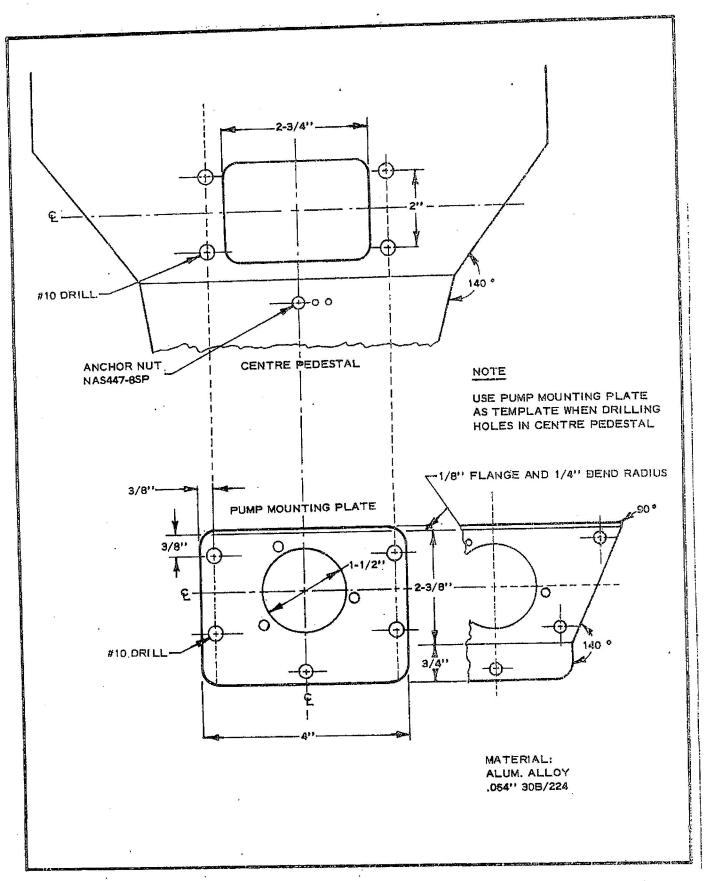
Figure 1

As a result of flexing of the control pedestal skin during priming pump operation cracks may develope in this area.

- (b) Cut hole in pedestal in accordance with Figures 1 and 3.
- (c) Manufacture mounting plate and doubler plate in accordance with Figures 1 and 2.
- (d) Using mounting plate and doubler as guide, drill five holes, in centre pedestal. (using #10 drill)
- (e) Locate priming pump on mounting plate by drilling 3 holes in mounting plate using pump as guide. Ensure OFF position on pump will be vertical when installed on aircraft.
- (f) Rivet doubler plate to centre pedestal with 8 rivets 28/5320-00-117-6938. (Utilizing the same 8 rivets to attach 4 anchor nuts Part NAS447-8SP to the bottom surface of doubler plate as per Figure 3).
- (g) Affix pump to mounting plate using existing screws and nuts.
- (h) Mount the pump on centre pedestal using 5 screws AN526-832R8.
- (j) Complete pipe connections under centre pedestal and check for leaks;
- (k) Paint mounting plate to match pedestal.
