LIST OF SPECIAL INFORMATION EXPEDITOR

(This EO replaces EO 05-45B-5A dated 26 Aug 66)

* Asterisks appearing opposite entries denote changes since last issue
ISSUED ON AUTHORITY OF THE CHIEF OF THE DEFENCE STAFF

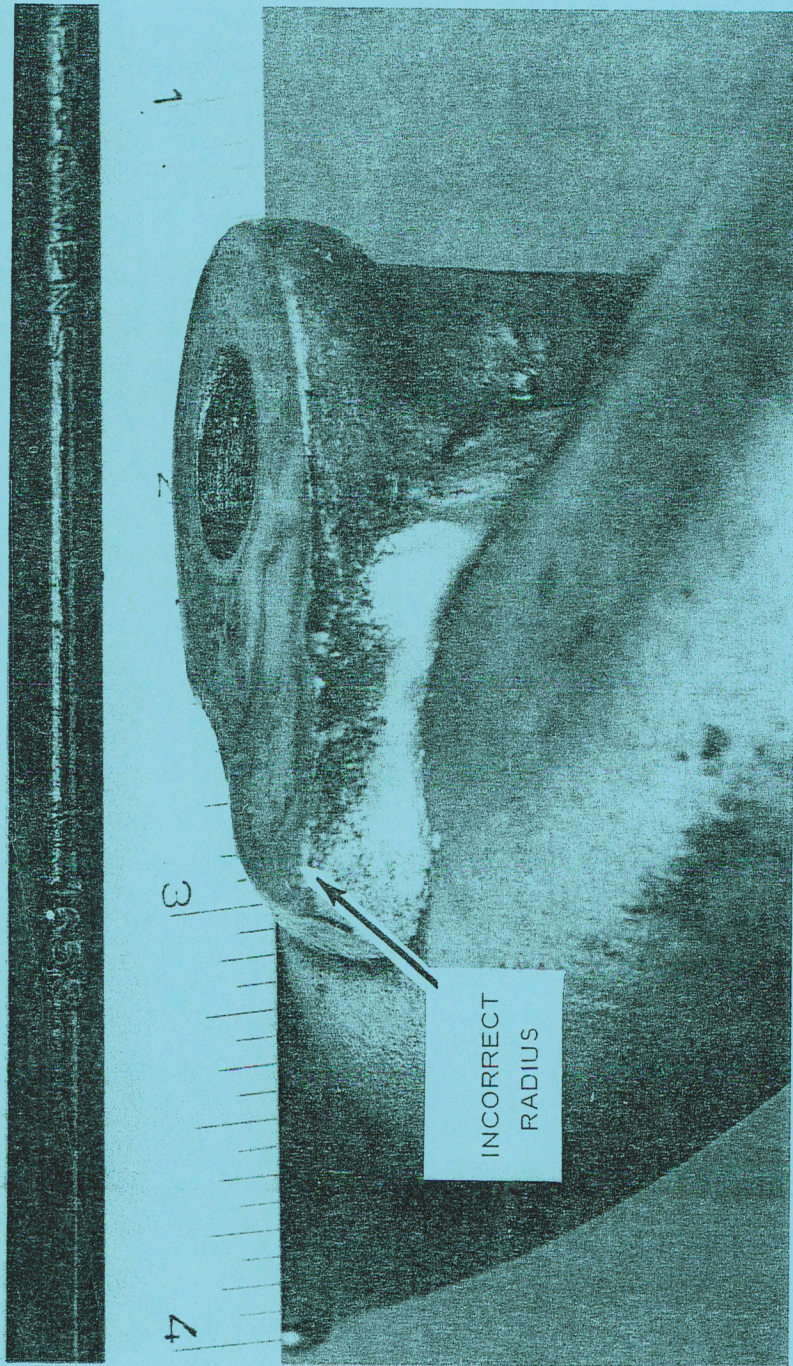
Figure 1

1 The purpose of this Engineering Order is to bring to the attention of operating units, that improper machine finish of engine mount brackets (refer to Figure 1) have been reported from the field. Such a condition results in inner cowling cracks when engine mount brackets come in contact and wear on the curvature of inner cowling ring.

Improper grinding in this area may induce fatigue problems and could seriously affect the strength of the engine mount.

3 After grinding the affected areas are to be primed and painted.

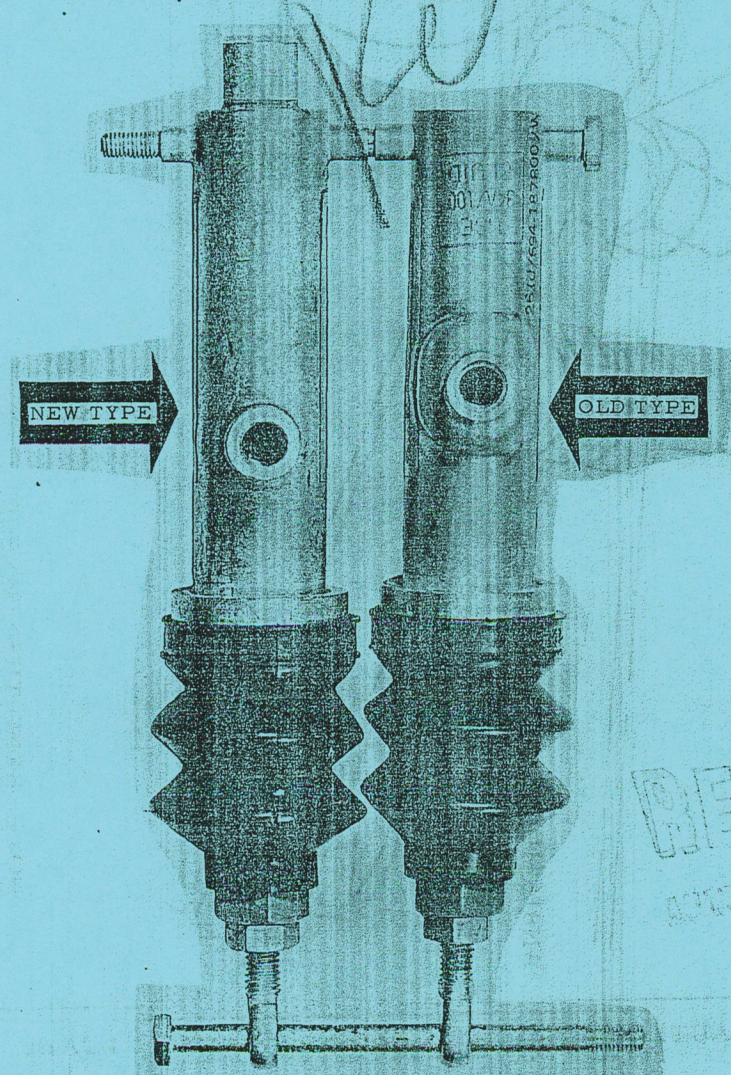
1 Further to the problem outlined in EO 05-5B-5A/21, an additional snag has been encountered by one operator when installing the latest design of Part 694-187800 cylinders. It will be noted from Figure 1 that the inlet boss on the later type of cylinders is located further aft than on the older type and is of increased height; on some aircraft installation of these later type cylinders on the co-pilot side will result in chafing of the rudder balance cable on the tee or elbow inlet fittings. The older type are quite satisfactory in any location.

2 Since there are approximately 1400 of the old type and only 120 of the later version it is recommended that whenever possible the new ones be reserved for use on the pilot side. When this becomes impossible or impractical bridging of the balance cable may be effected by local manufacture of a tube assembly and fitment as shown in Figure 2.

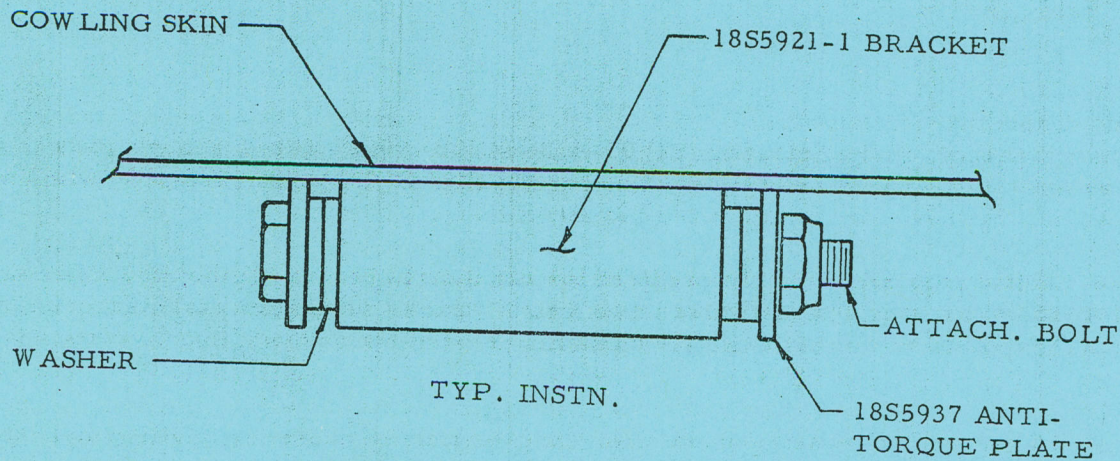
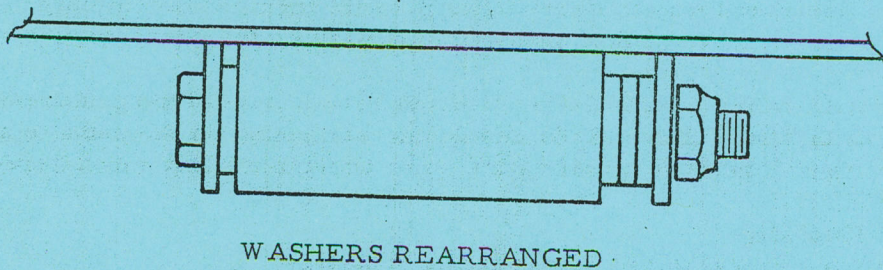
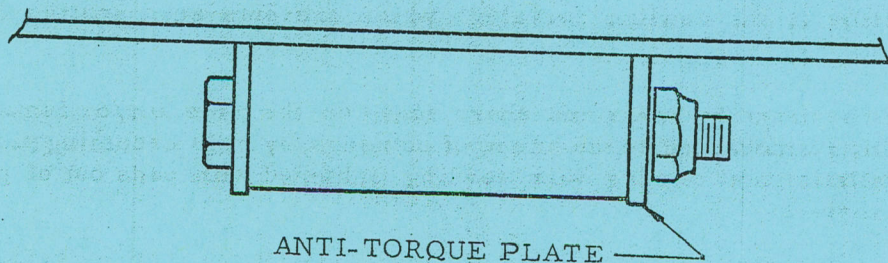
Figure 1

- (a) The adjustment difficulties, where there is a gap found between the upper and lower cowlings, are probably due to the Part 18S5937 anti-torque plates preventing correct cowling positioning or a distortion of the cowling curvature which prevents snug seating of the male and female cowl brackets.
- (b) Pad tearing is caused by burrs and sharp edges on the male and/or female brackets, by rough handling during removal and replacement of cowlings, by pads becoming partially unseated during cowling installation and tearing when cowling tightened with pads out of position, or any combination of the above.

INSTALLATION WITH NO WASHERS PRIOR
TO EMBODIMENT OF EO 05-45B-6A/85
THIS INSTN. REQUIRED FOR PROPOSED
MODIFICATION SHOWN FIGURE 2.

- 6 Cowling adjustment as outlined in EO 05-45B-5A/31 together with the following should be practised where applicable:-
- (a) Where brackets are misaligned or cowling contour is not as desired, judicious use of a rubber mallet may be necessary.
 - (b) On brackets with positioning plates so positioned as to prevent upper and lower cowlings mating, alter the number of washers on each side as applicable to rotate cowling position, refer to Figure 1.

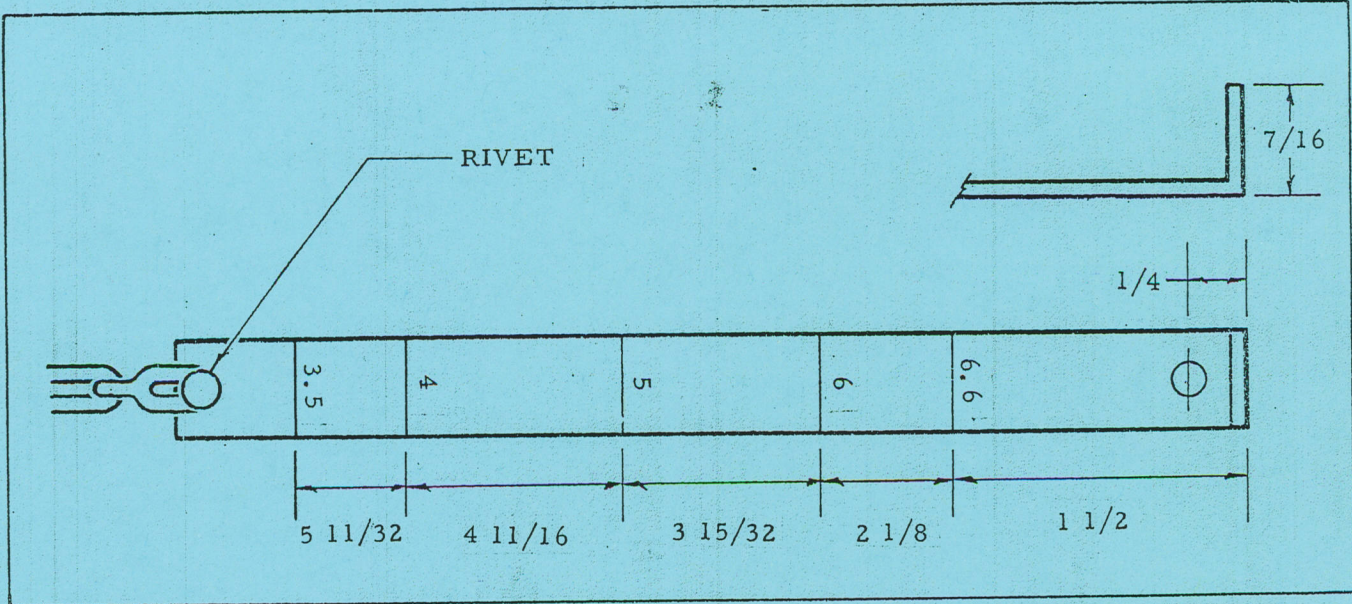
2 One unit also reports that, in the opinion of their technicians, the dipsticks are of value in preventing over or under filling the tank. These were originally omitted on the contractor's advice that installation on the new cap would increase the price considerably; since aircraft, such as the Harvard, managed to do without them, it was considered a non-essential item and accordingly left off. Operators who agree that the dipstick is desirable may utilize the one originally fitted to the old cap as shown in Figure 2. If the removed one is not available, local manufacture is recommended using Figure 3 as a reference.

When fitting dipstick to Part 111-66016 cap, ensure the centre relief hole is not covered.

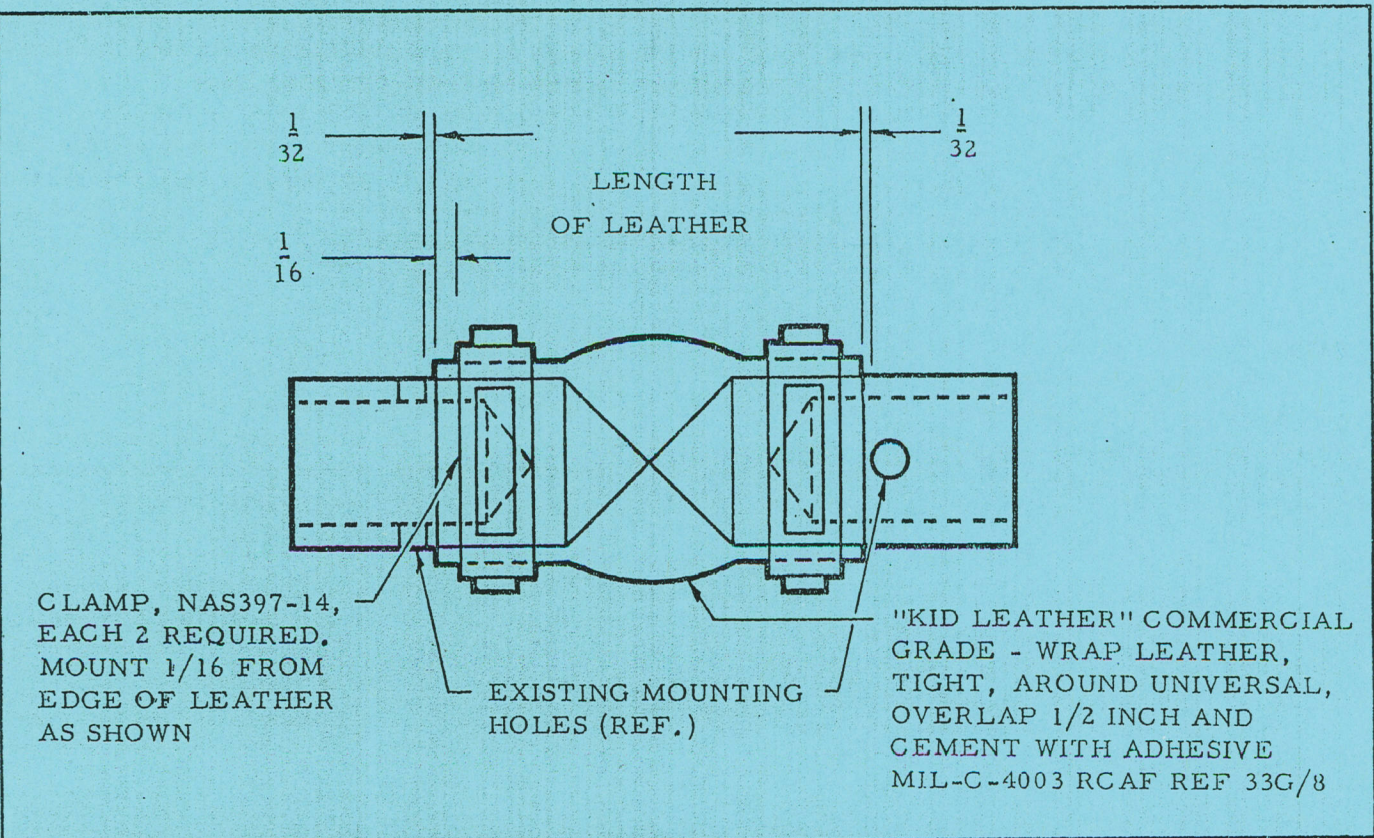
Figure 1

1 The rubber dust boot covers, fitted as original equipment on landing gear universals, are not listed in EO 05-45B-4. The universals are lubricated during manufacture and this lubricant should last until the rubber dust boot deteriorates allowing dust and dirt to enter.

2 Since the dust boot retaining bands are a swage type it is only possible to remove the boot by cutting the bands. This should not be normally necessary unless the existing boot has deteriorated to the extent replacement is necessary. Replacement boots are to be locally manufactured from commercial grade "kid leather" and attached as outlined in Figure 1.

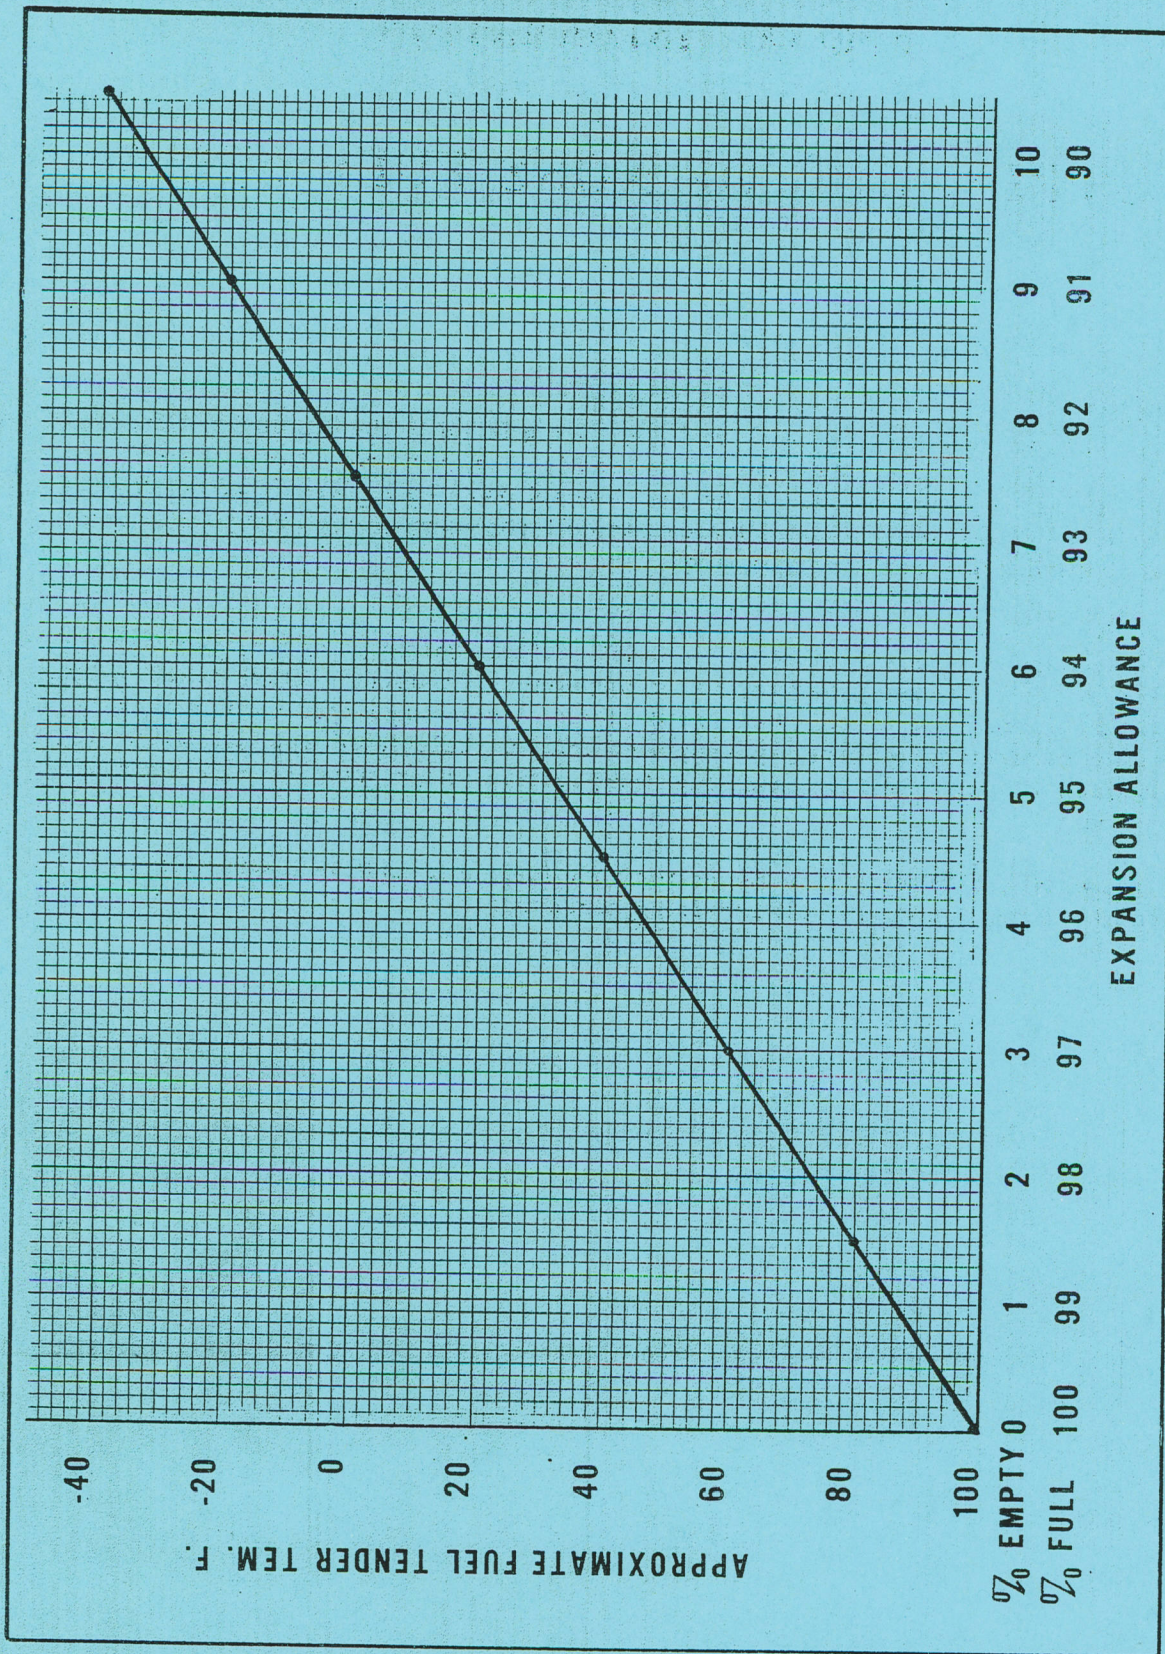
Figure 1

2 The seriousness of large amounts of aviation fuel spilled on hangar floors and thence to drainage and sewer systems cannot be over-emphasized. To obviate future cases of this nature ample provision for fuel expansion is to be made during refuelling Expeditor fuel tanks and cells. The necessary percentage of capacity reduction may be calculated approximately using 1 1/2 percent for each 20 degrees the tender fuel temperature is less than 37.8°C (100°F). Refer to chart in Figure 1.

3 The peculiar characteristic of Expeditor nose fuel cells and the instruction outlined above is to be brought to the attention of all servicing personnel.

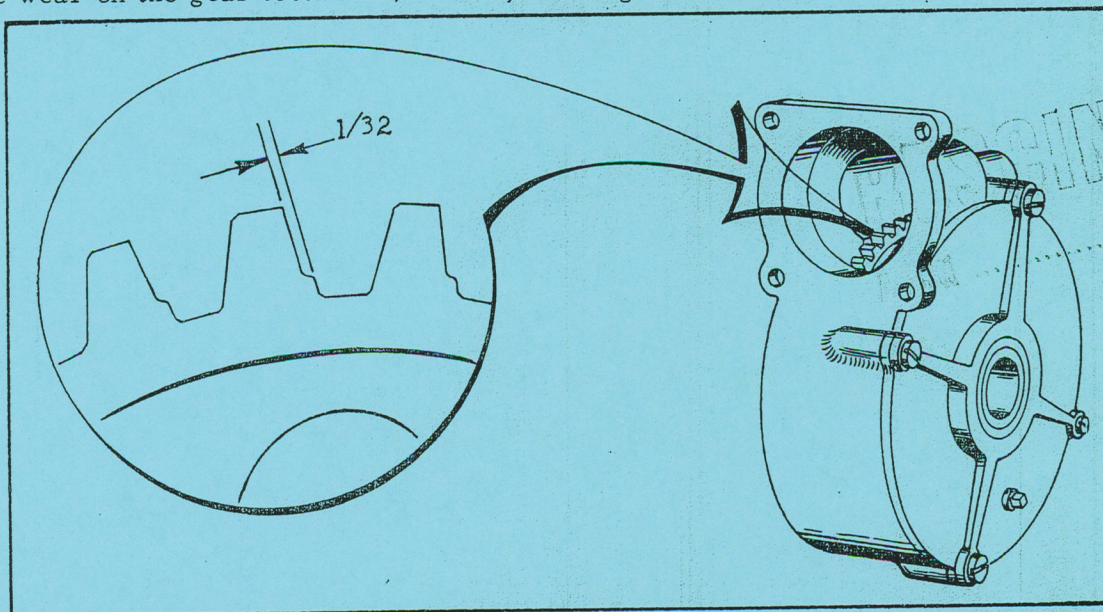
Figure 1

- (e) Check worm gear for roughness or scored, marred or otherwise damaged teeth.
- (f) If large gear is damaged or worn more than 1/32 inch it should be replaced, and if worm gear is damaged or rough enough to damage the large gear and cannot be polished, it should be replaced.
- (g) If gears are in acceptable condition, reassemble the units. Insure that sealing agent is spread over the surface of the gear housing against which the motor sets.

- (a) Remove the large inspection door under the cockpit in the center fuselage.
- (b) Disconnect the two wires to the actuator motor; remove the four bolts holding the motor to the gear housing and unfasten the strap.
- (c) While holding the motor have someone to operate the manual gear operation crank to back the worm and motor out of the housing.
- (d) Through the opening created by the removal of the motor and worm gear, inspect the gear with a flashlight and small inspection mirror for broken, damaged or worn teeth. The maximum allowable wear on the gear teeth is $1/32$ inch, see Figure 1.
