# LIST OF OVERHAUL MODIFICATIONS

## EXPEDITOR

(This EO replaces EO 05-45B-6B dated 13 Jun 62)

# MAGNETIC PARTICLE INSPECTION (MPI) AND SPAR REPAIR AND REINFORCEMENT

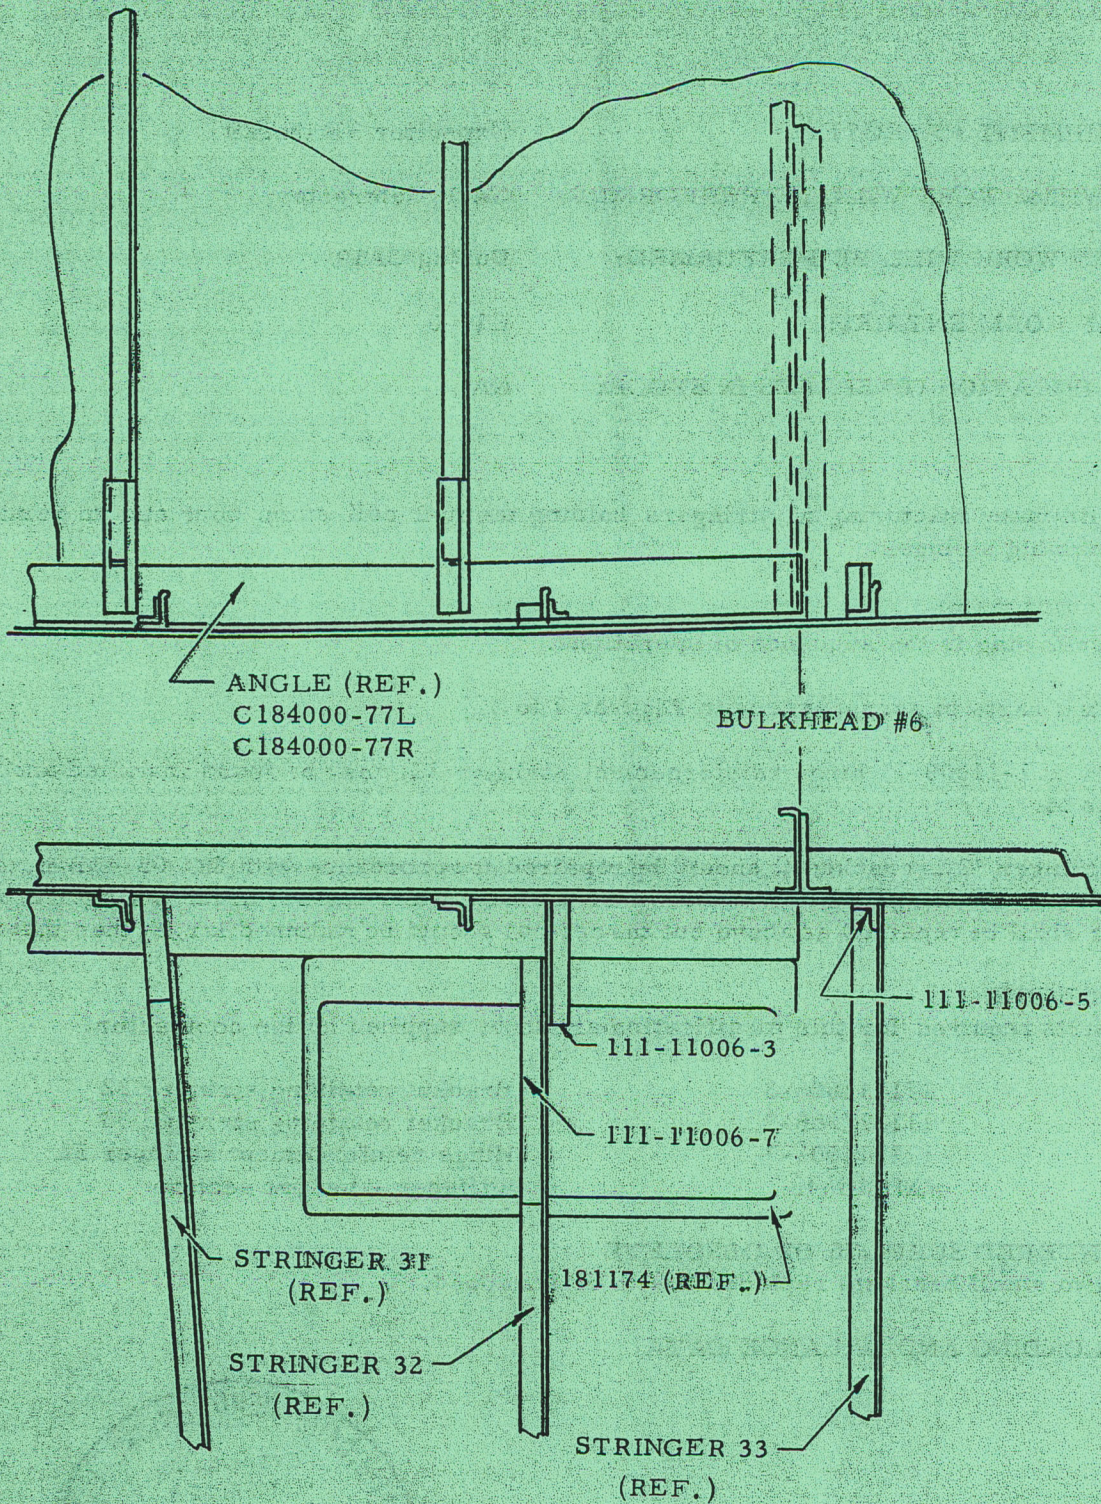
Figure 1

1 To eliminate fracturing of stringers holding the fuel cell sump door and to reinforce the bracket retaining stringer.

- (a) Install parts in accordance with Figures 1 to 4.
- (b) Part 111-11006-7, hinge reinforcement stringer 32, may be found installed and if so, is to be left as is.
- (c) If stringer 32 is cracked it should be repaired in accordance with EO 05-45B-3, Appendix A10, using replacement part given in Part 8 of the EO. If the cut-out in the stringer is cracked, the stringer shall be repaired as above but the cut-out should be radiused larger than that existing.
