**LIST OF SPECIAL INSPECTIONS**  
**WASP R985-AN5, -14B ENGINES**

**CHECK TO ENSURE THAT A SURPLUS GASKET  
36P/39577 IS NOT INSTALLED AND THAT  
PIPE ASSEMBLY 36P/39580  
IS IN SERVICEABLE CONDITION**

SPECIAL INSPECTION  
**CRACKED CRANKSHAFTS**

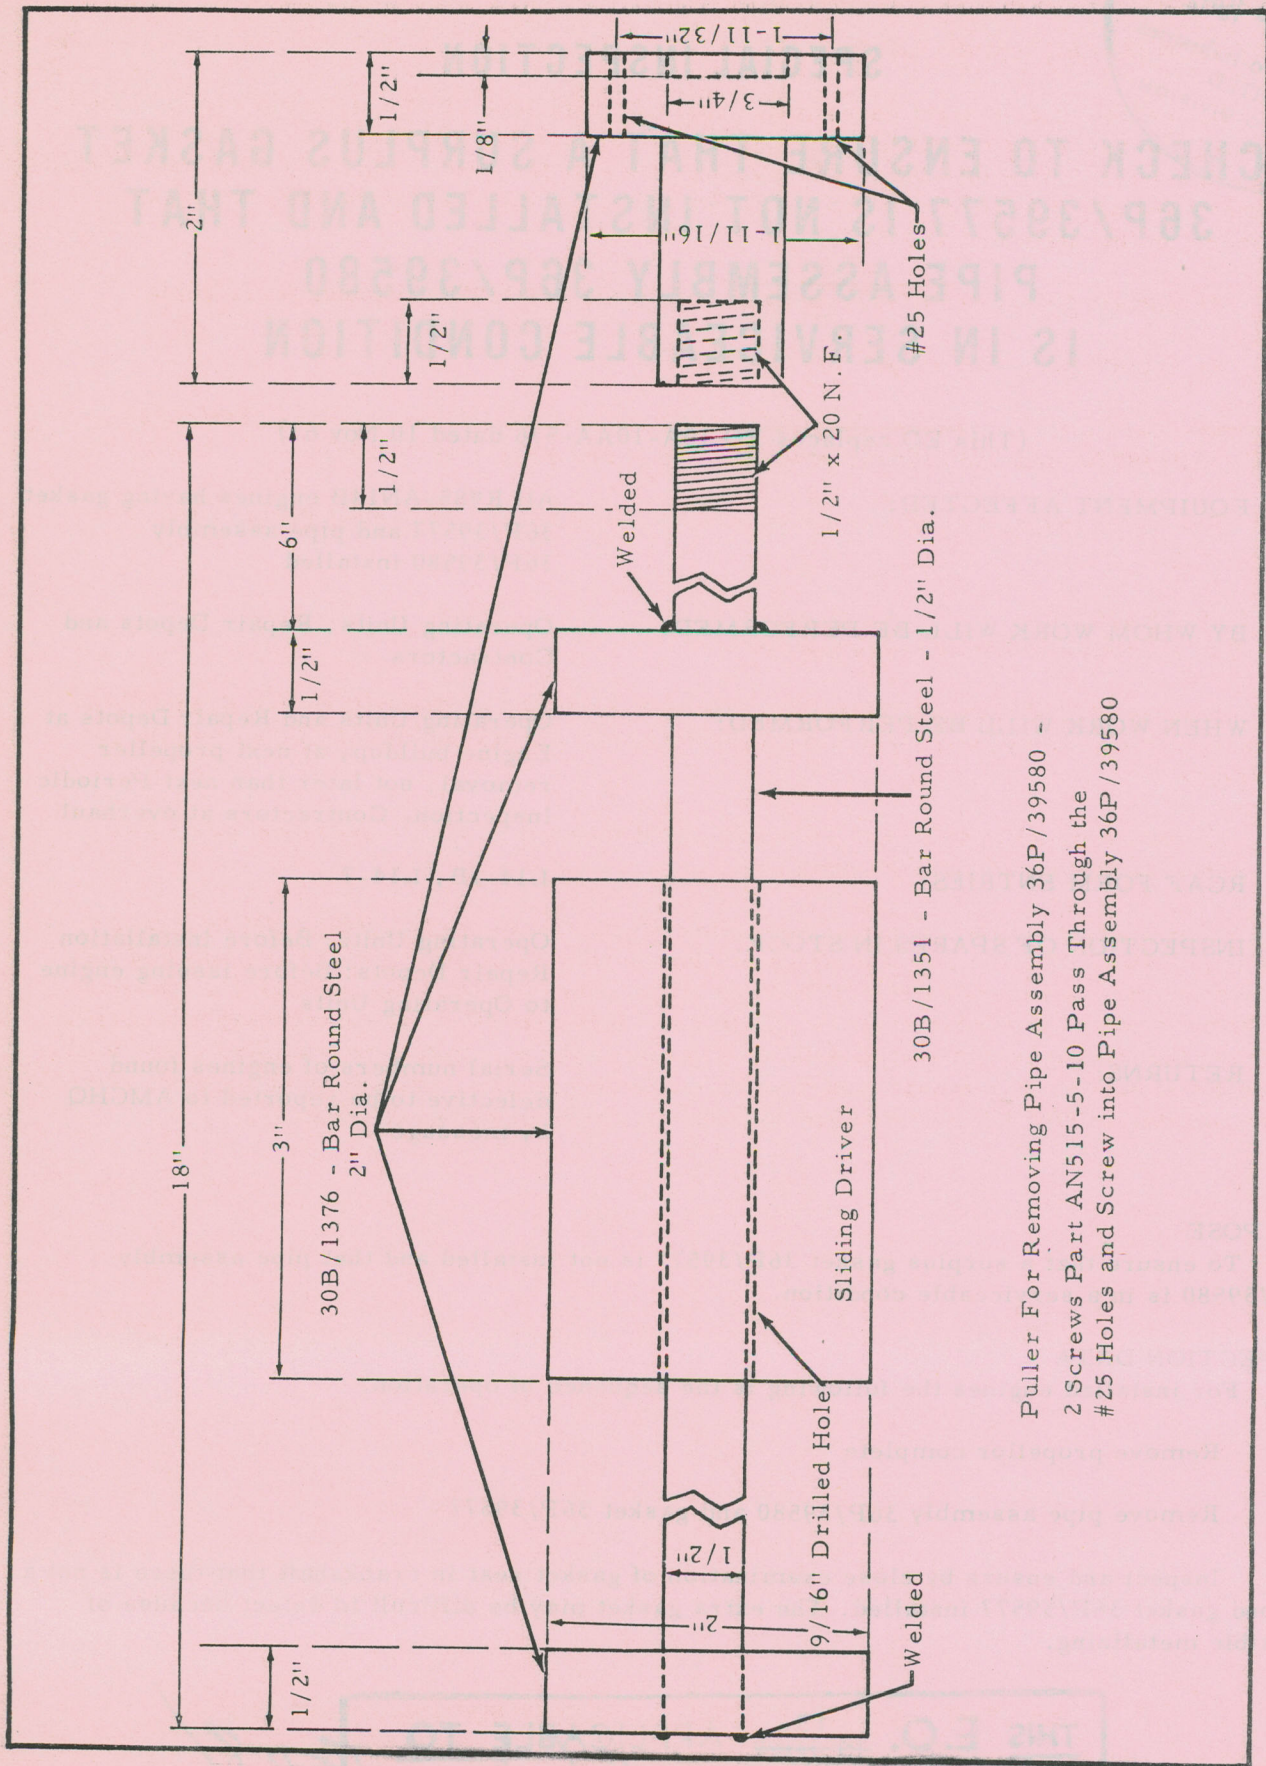
Figure 1

Puller For Removing Pipe Assembly 36P/39580 -  
 2 Screws Part AN515-5-10 Pass Through the  
 #25 Holes and Screw into Pipe Assembly 36P/39580

- (a) It is estimated that approximately one man-hour per engine will be required. Pipe assembly can be removed using wrench 36P/PWA2713 and puller manufactured locally as per Figure 1.

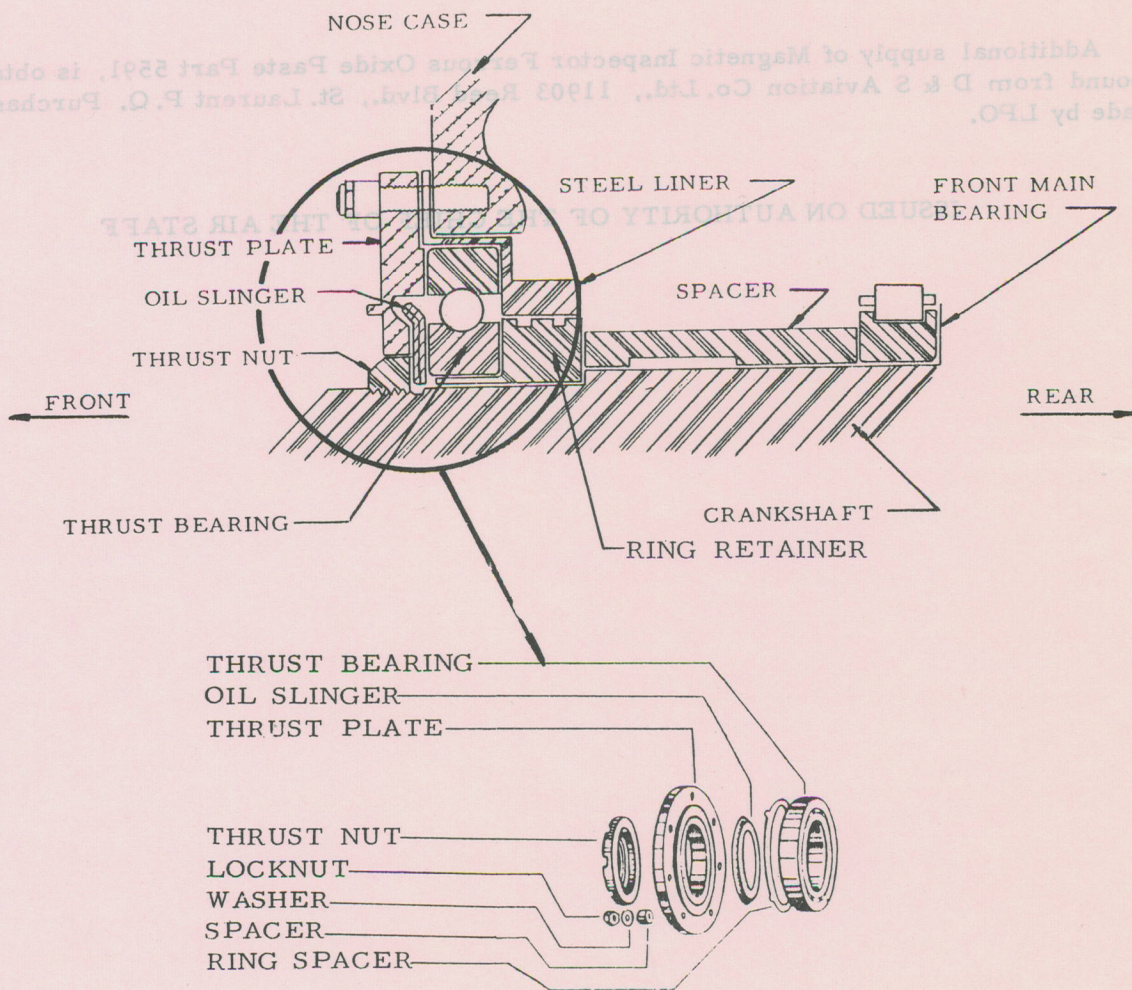
Figure 1 (Issue 1)

- (c) The following description and reference to Figure 1 will clarify and provide an explanation for these conditions.
- (1) When the thrust nut is locked in position it bears against the inner race of the thrust bearing, the ring retainer, the spacer, then the inner race of the front main bearing, which is then locked against the cheek of the crankshaft causing the whole assembly to turn with the crankshaft. Conversely when the thrust nut is removed, as the ring retainer, which the inner race of the thrust bearing is seated on, has a permissible clearance of .0025" to .004" between the crankshaft, it may not turn when the crankshaft is rotated.

- (2) The outer race of the thrust bearing is only locked in the nose section steel liner when the thrust plate is in position, and torqued. This bearing also has a maximum clearance of .004" between the OD of the race and the steel liner.
