**DESCRIPTION AND MAINTENANCE INSTRUCTIONS**

**MAGNETO SCINTILLA MODEL SB9RN  
VERNIER DRIVE COUPLING REMOVAL**

(This EO replaces EO 15-5A-2B dated 21 Feb 57)

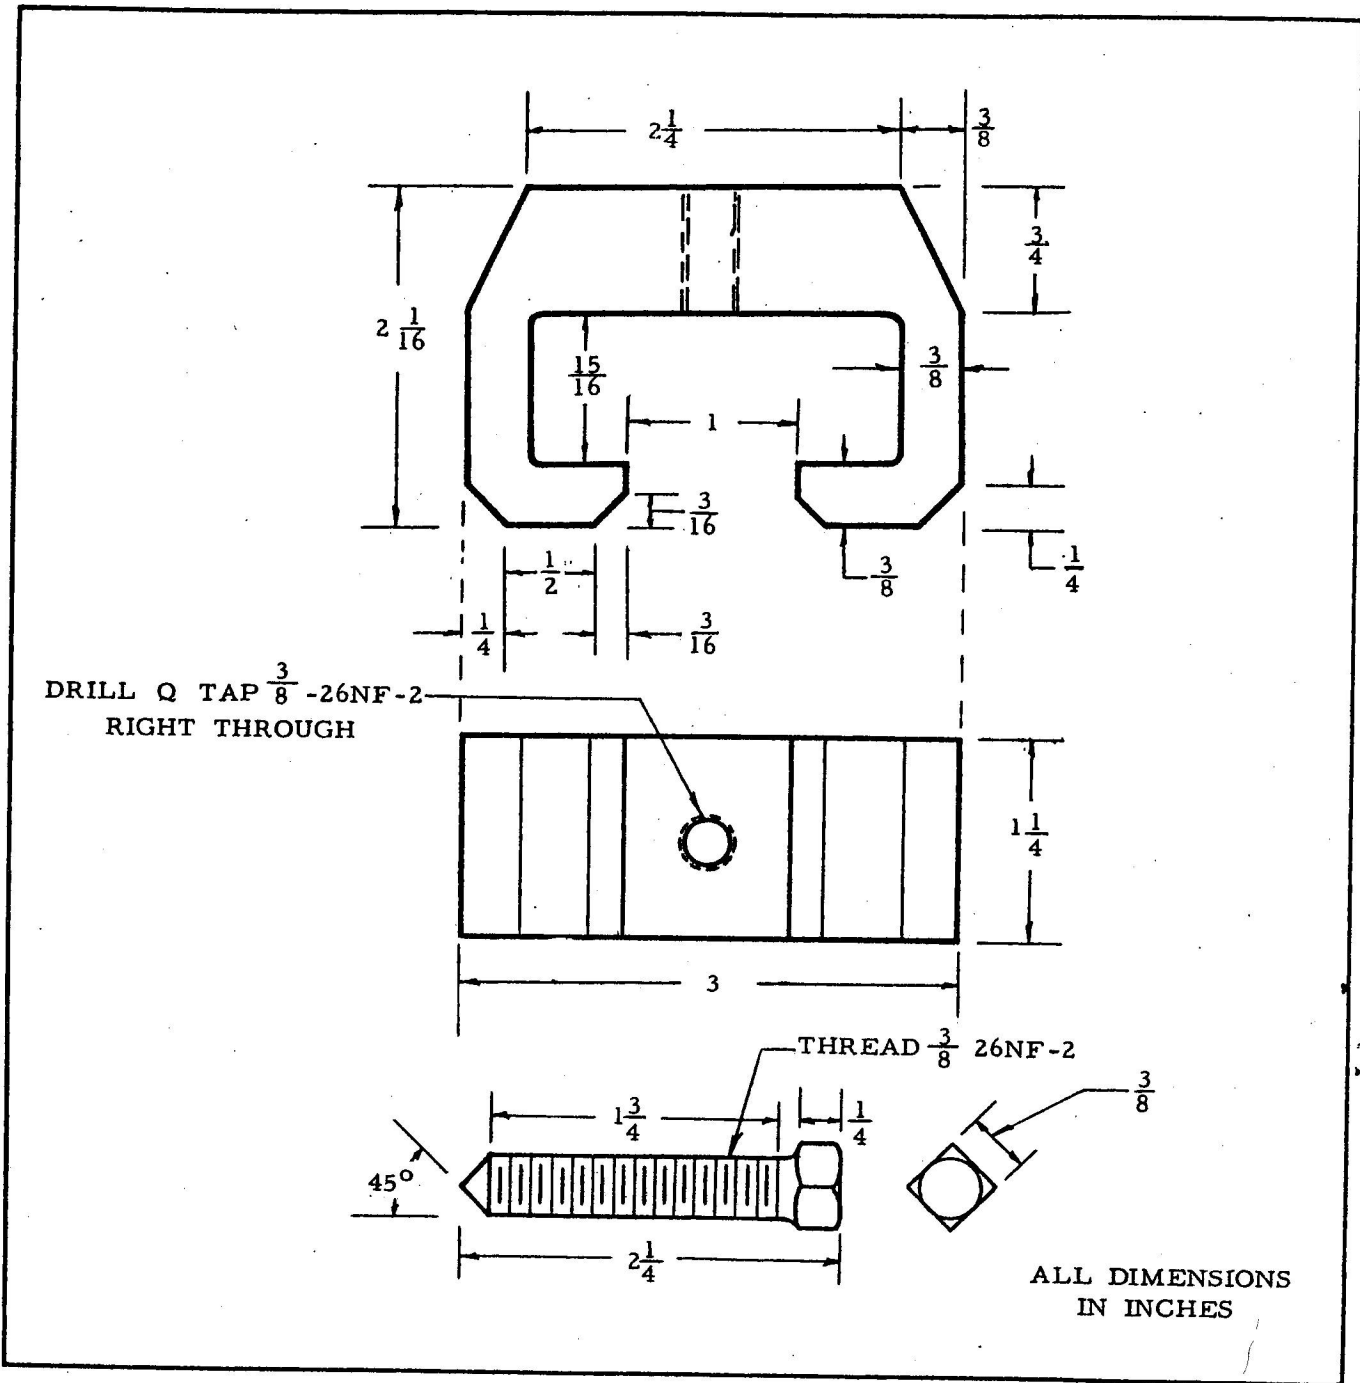
Figure 1

- 1 Contractors Technical Inspection Reports (L53) have indicated that an increasing number of Scintilla model SB9RN magnetos are still being damaged by the operators due to incorrect removal of the Vernier drive coupling gear Part 11048, ie prying off with pinch bar or screw-driver, and hammering when unable to remove by prying.
- 2 In future, when the Vernier drive coupling gear has to be removed, operating units are to ensure a puller is used. The puller is to be locally manufactured in accordance with Figure 1.
