**LIST OF FIELD MODIFICATIONS
ENGINE DRIVEN D-C GENERATOR
TYPES 30E16-1-A, 30E16-1-C AND 30E16-11-C
ECLIPSE PIONEER**

MODIFICATION INSTALLATION OF SHAFT ASSEMBLY RCAF DRAWING 35416-1

(This EO replaces EO 40-10BL-6A/1 dated 16 Mar 60)

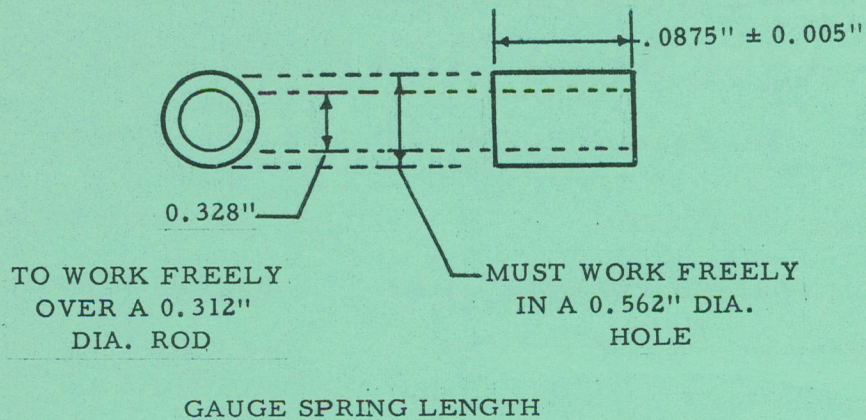
Figure 1 (Issue 1)

2 Manufacture locally from available materials the spring length gauge as detailed in Figure 1 and retain for further installations. Refer to EO 40-10BL-4 Parts List for parts identification. The following is the sequence of operations:-

- (g) Install shaft 35416-1, lining 1107478 and plate 862179 in armature assembly.
- (h) Temporarily fit gauge (manufactured as detailed in Figure 1) in armature cavity and install washer AN960-416 and nut AN364-428C (removed in para. 2(c)).

- (j) Snug nut up and carefully measure and note the protruding threaded portion of shaft 35416-1.
- (k) Remove gauge and replace with spring 883154, re-install washer AN960-416 and nut AN364-428C.
- (m) Tighten nut down on spring until the protruding threaded portion is of the same measurement as noted in para. 2(j)
- (n) Re-install bearing cover 886699 and Air Spout 867488 in reverse order to that removed (paras. 2(a) and 2(b)), lockwiring screws.
- (p) Re-identify the modified generators as follows:-
- (1) 30E16-1A change to 30E16-1A/M.
 - (2) 30E16-1C change to 30E16-1A/M.
