EO 40-5-5A

ROYAL CANADIAN AIR FORCE

# LIST OF SPECIAL INFORMATION

## BATTERIES - GENERAL

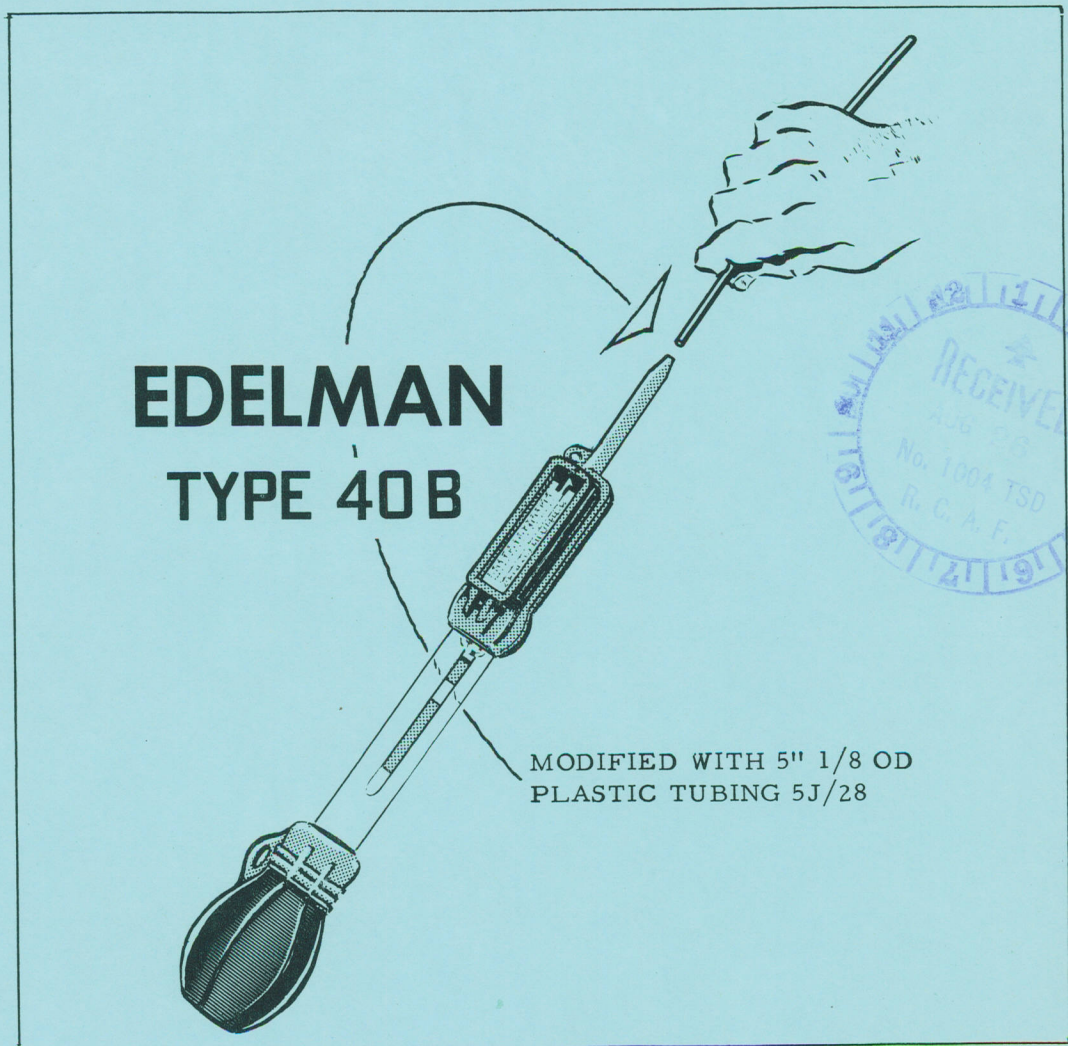
1 The present battery hydrometer RCAF Ref. 5J/28 has been found unsatisfactory in the testing of AR12-25 and AR12-36 Willard batteries. These batteries have smaller diameter filler wells which prevent the Edelman 40B type hydrometer from being used. To obviate this condition a 5" piece of tubing can be inserted into the hydrometer tip to facilitate the testing of these batteries.

2 A 5" piece of 1/8" diameter plastic, hard rubber or bakelite tubing or the plastic covering from line communication wire RCAF Ref. 5E/404 may be used for this installation, see Figure 1 for a general view.

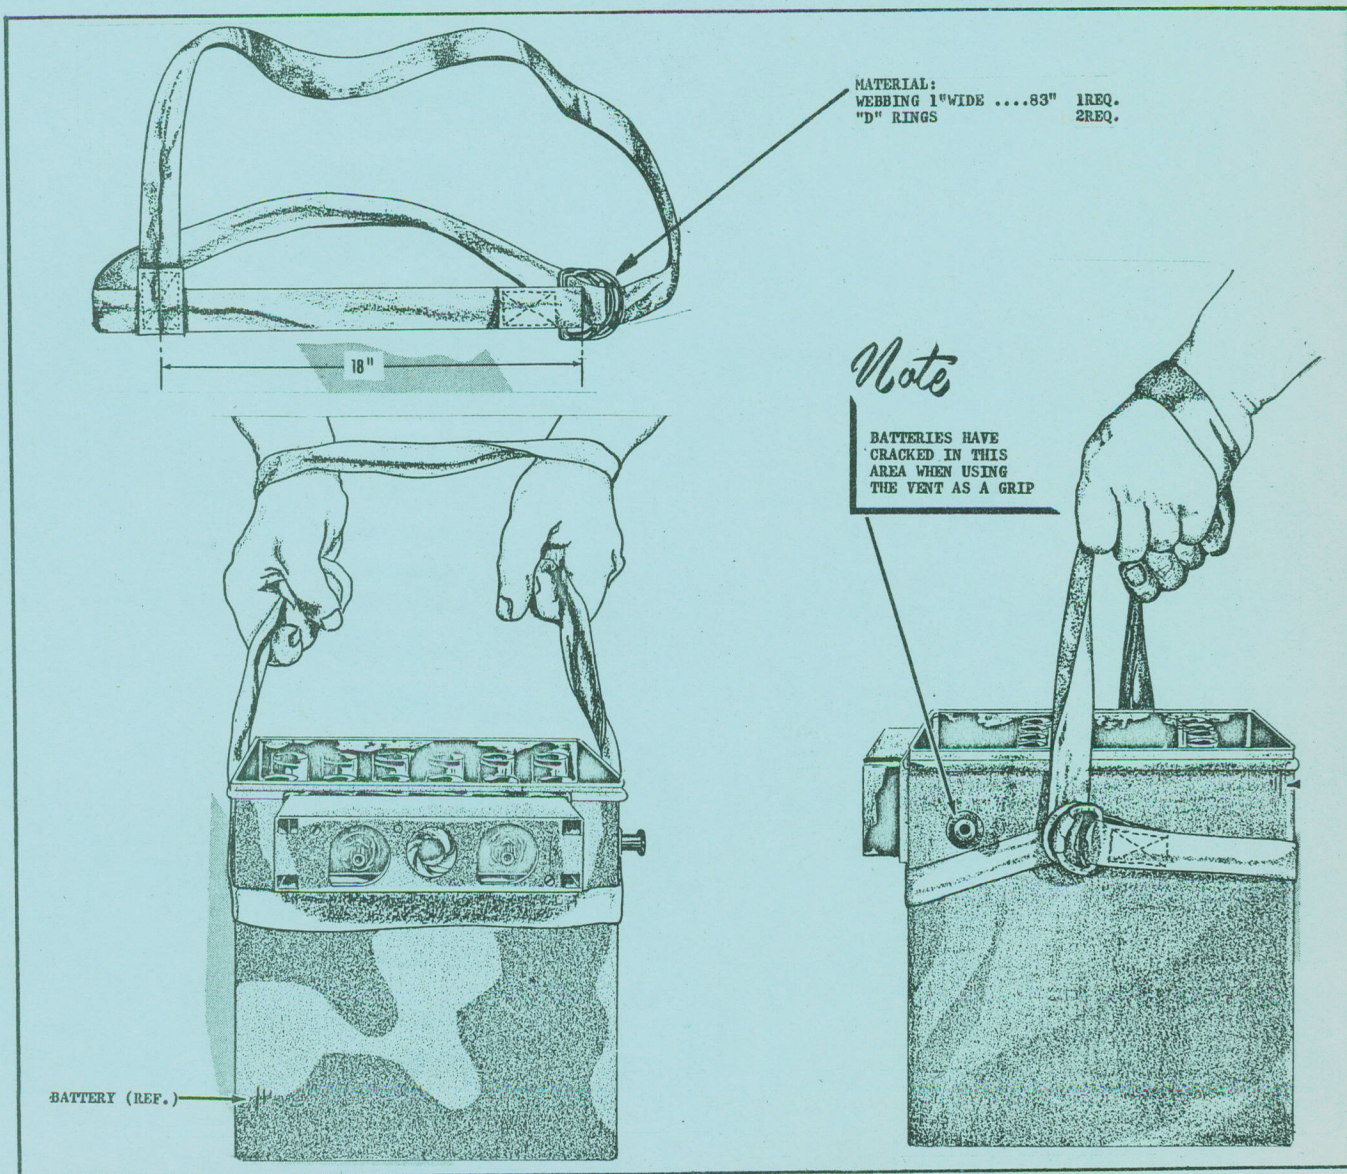
1 It has been reported that aircraft batteries RCAF Ref. 5J/174 have been found leaking near or around the battery vent. It is believed that failure of the battery in this area may be attributed to using the battery vent as a hand grip when removing or installing the batteries in aircraft.

2 A sling has been proposed as outlined in Figure 1 which will facilitate removal and installation of the battery. The sling may be manufactured locally on an as required basis.

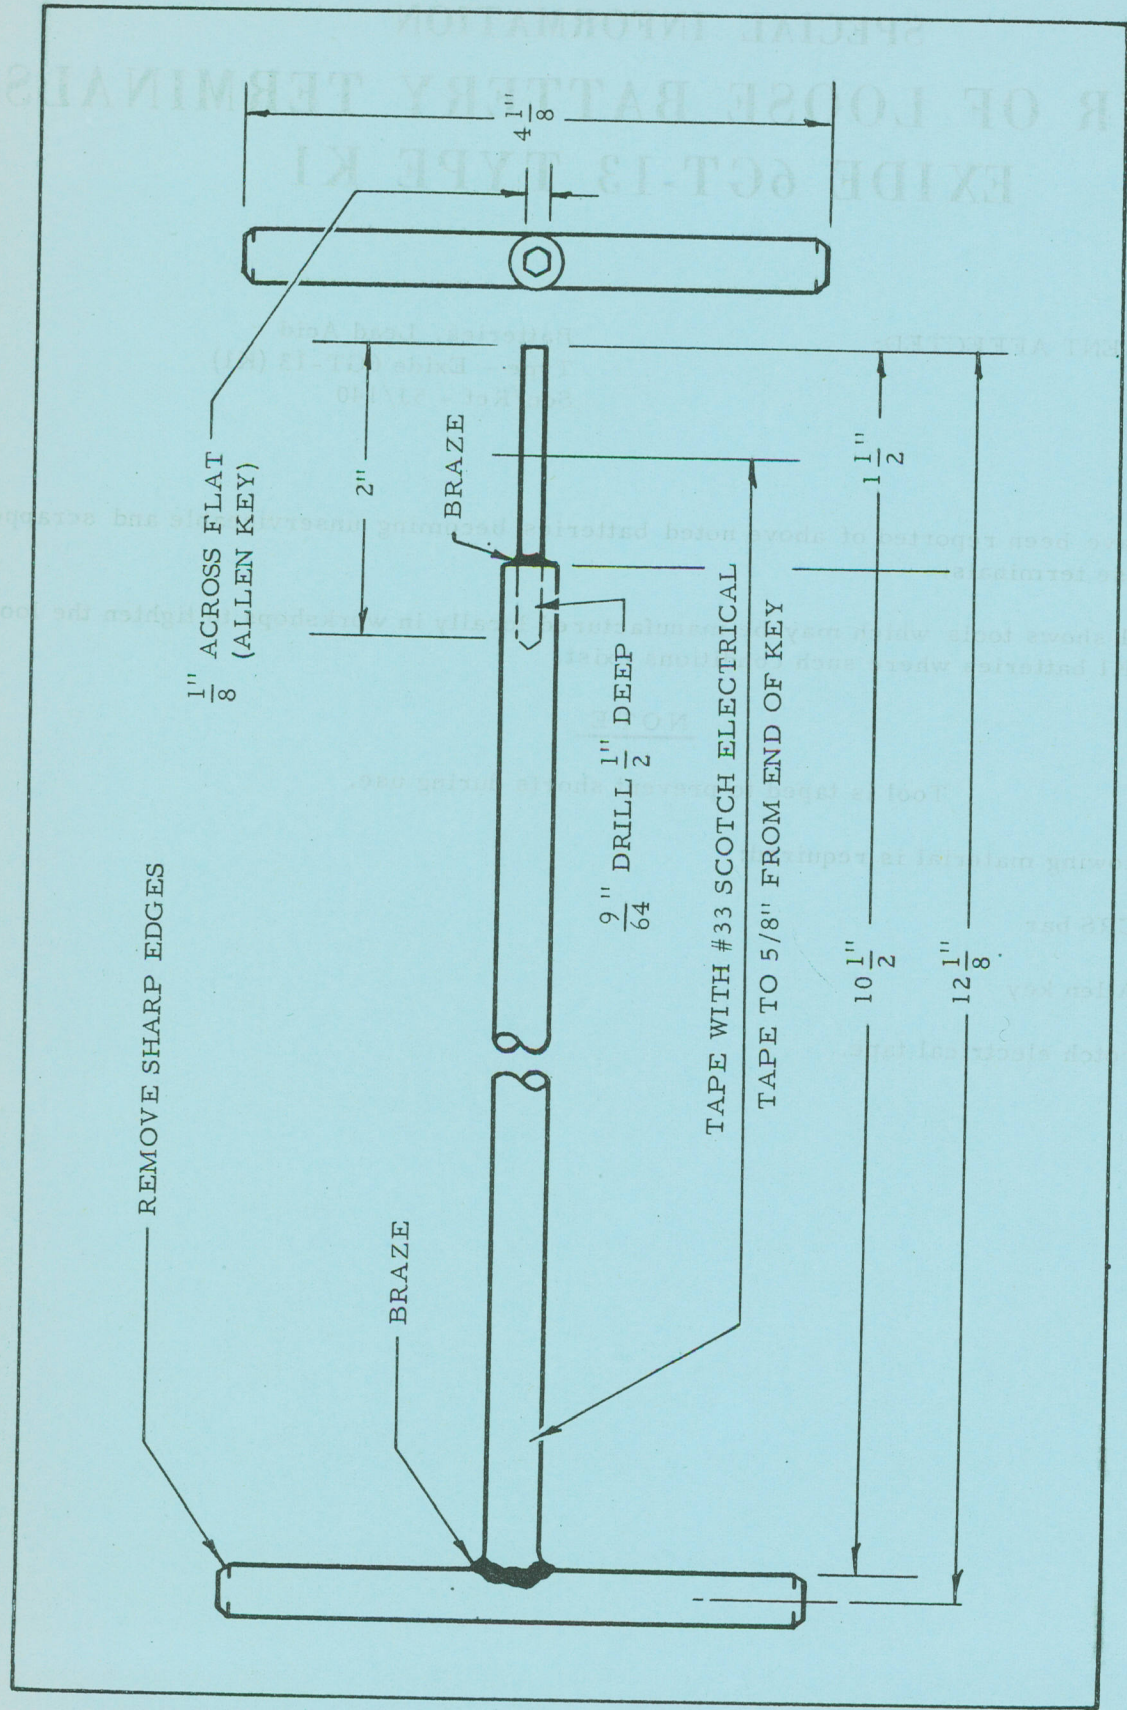
1 Cases have been reported of above noted batteries becoming unserviceable and scrapped because of loose terminals.

2 Figure 1 shows tools which may be manufactured locally in workshops to tighten the loose terminals on K1 batteries where such conditions exist.

Tool is taped to prevent shorts during use.

- (a) 1/4" CRS bar
- (b) 1/8" Allen key
- (c) #33 Scotch electrical tape.
