DESCRIPTION AND MAINTENANCE INSTRUCTIONS**ENGINE P & W R985-AN14B AND AN5
CRACKED CRANKSHAFT**

(This EO replaces EO 10A-10AA-2A dated 15 Feb 61)

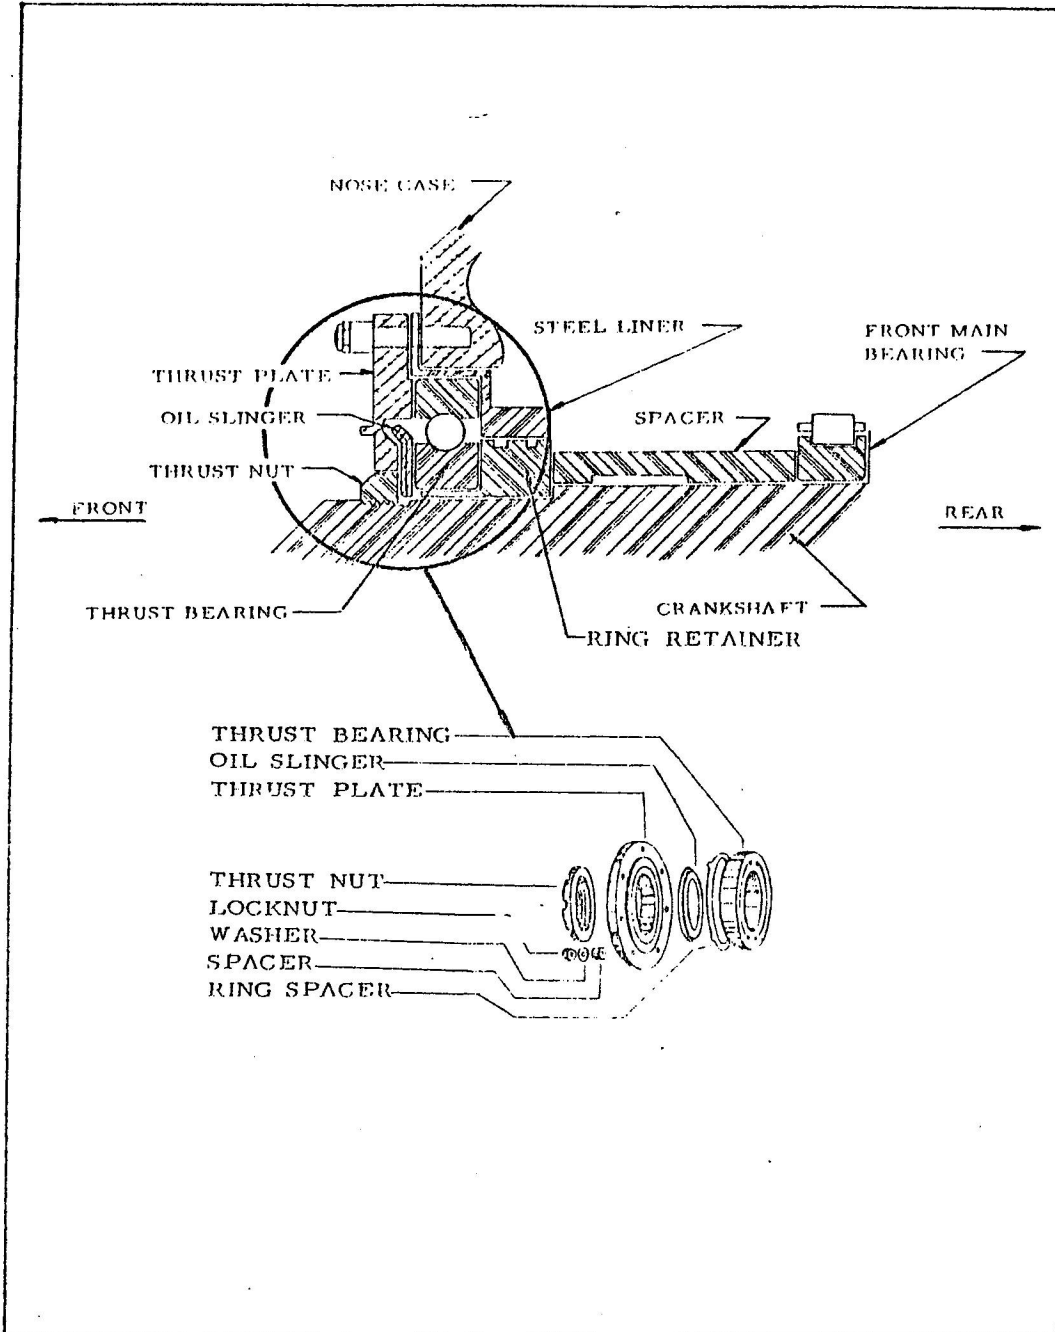
(c) The following description and reference to Figure 1 will clarify and provide an explanation for these conditions:-

(1) When the thrust nut is locked in position it bears against the inner race of the thrust bearing, the ring retainer, the spacer, then the inner race of the front main bearing, which is then locked against the cheek of the crankshaft causing the whole assembly to turn with the crankshaft. Conversely when the thrust nut is removed, as the ring retainer, which the inner race of the thrust bearing is seated on, has a permissible clearance of .00025" to .004" between the crankshaft, it may not turn when the crankshaft is rotated.

(2) The outer race of the thrust bearing is only locked in the nose section steel liner when the thrust plate is in position, and torqued. This bearing also has a maximum clearance of .004" between the OD of the race and the steel liner.

(d) Ensure that the thrust nut is torqued to the prescribed requirements i.e., using tool PWA 1093 modified to RCAF Drawing 21938 for adaption of torque wrenches 360 ft. lbs. or 3600 in. lbs. with 3/4" drive, torque to 250 ft. lbs. and further tighten through 25 to 30 degrees.
