Beech Aircraft Corporation

OVERHAUL SPECIFICATION

EMPERNAGE ASSEMBLY - MODEL C-45G

Overhaul Specification 6001

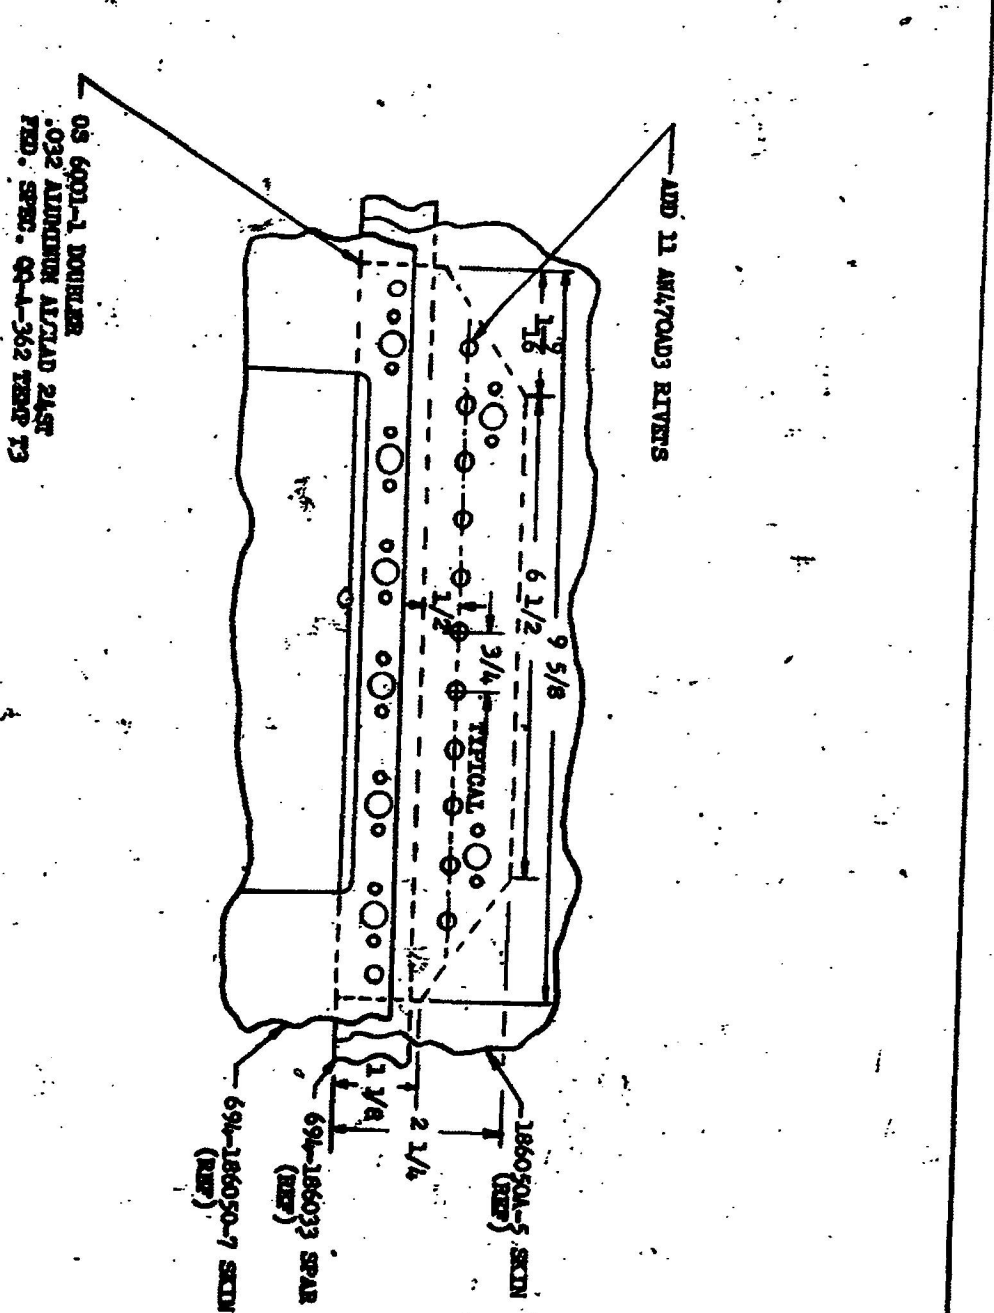
Figure 1

- (h) If the attaching holes through the 694-186050-7 skin for the 694-186040 door do not align with the holes in the 186050A-5 skin, install an OS 6001-1 doubler between the 186050A-5 skin and the 694-186033 spar. Pick up all existing rivets and add eleven AN470AD3 rivets as shown in Figure 1.

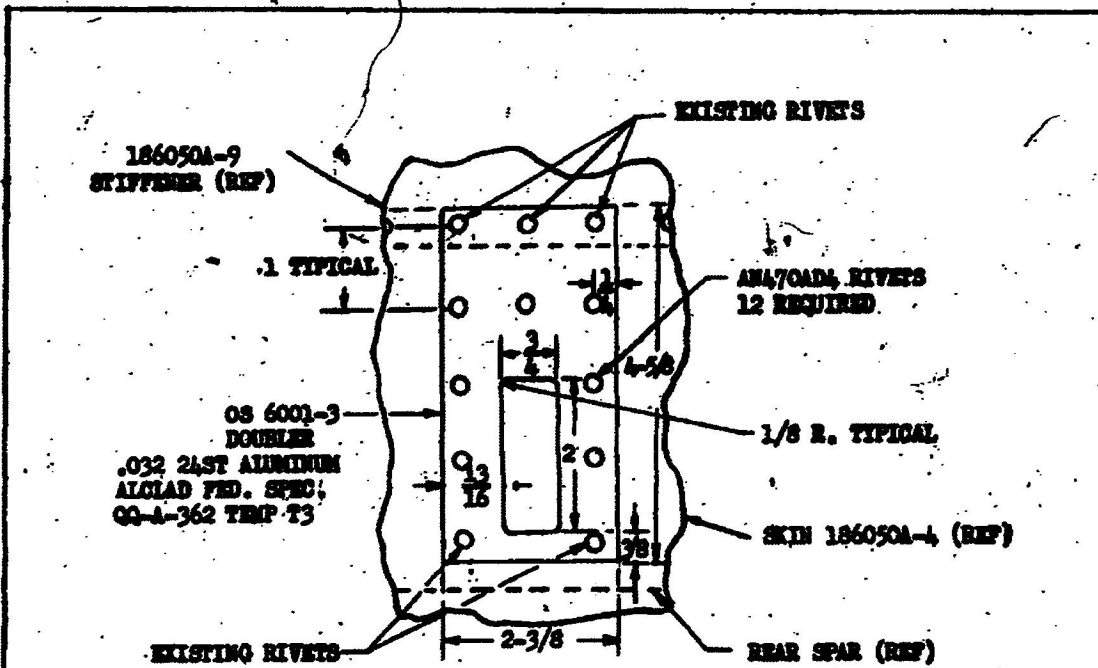
Figure 2

- (i) If the 5/8- by 2-inch cutout in the 186050A-4 skin for the elevator tab chain is oversize or cracked and does not exceed 3/16 inch, install an OS 6001-3 doubler on the outside of the skin as shown in Figure 2. Pick up the 5 existing rivets and add 7 AN470AD4 rivets spaced as shown in Figure 2, maintaining 1/4 inch edge distance. If cracks exceed 3/16 inch, repair the skin in accordance with OS 7007. Stop drill cracks.

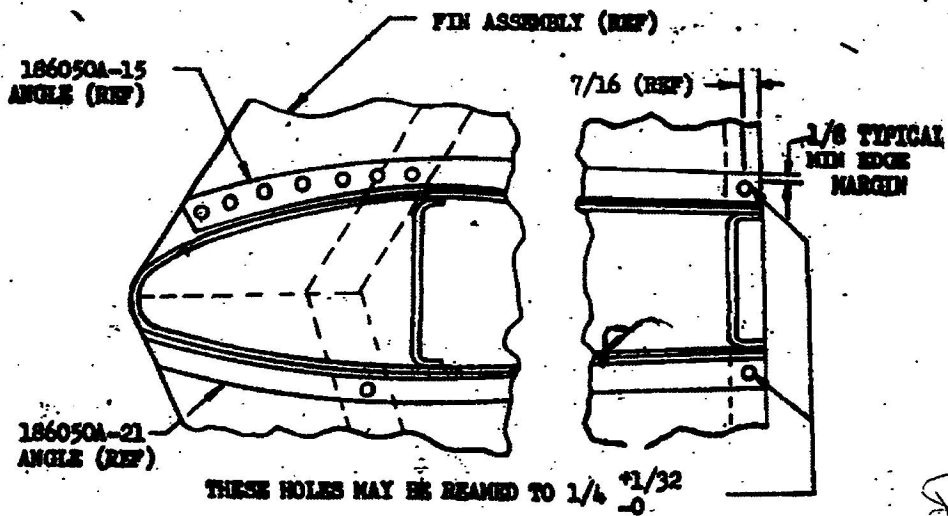
Figure 3

- (j) If the extreme aft 3/16-inch diameter fin attaching screw hole through the 186050A-15 or 186050A-21 attaching angles and fin rear spar (as shown in Detail E, Drawing 407-186000) is oversize, it may be reamed to 1/4-1/32 providing a 1/8 inch minimum edge margin is maintained. See Figure 3. Replace the AN502-10-12 screw, AN960-10 washer and AN365-1032 nut with AN4-6A bolt, AN960-416 washer, and AN365-428 nut.

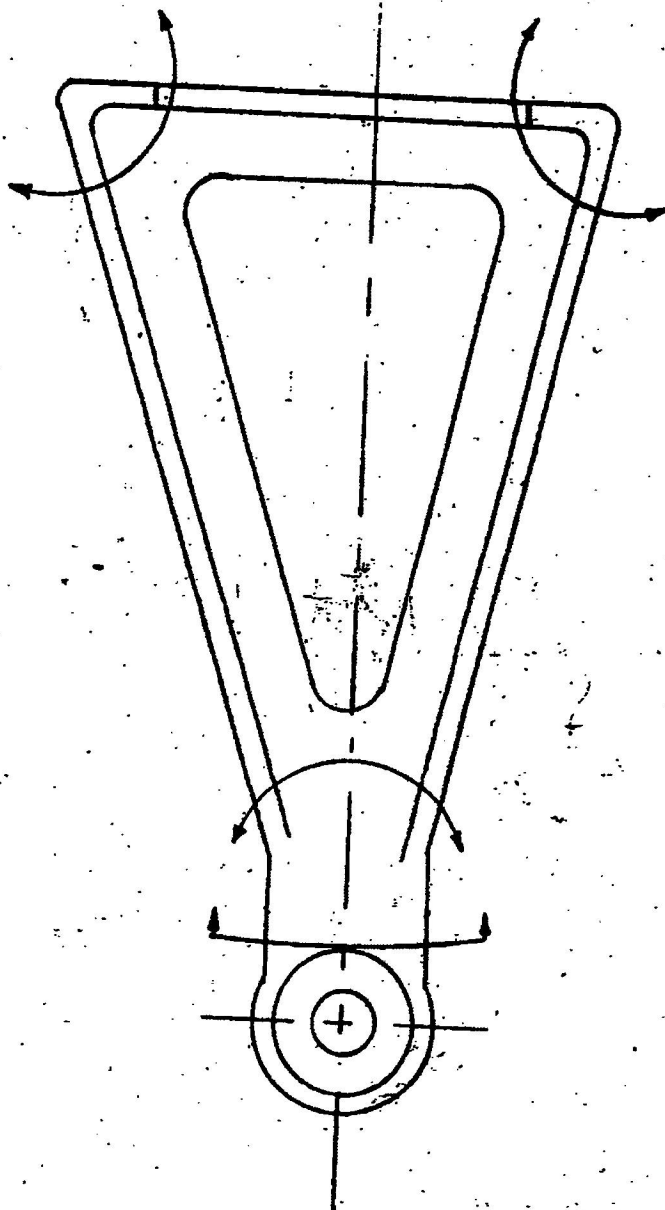
Figure 4

- (a) Skin deformity at ribs and stringers and small dents and scratches in the skin are not cause for rejection.
- (b) Scrap cracked or bent hinge castings, and those which show evidence of chisel marks, bar marks, nicks, dents, or scratches in the encircled areas shown in Figure 4. Small surface scratches, nicks, and dents not in the encircled areas will be acceptable if polished out with aluminum wool.
- (c) Skins installed under the elevator hinge castings on airplanes as they are received from the field are acceptable so long as alignment of the hinge points is not affected.

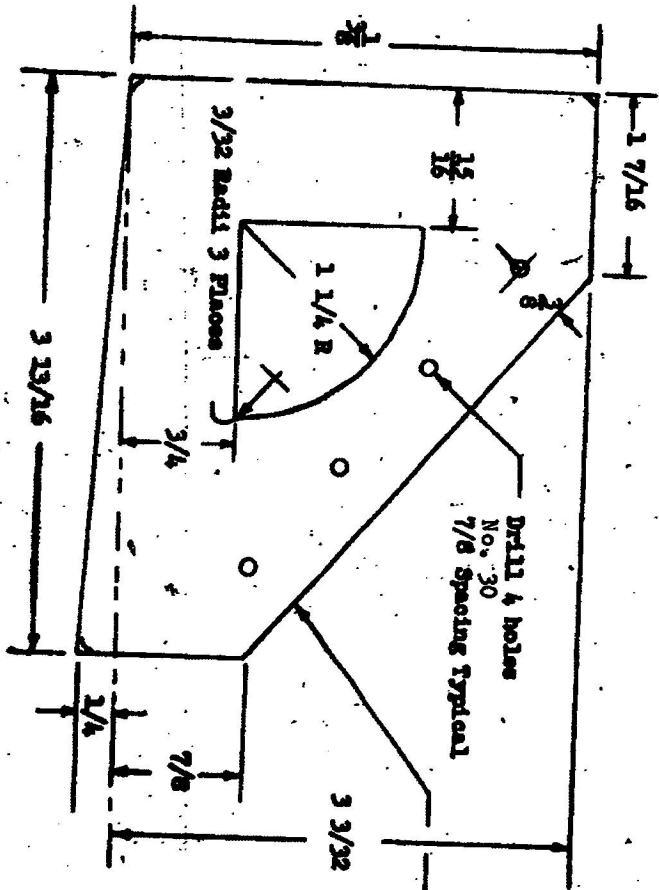
FIGURE 5

- (d) Modify the horizontal stabilizer to conform to Drawing 694-186050 except do not install the 694-186050-2 and 694-186050-3 nose skins and 694-186050-5 skin. Install OS 6001-2 doubler shown in Figure 5 in place of 404-186052 doubler shown on Drawing 694-186050.
- (e) Install a new 186050A-4 skin if stabilizer attaching-holes are mislocated in the old skin.
- (f) Install deicing boots in accordance with Drawing IL80482.
- (g) Install new 186033-3 felt strips in the 186033 rudder horn box. If the No. 40 holes are oversize or elongated, use AN426AD4 rivets for attaching the new felt.
- (h) Recondition the 4707-2-10 Breeze drive for the rudder tab in accordance with OS 5211.
- (i) Recondition the 187690 elevator tab drives and 187719 shafts in accordance with OS 5211.
- (j) Recondition the 186170 rudder bellcranks and all phenolic pulleys in accordance with OS 5201.
