1. SCOPE

WRITTEN BY <i>W. Fitzpatrick</i>	DATE ISSUED 4-24-53	OVERHAUL SPECIFICATION POWER PLANT INSTALLATION - MODEL C-45G AND C-45H		
PROJECT ENGINEER <i>[Signature]</i>				
APPROVAL <i>[Signature]</i>	DATE REVISED:	Beech Aircraft CORPORATION Wichita 1 Kansas	OVERHAUL SPECIFICATION NO. 9101	PAGE 1
APPROVAL <i>[Signature]</i>

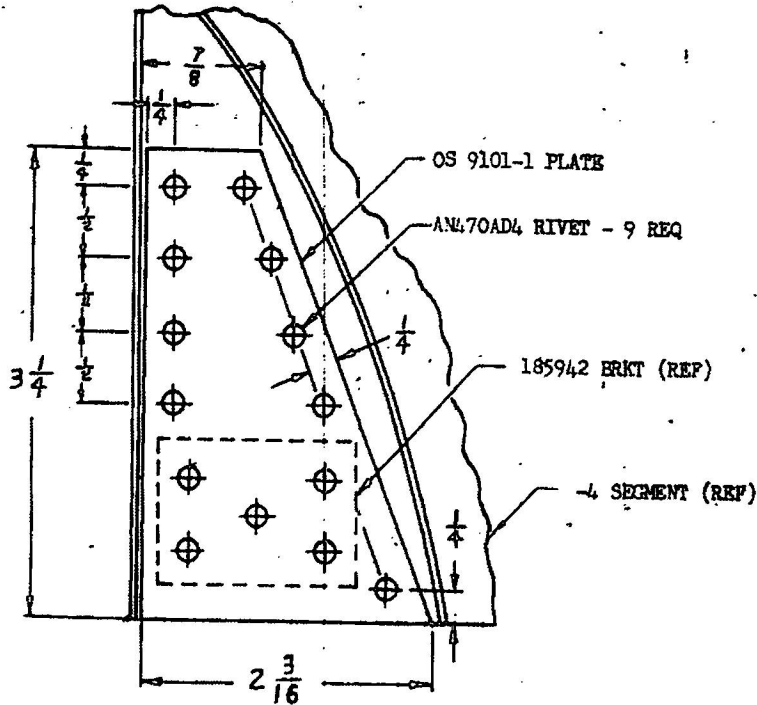
FIGURE 1

- (a) Former rings that have cracks in the 185940-3 or -4 segment or the 804-185940-3 or -4 segments at the 185942 bracket location shall be repaired as shown in Figure 1 of this specification.

Stop drill all cracks in -3 and -4 segments with No. 50 drill at 185942 bracket location. Add reinforcing plate made from 3-1/4- by 2-3/16- by .064-inch 24S-T3 AL, Specification QQ-A-362, fabricated as shown. Attach plate to segment with AN470AD4 rivets, 9 required. Space rivets approximately as shown, maintaining 1/4-inch edge distance. Locate plate flush with lower edge of -3 or -4 segment. Pick up existing rivets in 185942 bracket. Plate should not be pre-drilled, but drilled at assembly.

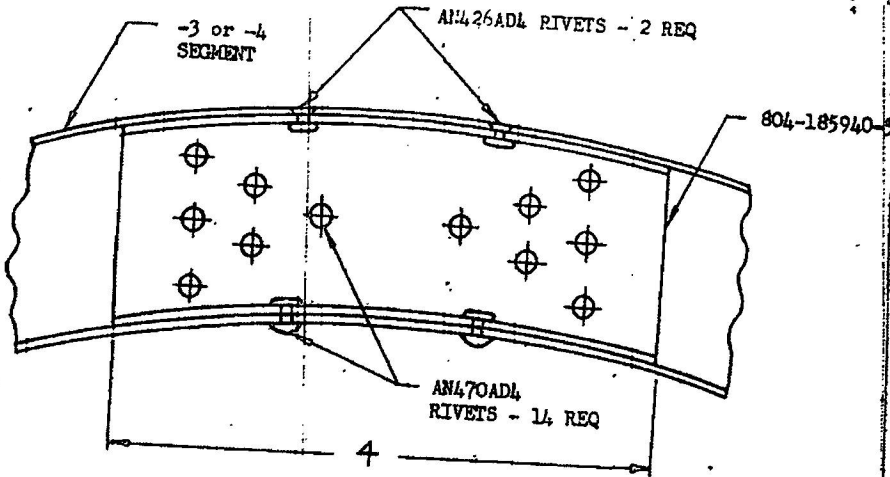
FIGURE 2

- (b) Former rings that have cracks or broken out portions in any part of the -3 or -4 segments that has a cross-section measuring approximately 1-1/2 by 5/8 will be repaired as shown in Figure 2 of this specification.

Stop drill all cracks in -3 or -4 segments with a No. 50 drill. Smooth all rough surfaces to best shop practices. Add 804-185940-5 reinforcement. Place reinforcement so that pre-drilled holes in the reinforcement maintain 1/4-inch minimum edge distance from cracks or damage in segment. Add AN470AD4 rivets as shown - 14 required. Add AN426AD4 rivets to outside flange - 2 required. Countersink segment for AN426 rivets. Location of rivets in flange may vary as long as 1/4-inch minimum edge distance and 3/8-inch minimum rivet spacing is maintained.

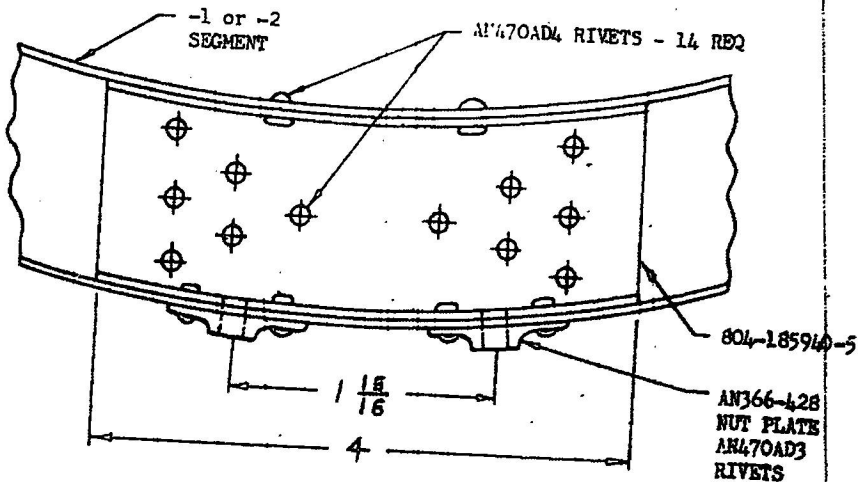
FIGURE 3

- (c) Former rings that have cracks or damage at any part of the -1 or -2 segments at the 804-185941 support assembly locations will be repaired as shown in Figure 3 of this specification.

Stop drill all cracks in -1 or -2 segment with No. 50 drill. Smooth all rough surfaces to best shop practices. Add 804-185940-5 reinforcement as shown, squarely over old nut plate center holes in segment. Add AN470AD4 rivets as shown - 14 required. Location of inner flange rivets may vary. Back drill nut plate rivet holes in segment thru reinforcing plate. Back drill center hole for support bolts with 1/4-inch drill. Attach AN366-428 nut plates with AN470AD3 rivets - 4 required. Sufficient metal must remain on segment flange to provide a good bearing surface for nut plates. Maintain 1/4-inch minimum edge distance on flange rivets.
