OVERHAUL SPECIFICATION

WING INSTALLATION - MODEL C-45G, C-45H, AND SNB-5

Overhaul Specification 1001

REVISED October 29, 1954

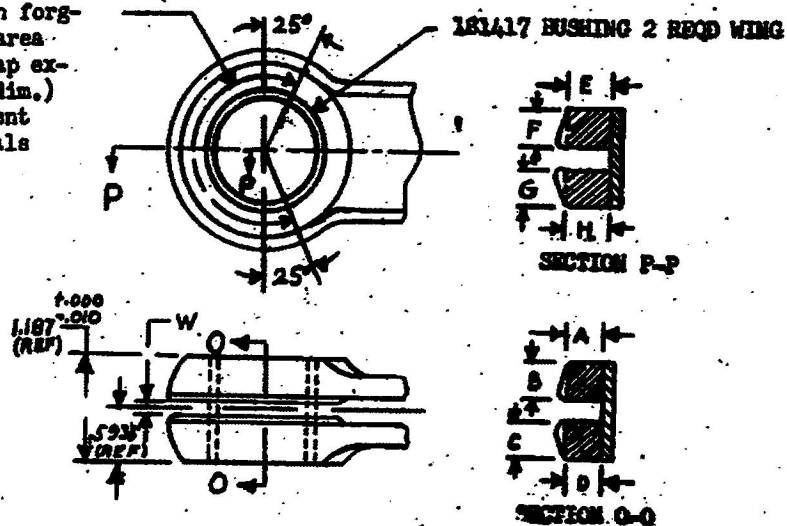
FIGURE 4

No weld to be on forgings thru this area when forgings gap exceeds 1/8 ("W" dim.) If weld is present refer to Materials Review Board.

After machining forgings for bushings, cross sectional areas (Ref. Sections "O-O" and "P-P") must not be less than the following:

1. $(A \times B) \div (C \times D) = .328$ sq. in. area (min)
2. $(A \times B) = .155$ sq. in. area (min)
3. $(C \times D) = .155$ sq. in. area (min)
4. $(E \times F) \div (G \times H) = .468$ sq. in. area (min)
5. $(E \times F) = .227$ sq. in. area (min)
6. $(G \times H) = .227$ sq. in. area (min)
7. $F = G \pm 1/32$
8. $B = C \pm 1/32$

- (g) Ream wing attaching fittings which do not have the 181417 bushings installed to 1.250 ^{-.0000}_{-.0015} and install bushings in accordance with Drawing 181410. If one or more of the cross sectional areas shown in Figure 4 are not maintained after reaming, refer the wing assembly to the Material Review Board for disposition.

When wings are received which have not been reamed for the 181417 bushings per latest revision of drawing 181410, ream holes to 1.250 \pm .000 if the minimum area as noted can be maintained. (Refer to Materials Review Board if minimum area cannot be maintained.)
