EO 05-1-2L

ROYAL CANADIAN AIR FORCE

**SELF-SEALING FUEL & OIL
CELLS PACKING, STORAGE,
MAINTENANCE & SALVAGE**

25 AUG 60

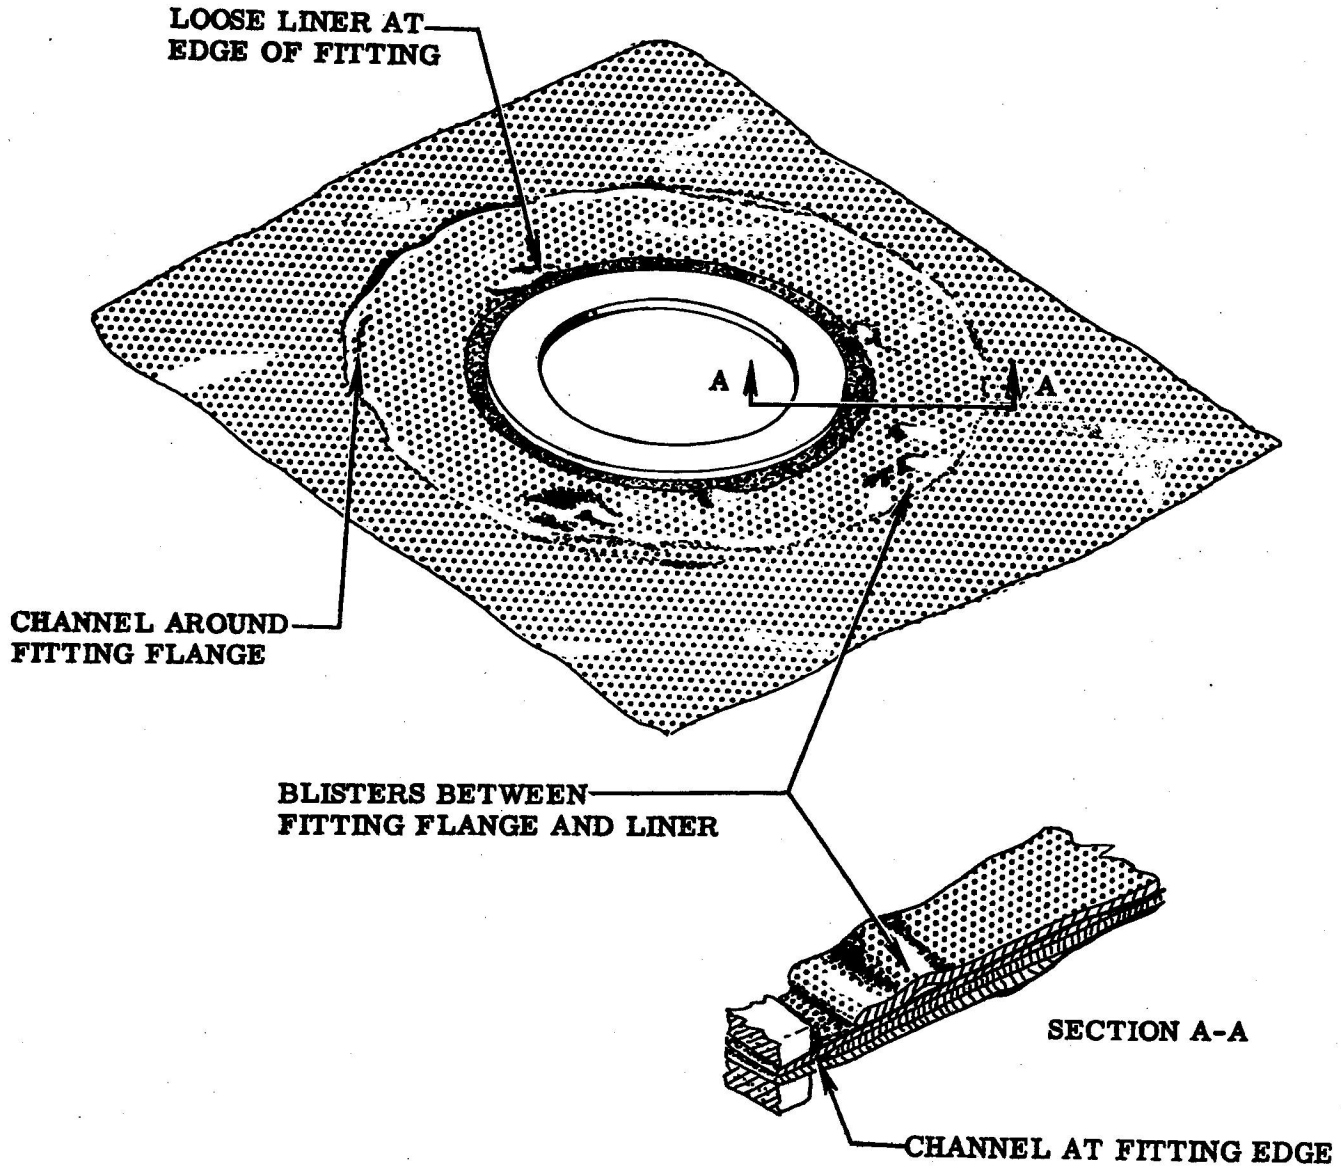
Figure 2

CONDITION	LIMIT
(1) Loose liner at throat of fitting.	1/2-inch looseness in width around entire circumference at throat of fitting (see figure 2).
(2) Edge looseness at liner lap.	Acceptable up to 1/4-inch width maximum length of liner lap, provided 1-inch bond is maintained.

(5) Blisters between liner and fitting flange.	1/4-inch maximum dimension; maximum one per lineal foot and two per fitting provided 1-inch bond is maintained (see figure 2).

(11) Channels in inner-liner laps.	1/8-inch by 3-inch maximum dimension with a maximum of one in any 5 lineal feet of splice (see figure 4).
(12) Channels around entire outer edge of fitting flange.	1/4-inch maximum width (see figure 2).

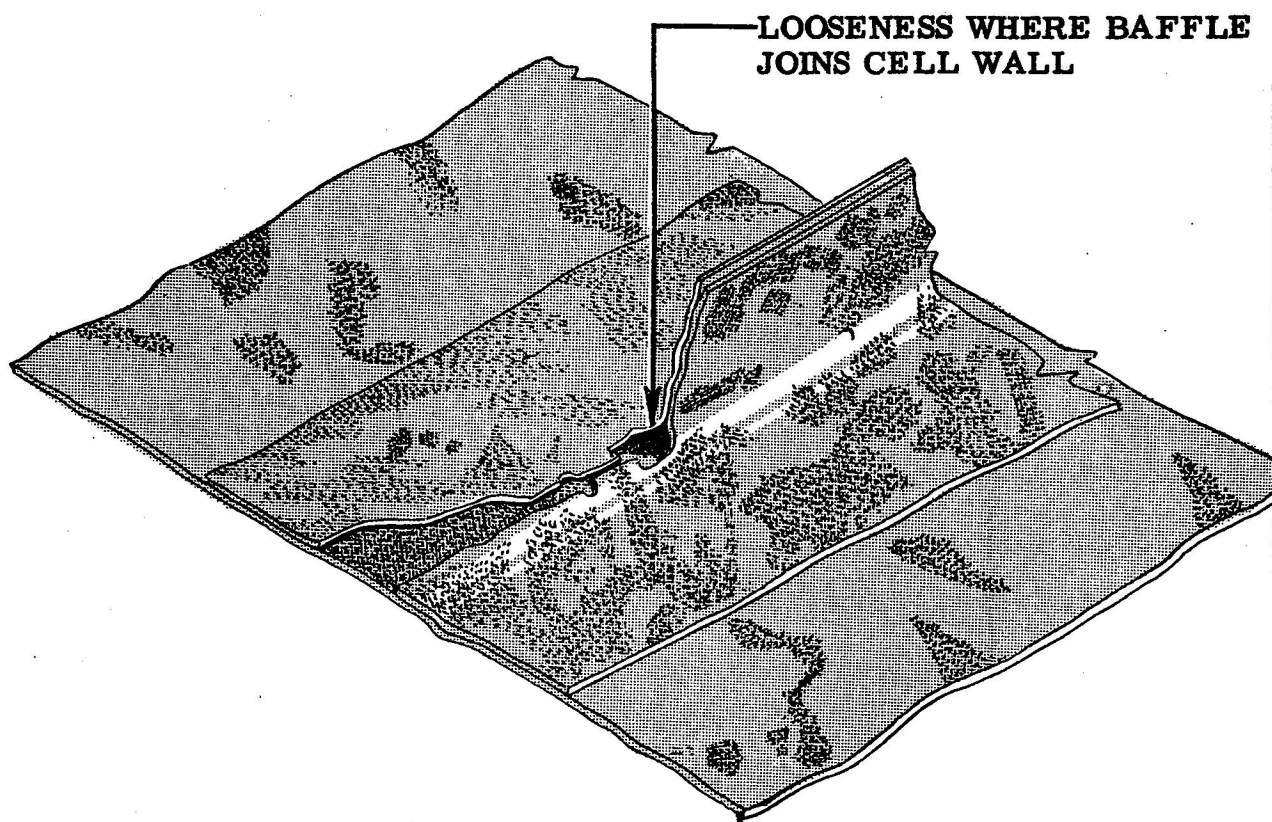
Figure 3

(4) Looseness under cemented components such as attaching straps, baffle shoes, etc.	15 percent of individual area provided 1/4-inch bond is maintained around the edge (see figure 3).

(4) Looseness of cemented internal support components such as attaching straps, baffle supports, etc.	Acceptable up to 15 percent of component area provided 1/4-inch solid bond is maintained around the edge (see figure 3).

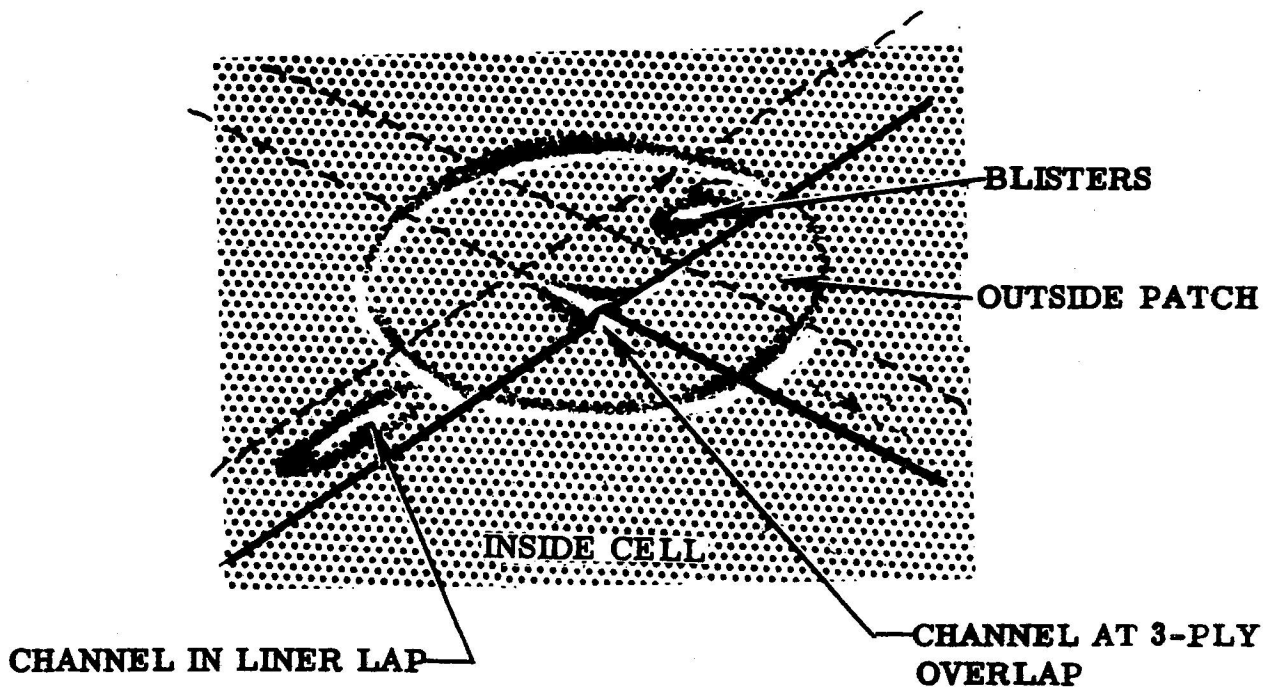
Figure 4

(8) Checking due to weather, ozone, dry cracking or surface imperfections	Acceptable provided there is no indication of activation.
(9) Blisters in liner laps.	1/4-inch maximum dimension; average one per lineal foot of splice with a maximum of five in any one 5-foot length of splice (see figure 4).

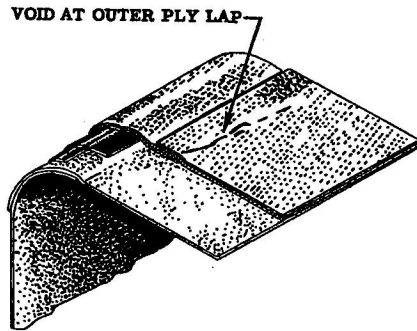
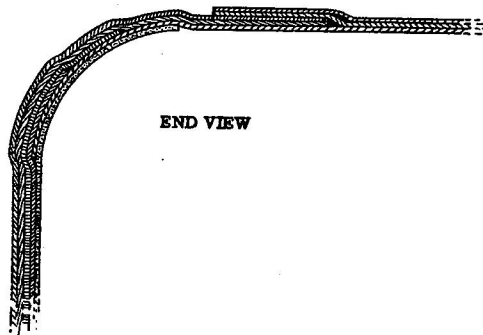
Figure 6

(7) Damage through outer cord or fabric ply.	Not acceptable.
(8) Channels or bridging of outer plies at cord or fabric splice.	1/2-inch maximum width full length of splice (see figure 6).

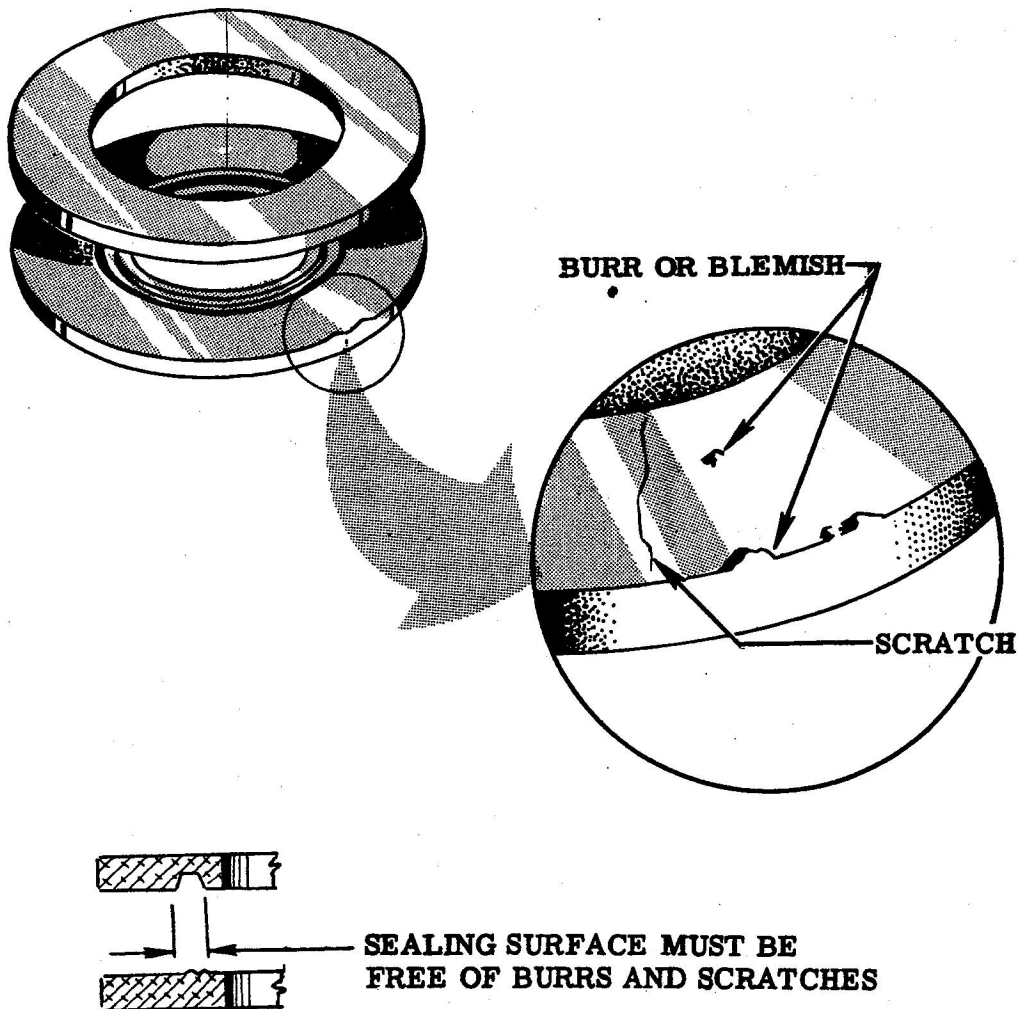
Figure 7

CONDITION	LIMIT
(b) Sealing face with groove:	
1. Minor surface damage outside of "O" ring groove other than rust, corrosion or burrs.	Acceptable (see figure 7).
2. Physical damage to "O" ring groove.	Not acceptable.
3. Corrosion or rust.	Not acceptable.
4. Cement or other foreign material in "O" ring groove.	Not acceptable.
(3) Bent or broken fittings.	Not acceptable.
(4) Thread damaged fittings.	Acceptable provided serviceability is not affected.

(b) Weather checking of surfaces other than sealing surface	Acceptable.
(2) "O" Ring Fittings.	
(a) Sealing surface without groove:	
<u>1.</u> Scratches within the sealing area.	Not acceptable (see figure 7).
<u>2.</u> Burrs on mating surface.	Not acceptable (see figure 7).
<u>3.</u> Corrosion or rust.	Not acceptable.

(b) Sealing surface with groove:	
<u>1.</u> Minor surface damage outside "O" ring groove other than rust, corrosion or burrs.	Acceptable (see figure 7).
<u>2.</u> Physical damage to "O" ring groove.	Not acceptable.
<u>3.</u> Corrosion or rust.	Not acceptable.
<u>4.</u> Cement or other foreign matter in "O" ring groove.	Not acceptable.

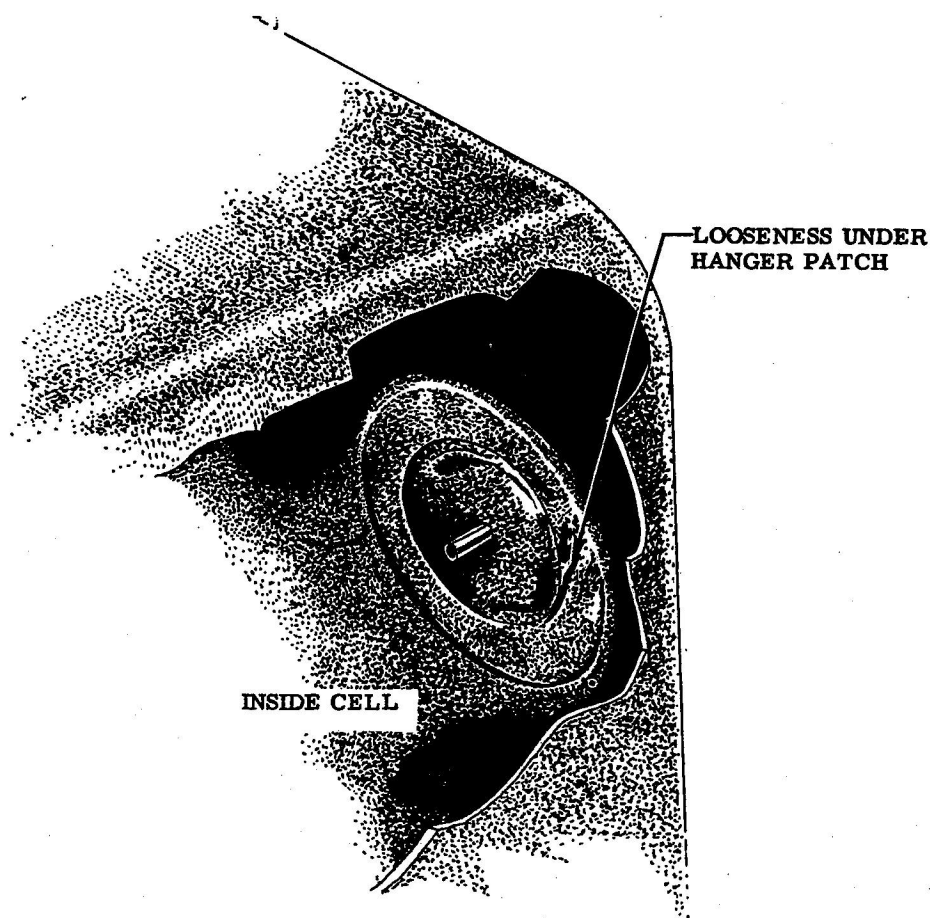
Figure 8

(3) Loose or damaged hanger straps or hanger attaching points.	Acceptable up to 15 percent of component area provided 1/4-inch solid bond is maintained around the edge (see figure 8).

CONDITION	LIMIT
(1) Skim coat blisters.	Acceptable.
(2) Loose or damaged hanger straps or hanger attaching points.	Acceptable up to 20 percent of component area provided 1/4-inch solid bond is maintained around the edge (see figure 8).

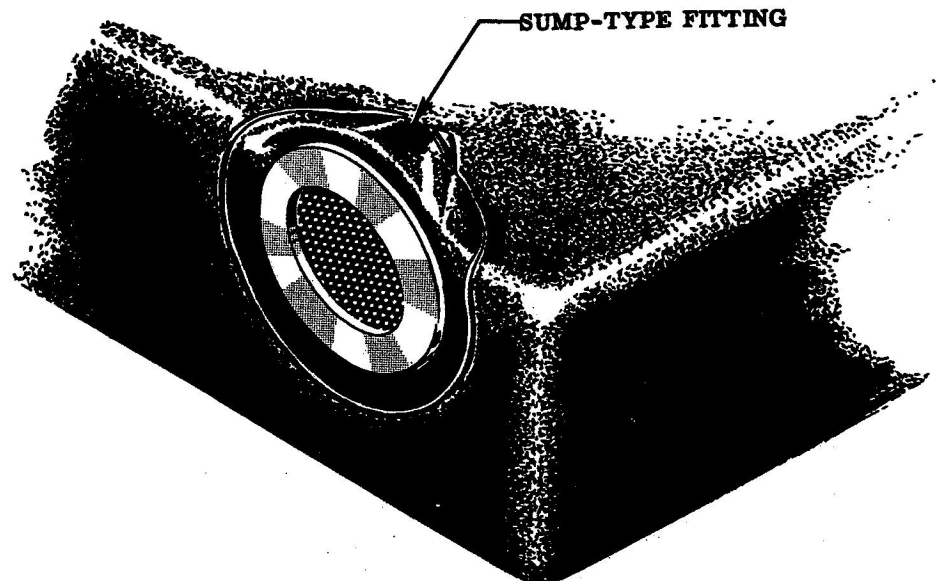
Figure 9

(2) Loose liner at throat of sump type and 3-plane fittings.	1/4-inch maximum looseness (see figures 9 and 10)
(3) Loose liner lap.	1/4-inch looseness maximum width in edge of liner lap and full length of lap provided 1-inch bond is maintained, except*Firestone 1052-6 construction on which 1/16-inch edge looseness will be acceptable.
