# OVERHAUL SPECIFICATION

ENGINE COWLING - MODEL C-45G, C-45H, AND SNB-5

Overhaul Specification 9810

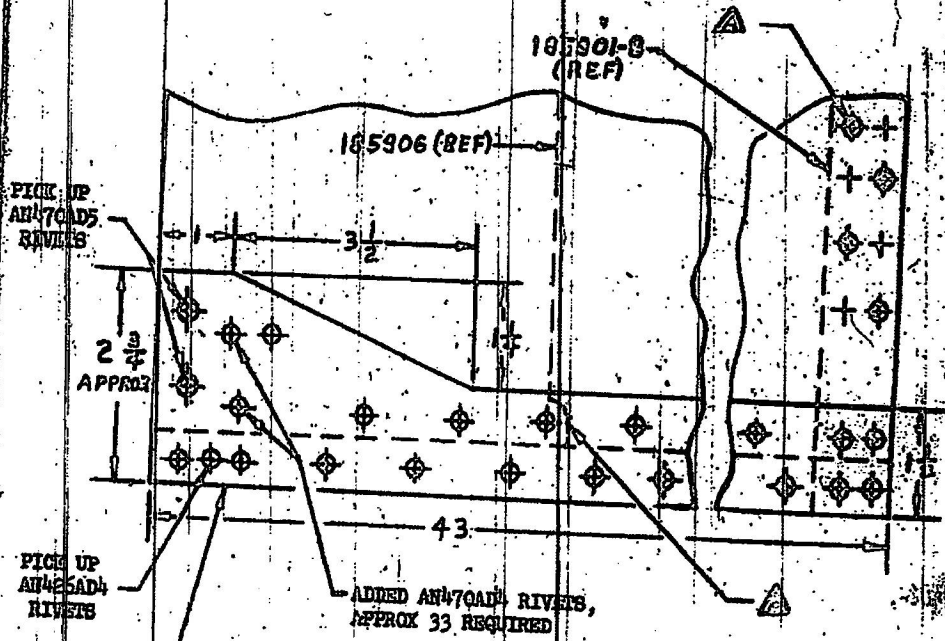
FIGURE 1

- (d) Repair skins that are frayed and worn at the mating edges of the cowling by adding an OS 9810-1 strip reinforcement, as shown in Figure 1 of this specification. Remove the outside row of 1/8-inch rivets along the mating edge and the first two 5/32-inch rivets at the leading edge of the cowling. Stop drill all skin cracks that do not end in rivet holes and fall under reinforcement with a No. 50 drill. Disregard cracks running from rivet holes to the edge of the skin and cracks running between rivet holes. Make reinforcement as shown. Pick up existing rivet holes along edge with AN426AD4 rivets. Pick up the two existing 5/32-inch rivets at the leading edge. Add AN470AD4 rivets, as shown, staggered with the existing row. Maintain twice rivet diameter edge distance. Smooth all rough edges before attaching reinforcement.

CS 9810-1 REINF. - MAKE FROM  
.051 SHEET OF STRIP, 24S-T AL ANGLAD,  
FIG. 98-A-362, COND T3

- ▲ When 185901-8 reinforcement is not flush with skin and gaps are evident, add AN426AD5 rivets, evenly spaced between existing rivets or spotwelds.
- ▲ Spotface 185906 with 1/2 spotfacer to allow clearance for rivets through reinforcement which have insufficient edge distance in 185906.

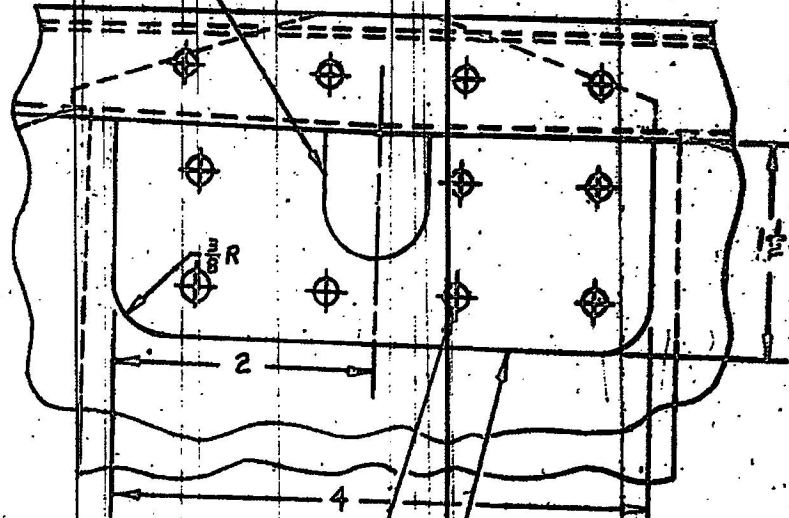
FIGURE 2

- (e) Skin surrounding the Dzus fastener cutout that is worn more than .015-inch deep, cracked or otherwise damaged, will be repaired by removing the damaged skin and installing an OS 9810-3 flush plug as shown in Figure 2 of this specification.

(e) Skin surrounding the Dzus fastener cutout that is worn more than .015 inch deep, cracked or otherwise damaged, will be required by removing the damaged skin and installing an OS 9810-3 flush plug as shown in Figure 2 of this specification.

CUT-OUT IN PLUG TO MATCH EXISTING CUT-OUT IN SKIN WHICH IS TO BE REMOVED.

PICK UP EXISTING RIVETS IN BEARING PLATE. 7 REQUIRED. USE SAME TYPE HEAD AS ORIGINAL.

CS 9810-3 FUSE PLUG. MAKE FROM .040 SHEET OR STRIP, 24S-43 AL ALCLAD, FHD. EQ-A-362, COND T3

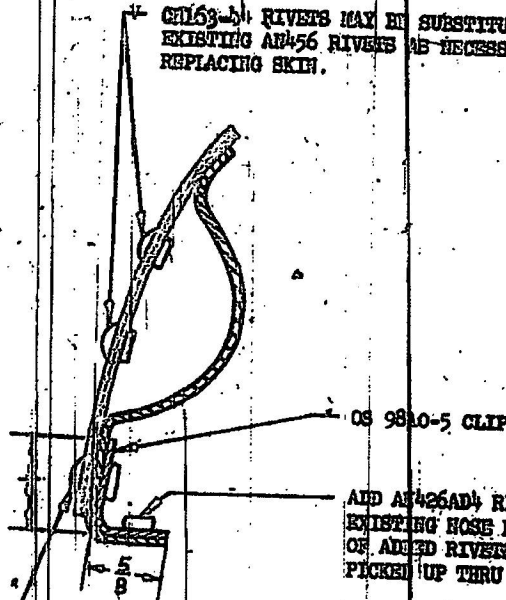
FIGURE 3

(g) Nose rings worn more than .020 inch deep will be repaired by adding an OS 9810-5 clip as shown in Figure 3 of this specification. Make clip from another nose ring so that the proper contour can be maintained. Length of clip will be sufficient to allow the addition of one rivet on each side of the worn area. Maintain 1/4-inch edge distance on all rivets.

CS 153-1 RIVETS MAY BE SUBSTITUTED FOR EXISTING AN-56 RIVETS AS NECESSARY, WHEN REPLACING SKIN.

ADD AN-266AD RIVETS THRU CLIP AND EXISTING NOSE RING. USE SAME NUMBER OF ADDED RIVETS AS EXISTING RIVETS PICKED UP THRU SKIN AND NOSE RING.

PICK UP RIVETS THRU SKIN AND NOSE RING. TWO RIVETS MINIMUM AND EIGHT RIVETS MAXIMUM.

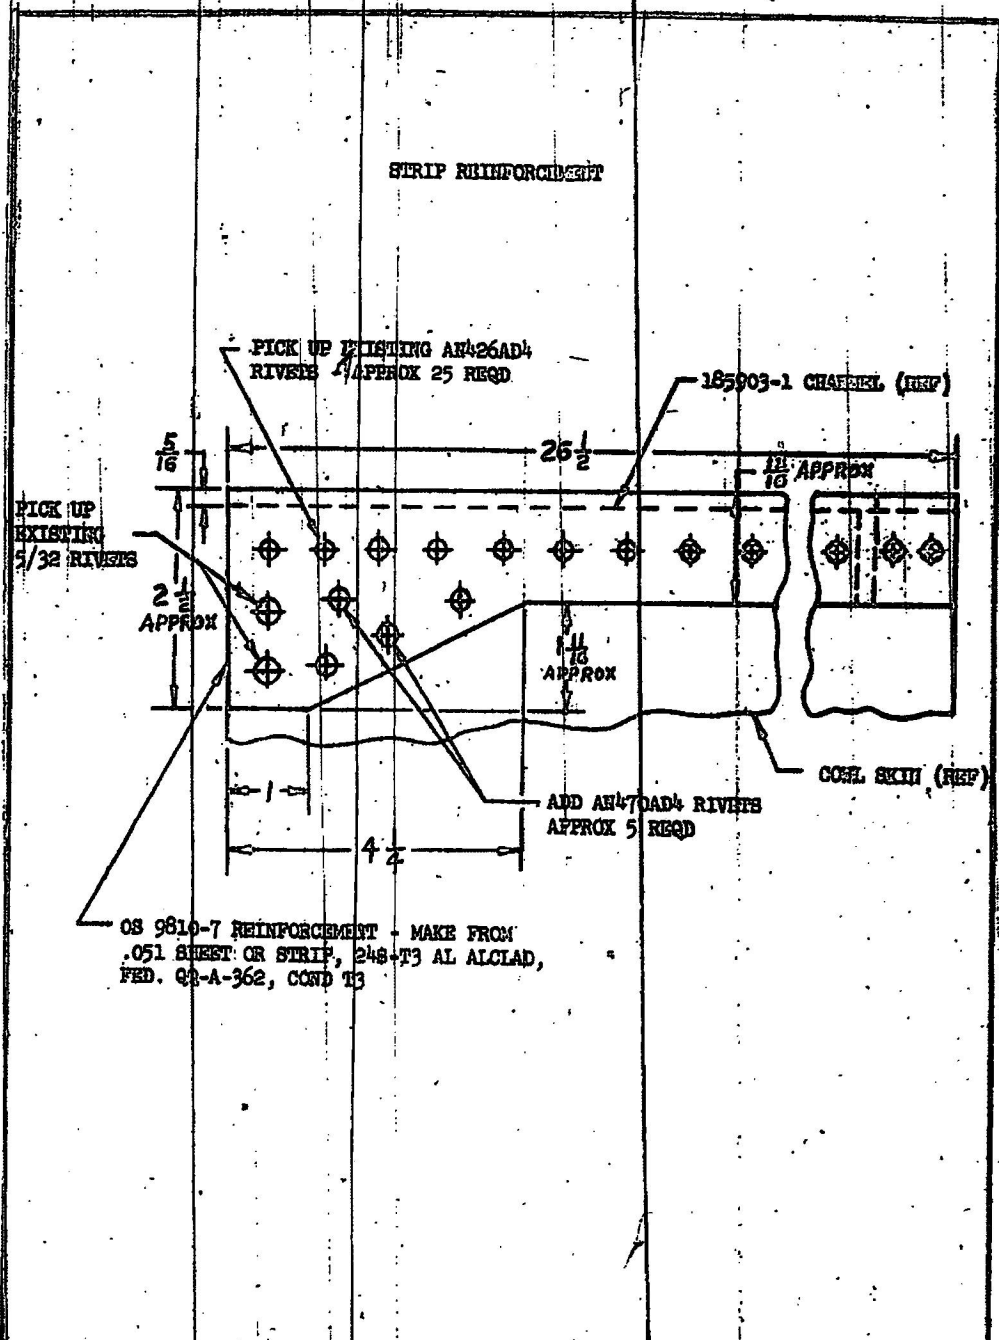
FIGURE 4

(d) Skins that are worn and frayed at the mating edges of the lower cowling will be repaired by adding an OS 9810-7 strip reinforcement as shown in Figure 4 of this specification. Trim the edge of the skin flush with the 185903-1 channel. Remove the outside row of 1/8-inch rivets next to the mating edge and the first two 5/32-inch rivets on the leading edge.

Stop drill skin cracks that do not end in rivet holes and that fall under reinforcement with a No. 50 drill. Disregard cracks that run from rivet holes to the edge of the skin and cracks that run between rivet holes. Make reinforcement and install as shown in Figure 4. Maintain twice rivet diameter edge distance. Smooth all ragged edges of skin before installing reinforcement.

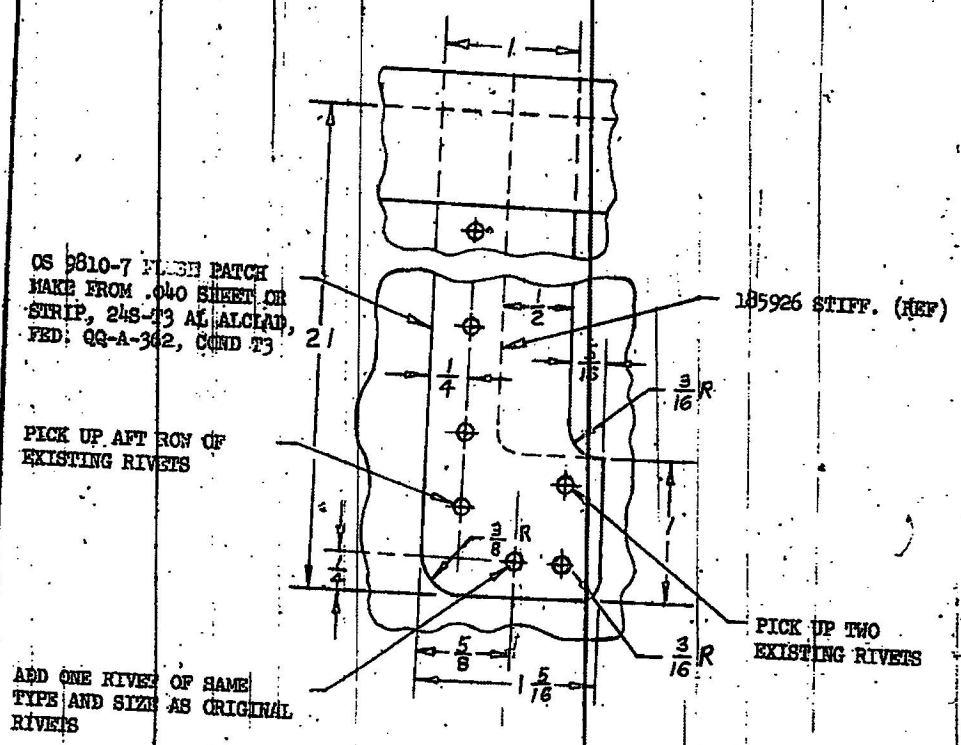
FIGURE 5

(h) Skins that are worn .015 inch or deeper, or that have cracks not exceeding 7/8-inch in length at the trailing edge just forward of the cowl flaps, will be repaired by installing a patch as shown in Figure 5 of this specification. Cut out the skin as shown flush with the trailing edge of the 185926 stiffener. Install the patch as shown. The trailing edge of the patch shall match original trailing edge of the skin which is removed.

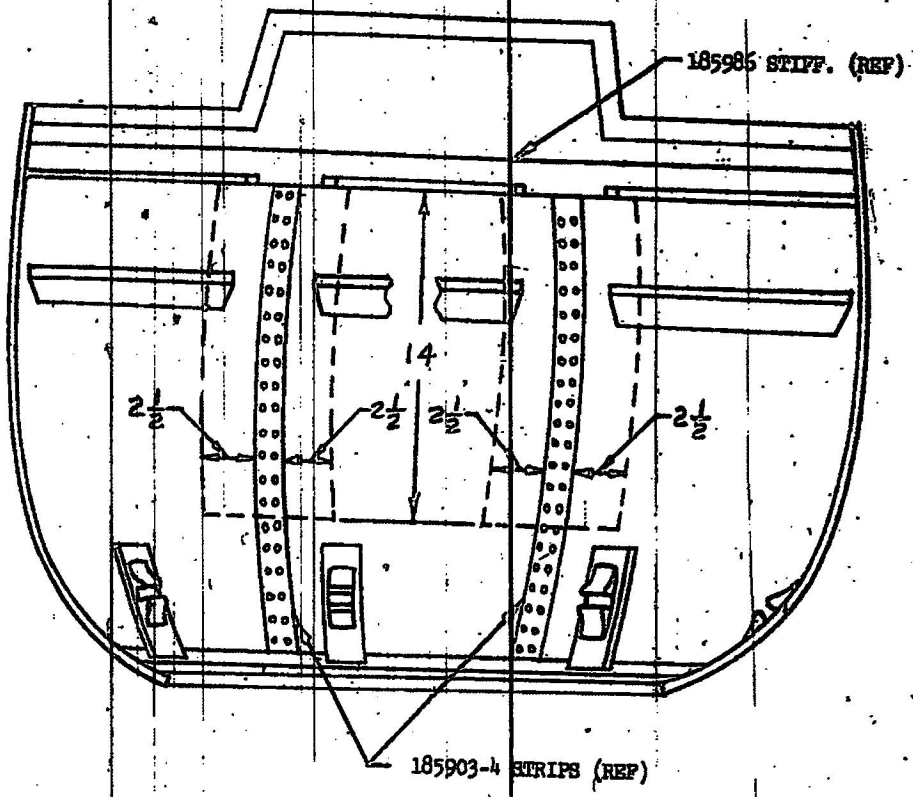
FIGURE 6

(c) Repair skins with holes or abrasions deeper than .015 inch on the outside surface with a plug and doubler type patch as shown in OS 7007. Repairs on skin must also conform to the requirements of Figure 6 of this specification.

ALL RIVETS THAT FALL IN THE AREA DIMENSIONED ABOVE, WHEN MAKING LOWER COWLING SKIN PATCHES, WILL BE FLUSH DRIVEN ON THE INSIDE SURFACE. USE AN470 RIVETS AND MAKE PATCHES IN ACCORDANCE WITH CG 7007 AND/OR FIGURES 7 AND 8 OF THIS SPECIFICATION.

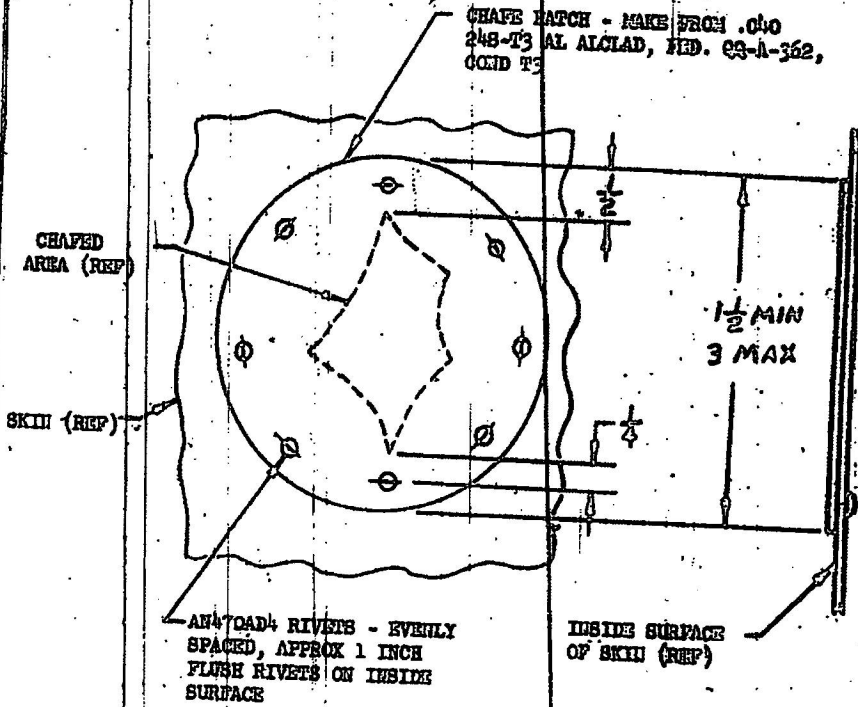
FIGURE 7

- (b) Repair skins which are worn on the inside surface more than .015 inch deep but not more than .020 inch deep by adding a chafe patch as shown in Figure 7 of this specification. Make a round patch, as shown, and form to fit the cowl contour. Corrosion proof chafed area in accordance with FS 370A before installing patch.

(b) Repair skins which are worn on the inside surface more than .015 inch deep, but not more than .020 inch deep, by adding a chafe patch as shown in Figure 7 of this specification. Make a round patch as shown and form to fit the cowl contour. Corrosion proof the chafed area in accordance with FS 370A before installing patch.

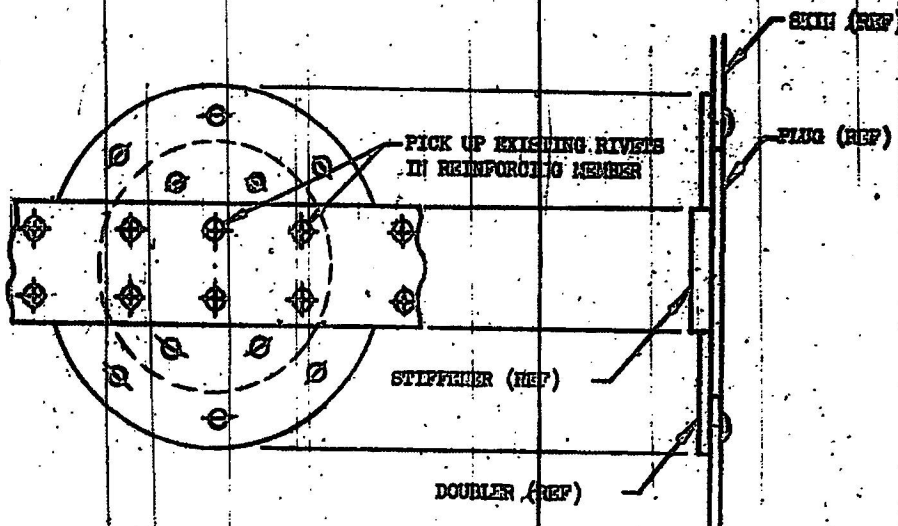
FIGURE 8

- (j) Damaged skin adjacent to structural members requiring repairs will be patched as shown in Figure 8 of this specification.

PATCHES ADJACENT TO STRUCTURAL MEMBERS WILL BE THE SAME AS THE PLUG AND DOUBLER TYPE REPAIRS SHOWN IN CS 7007 EXCEPT THE DOUBLER WILL BE CUT AS SHOWN TO PROVIDE CLEARANCE FOR REINFORCING MEMBER. THE PLUG MUST PICK UP A MINIMUM OF TWO RIVETS IN THE REINFORCING MEMBER.
