ROYAL CANADIAN AIR FORCE

DESCRIPTION AND MAINTENANCE

INSPECTION OF

AIRCRAFT TIRES & TUBES

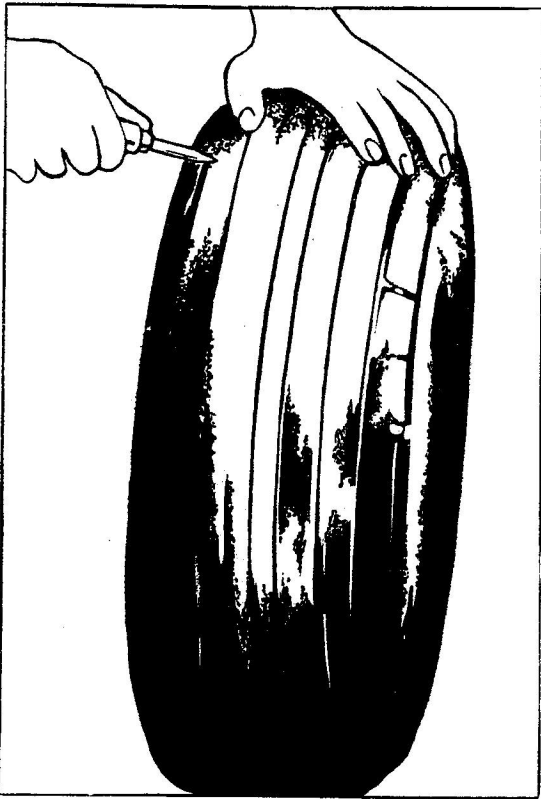
Figure 1-11 Inspecting for Cuts, Nail Holes, Stones and Glass

- (e) Go over the tread and sidewall of the tire carefully. Look for cuts - remove pieces of glass, stones, nails, or any other foreign objects embedded in the tread. It is recommended that a blunt awl be used for this purpose, although a medium sized screwdriver can be used if an awl is not available. In probing for foreign material, care is to be exercised so as not to drive the awl or screwdriver into the cord body of the tire, or to enlarge the injury.

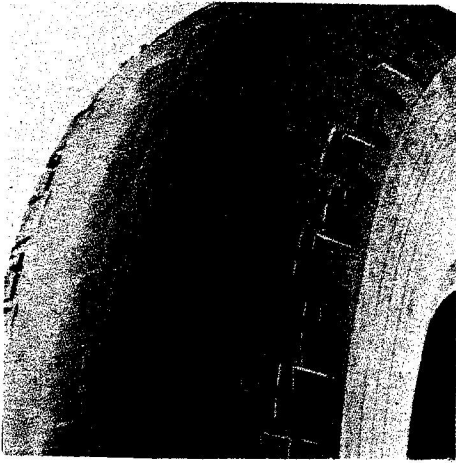
Figure 1-22 Showing a Cover Worn to the Base of the Tread Pattern

20 Tread wear may be either normal general wear or wear in one part of the tread only, which produces a "flat spot". It is difficult to assess the extent of wear on smooth-treaded tires, but the depth of the pattern grooves is a good guide for pattern treaded tires. After the tread has worn to the bottom of the grooves, 25% to 30% of the total tread thickness remains.
