STRUCTURAL REPAIR MANUAL REPAIR SCHEME TO STRIKE - CLUTCH RELEASE PEDAL COVER

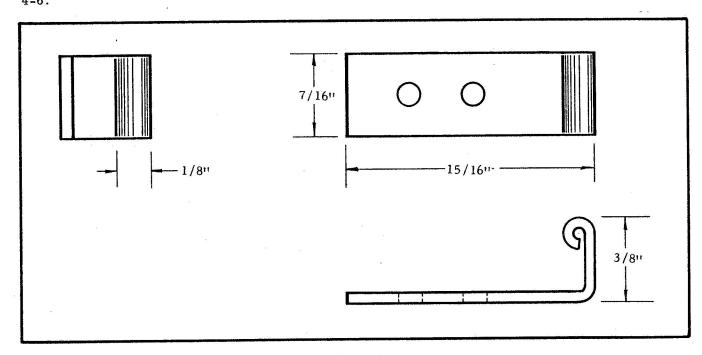
Figure 1

The strike Part 404-188951 is frequently found damaged, necessitating replacement.

- 2 Carry out the replacement in accordance with the following information:-
- (a) Remove the damaged strike by drilling the two rivets using a 3/16" drill.
- (b) Locally manufacture the strike in accordance with Figure 1, using .048 4130 steel.
- (c) Fit strike to plate item 2B, Figure 27, EO 05-45B-4 using cherry rivets 28NS/CR163-4-6.
