EO 05-1-2L

ROYAL CANADIAN AIR FORCE

**SELF-SEALING FUEL & OIL
CELLS PACKING, STORAGE,
MAINTENANCE & SALVAGE**

25 AUG 60

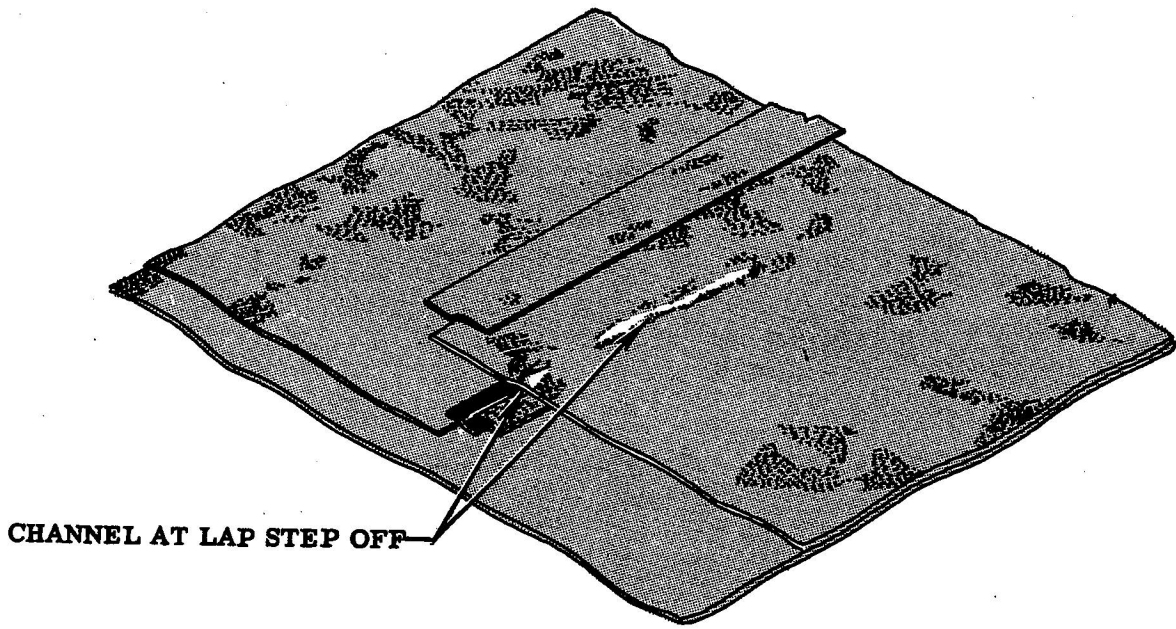
Figure 5

(13) Channels at tapered construction step-off area or edge of lap splices of any ply.	1/4-inch maximum width entire length of lap (see figure 5).
(14) Open end channels in three-ply liner overlaps or tailored corners.	1/8-inch by 3-inch maximum dimension provided 1-inch minimum bond is maintained between end of channel and sealant (see figure 4).

(13) Channels at tapered construction step-off area or edge of lap splices of any ply.	1/2-inch maximum width (see figure 5).
(14) Open end channels in three ply liner overlaps or tailored corners.	1/4-inch by 3-inch maximum dimension provided 1-inch minimum bond is maintained between end of channel and sealant (see figure 4).
