LIST OF SPECIAL INFORMATION EXPEDITOR

(This EO replaces EO 05-45B-5A dated 26 Aug 66)

* Asterisks appearing opposite entries denote changes since last issue
ISSUED ON AUTHORITY OF THE CHIEF OF THE DEFENCE STAFF

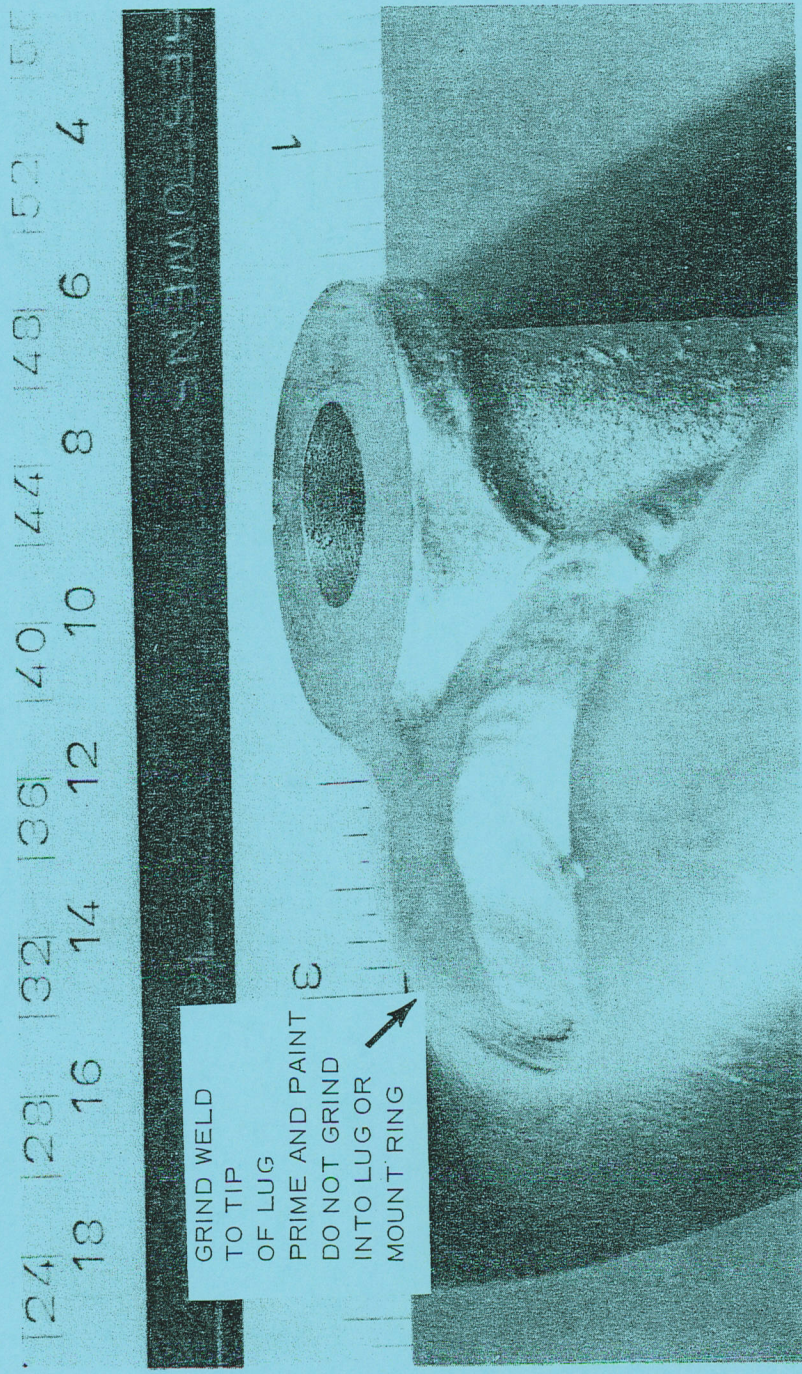
Figure 1

1 The purpose of this Engineering Order is to bring to the attention of operating units, that improper machine finish of engine mount brackets (refer to Figure 1) have been reported from the field. Such a condition results in inner cowling cracks when engine mount brackets come in contact and wear on the curvature of inner cowling ring.

Improper grinding in this area may induce fatigue problems and could seriously affect the strength of the engine mount.

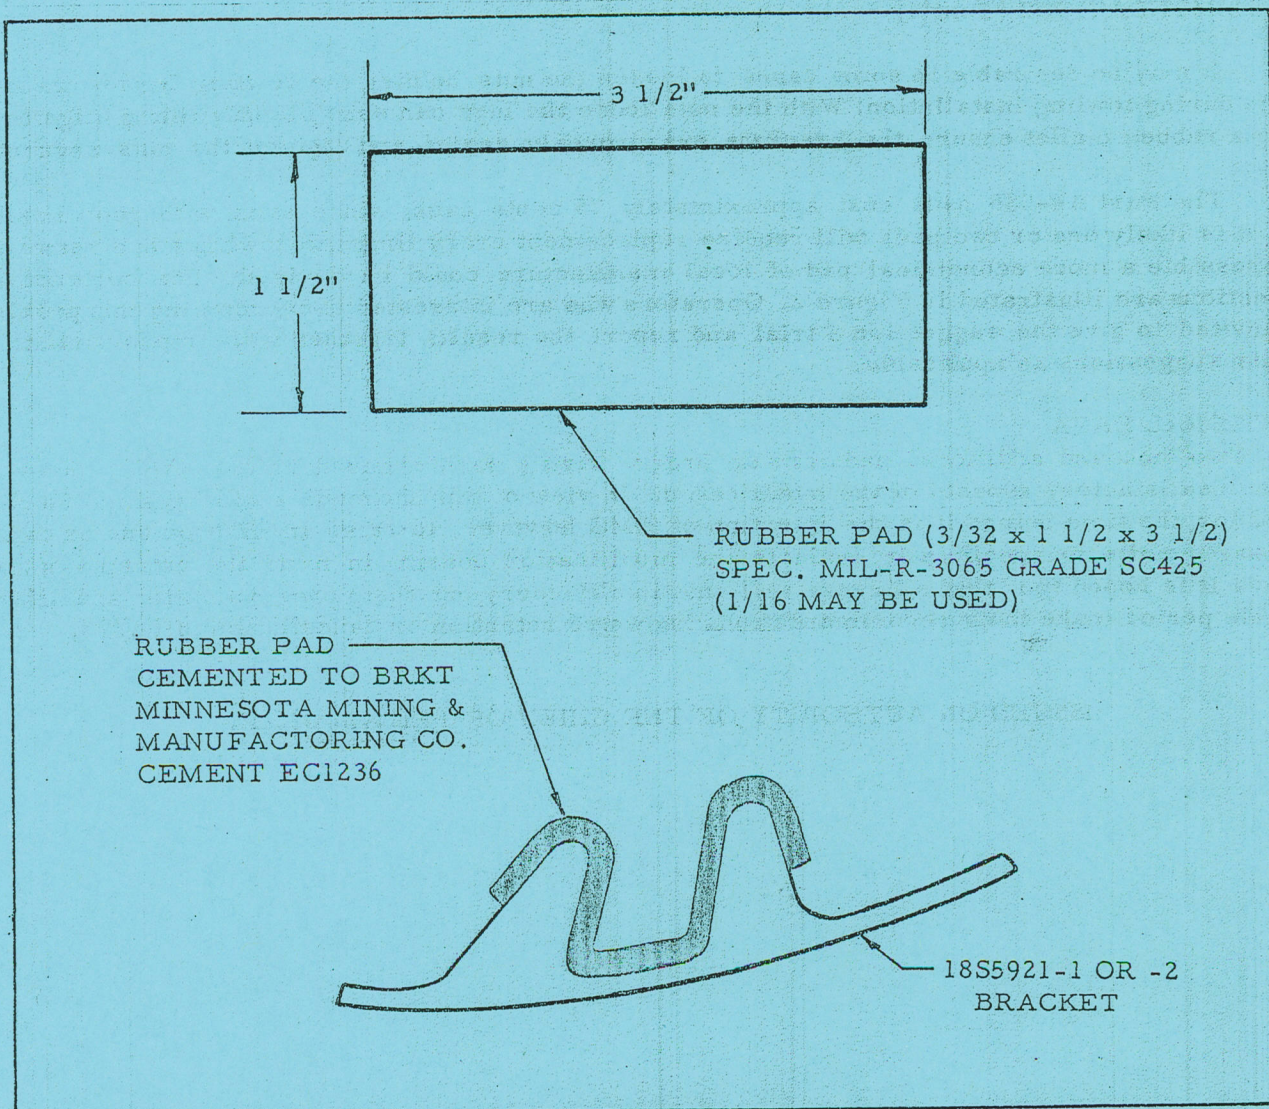
Figure 1

- (a) The adjustment difficulties, where there is a gap found between the upper and lower cowlings, are probably due to the Part 18S5937 anti-torque plates preventing correct cowling positioning or a distortion of the cowling curvature which prevents snug seating of the male and female cowl brackets.
- (b) Pad tearing is caused by burrs and sharp edges on the male and/or female brackets, by rough handling during removal and replacement of cowlings, by pads becoming partially unseated during cowling installation and tearing when cowling tightened with pads out of position, or any combination of the above.

INSTALLATION WITH NO WASHERS PRIOR
TO EMBODIMENT OF EO 05-45B-6A/85
THIS INSTN. REQUIRED FOR PROPOSED
MODIFICATION SHOWN FIGURE 2.

(g) It may be desirable in some cases to loosen the nuts holding the cowling lugs to the cylinders during cowling installation. With the nuts loose the lugs can shift slightly aiding alignment; using a rubber mallet ensure the brackets are properly seated and tighten the nuts securely.

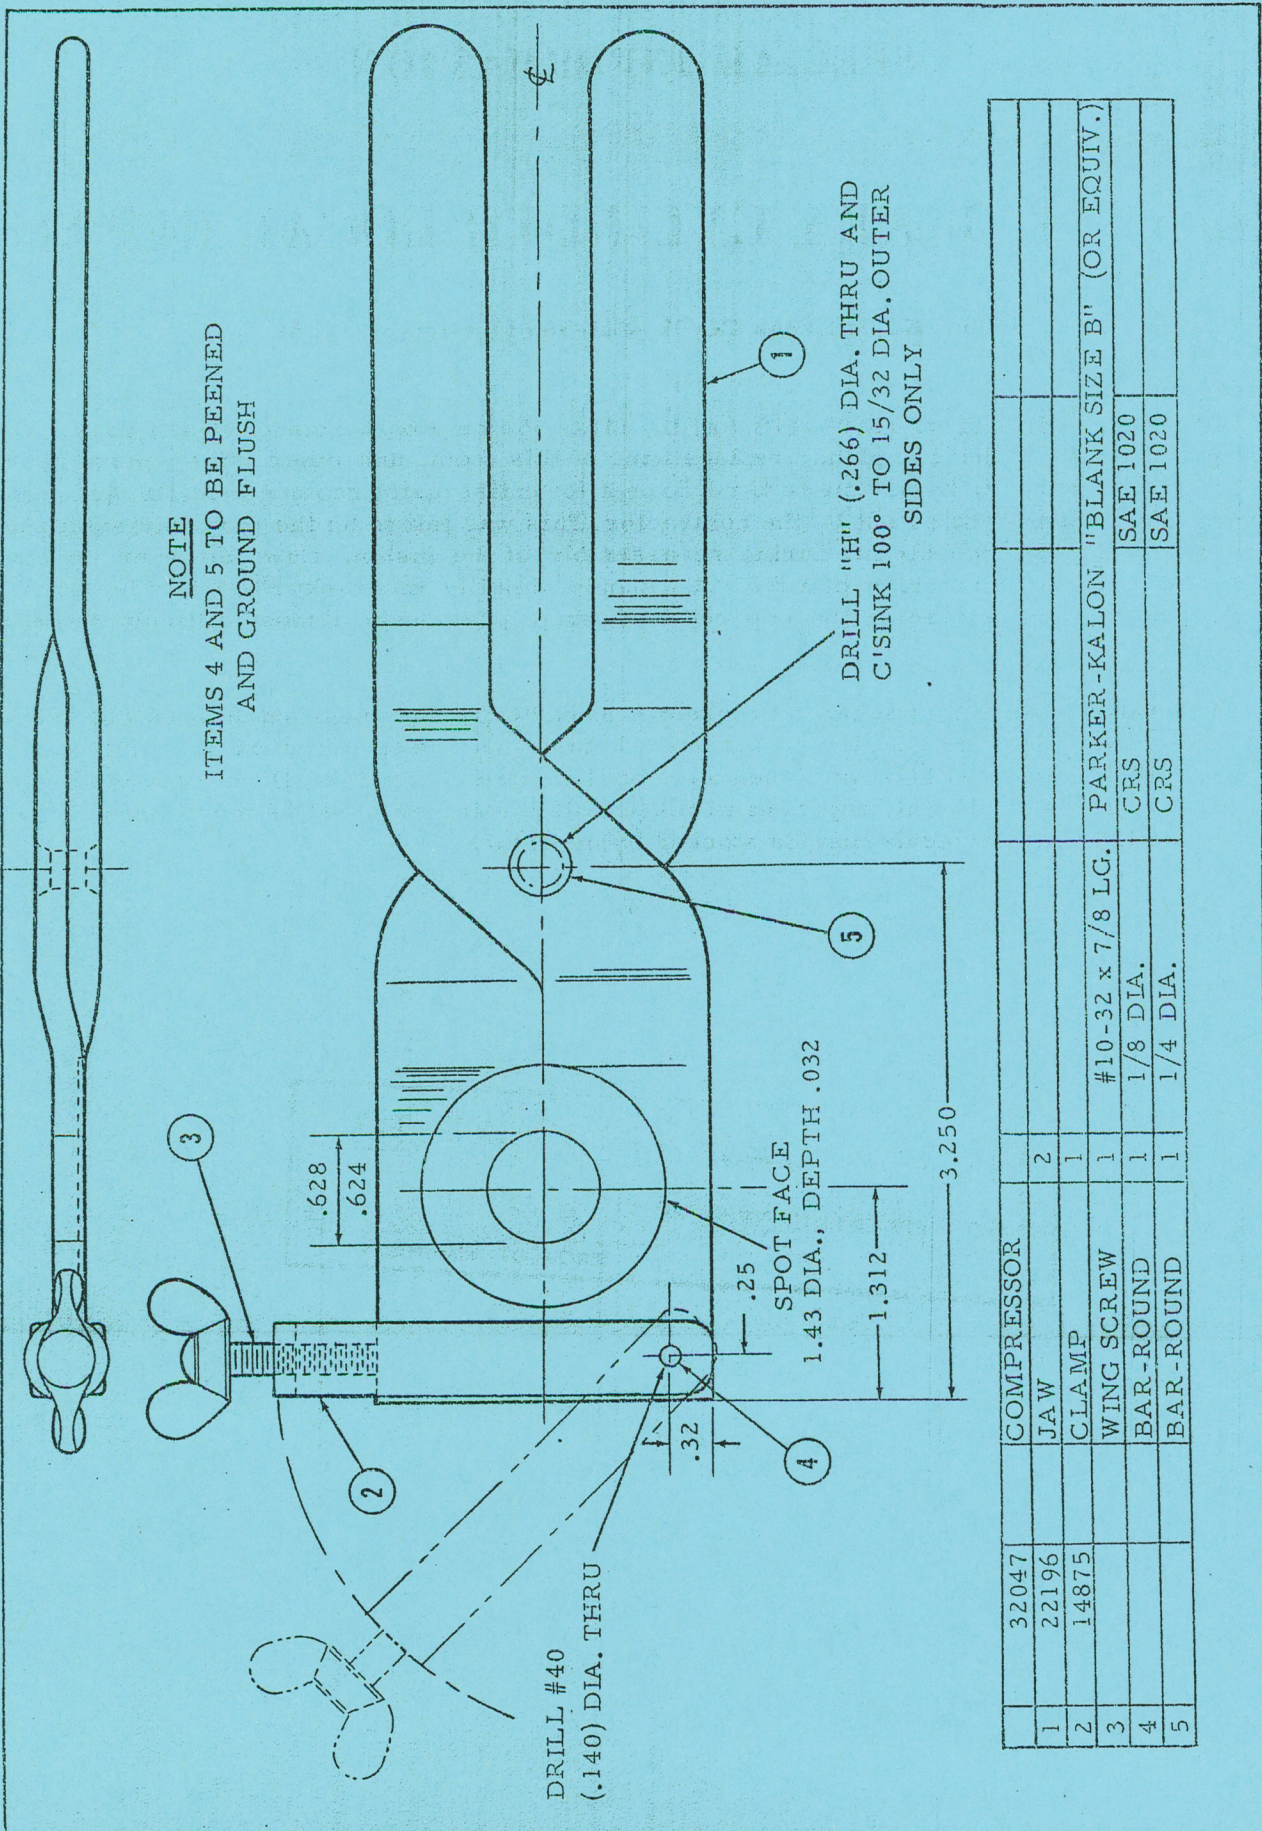
1 Further to the problem outlined in EO 05-5B-5A/21, an additional snag has been encountered by one operator when installing the latest design of Part 694-187800 cylinders. It will be noted from Figure 1 that the inlet boss on the later type of cylinders is located further aft than on the older type and is of increased height; on some aircraft installation of these later type cylinders on the co-pilot side will result in chafing of the rudder balance cable on the tee or elbow inlet fittings. The older type are quite satisfactory in any location.

2 Since there are approximately 1400 of the old type and only 120 of the later version it is recommended that whenever possible the new ones be reserved for use on the pilot side. When this becomes impossible or impractical bridging of the balance cable may be effected by local manufacture of a tube assembly and fitment as shown in Figure 2.

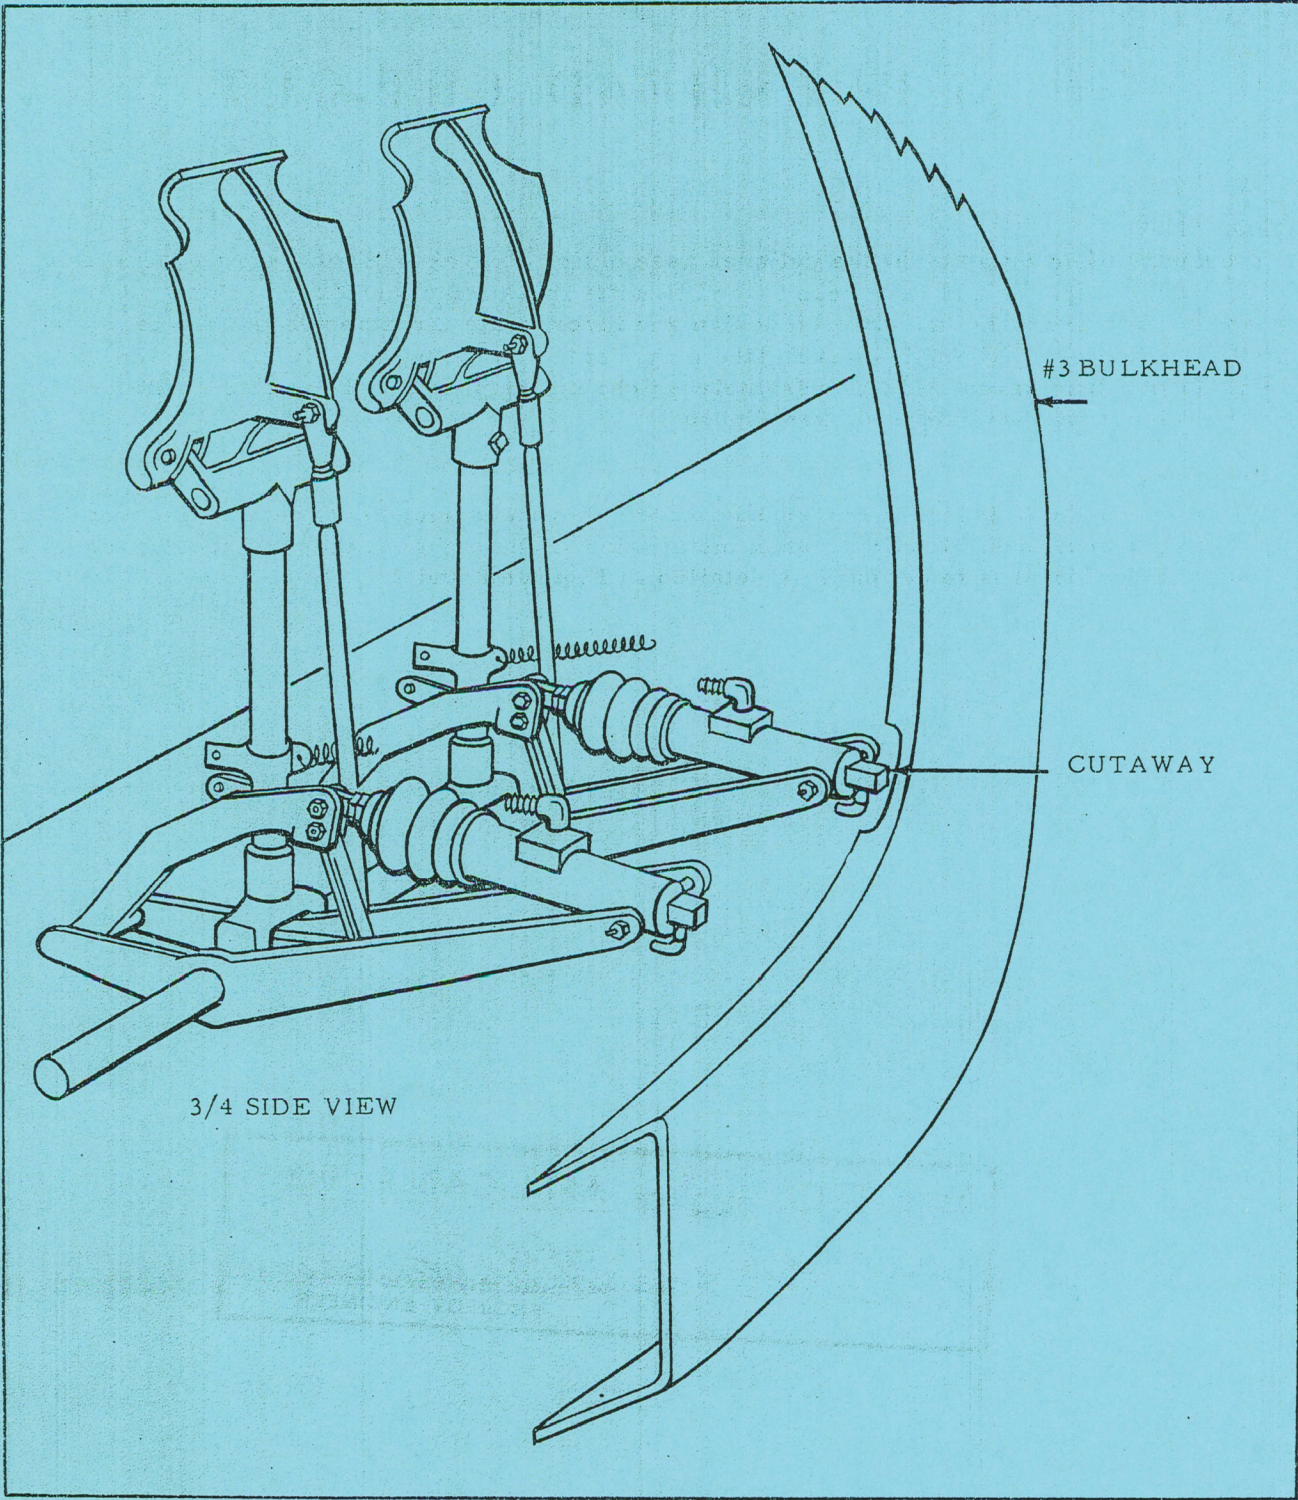
Figure 1

2 Wherever possible it is recommended that the above described cylinders be located in the inboard cylinder positions. However, when installation in the outboard position(s) is unavoidable a cut-out on #3 bulkhead is to be made as detailed in Figures 2 and 3
