ENGINEERING MEMORANDUM

REPAIR OF CRACK - TAIL WHEEL FORK

12057

PART NO. 404-188675		PART NAME Fork assy. tail wheel		JOB NO. 10-4635		CUSTOMER'S ORDER NO.		COPIES TO	
USE OF E.M.		DISPOSITION OF STOCK		ORIGINATED BY		CUSTOMER		NO	
SALVAGE	✓	CHECK BLOCKS AFFECTED	AS NOTED	<i>A. J. ...</i> P. A. W. PROJ. ENG.	ENG.	INSPEC	PROG.	PLANNING	2
CONCESSION		NOT AFFECTED	SCRAP		ESTIMATING	2	2	2	1
STOP ORDER/RELEASE		PARTS COMPLETED	REWORK	<i>J. ...</i> P. W. INSPECTION	MAT. CONT.	CONT. ADM.	R.C.A.F.	3	9
NEW DRAWING		PARTS IN PROCESS	USE TO DEPLETION		AIRCRAFT REGISTRATION NO.	1	3	1	2
REVISED DRAWING		TOOLING	STRENGTH AFFECTED	DATE	Aug. 28/56	DWG. CHANGE	YES	NO	1
VARIATION		RAW MAT'L	YES	NO	YES	NO			4
OBsolete NOTICE		INTERCHANGEABILITY AFFECTED	NO	YES	NO				
USE AS NOTED

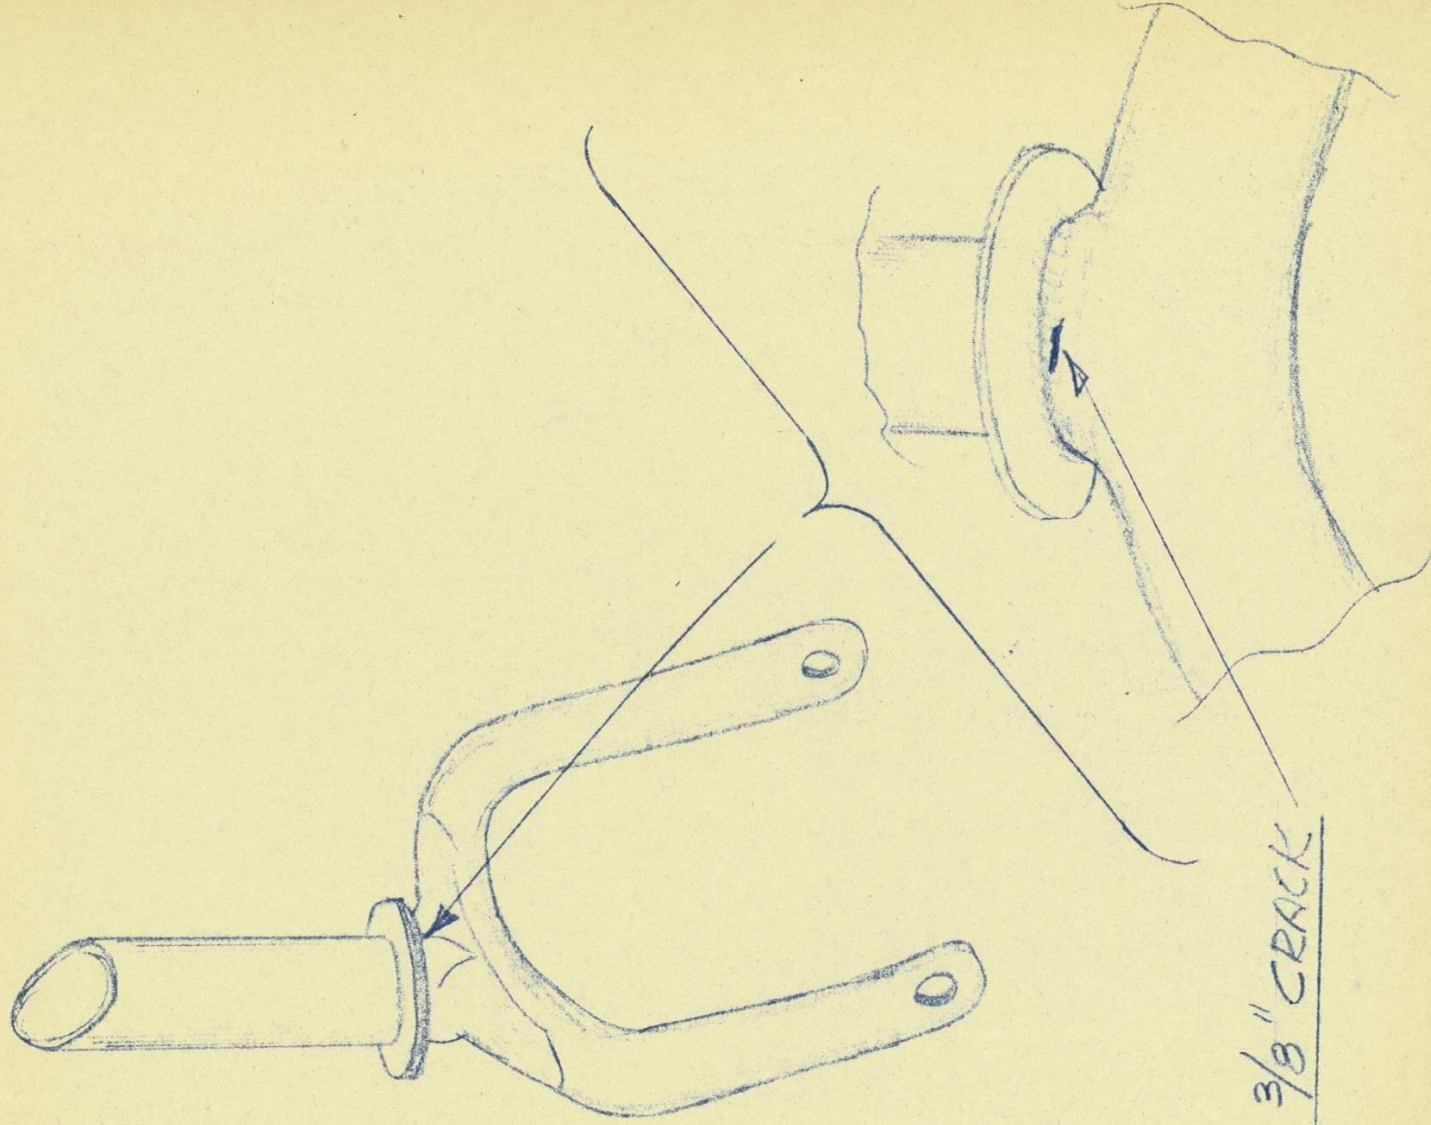
The approximately 3/8 inch crack found in the weld between the flange and the fork, is to be repaired as follows:-

1. Grind out crack
 2. Pack with wet asbestos mud as close to area to be welded as possible.
 3. Pre heat to 800° F.
 4. Weld area previously removed in step 1. (Welding rod per MIL-E-6843 class C)
 5. Post heat to 800° F.
 6. Magnaflux repair area
 7. Clean, prime and paint
- Special notes:
1. This is a heat treated component
 2. This repair applies to W/O 10-4635 only
 3. Since heat treatment is destroyed in a small area only, this repair is considered satisfactory.
